## 6. 내 리 교

## 손상현황

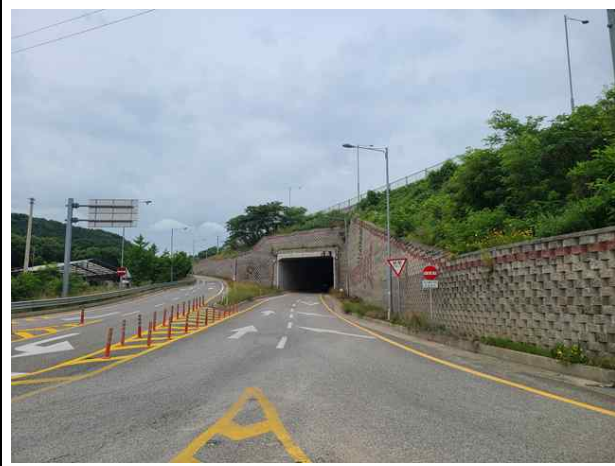
측면 전경

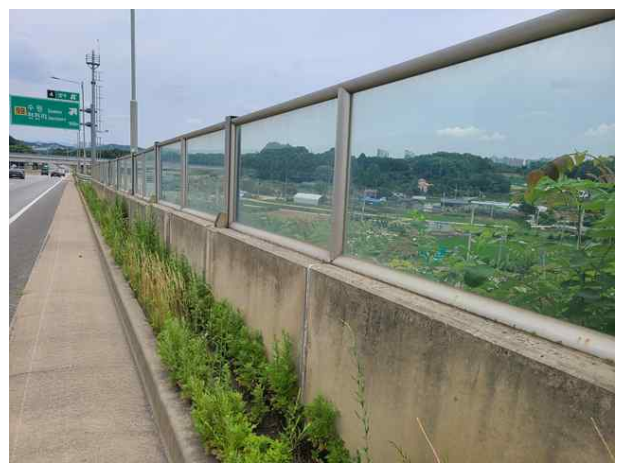
난간 및 연석 전경

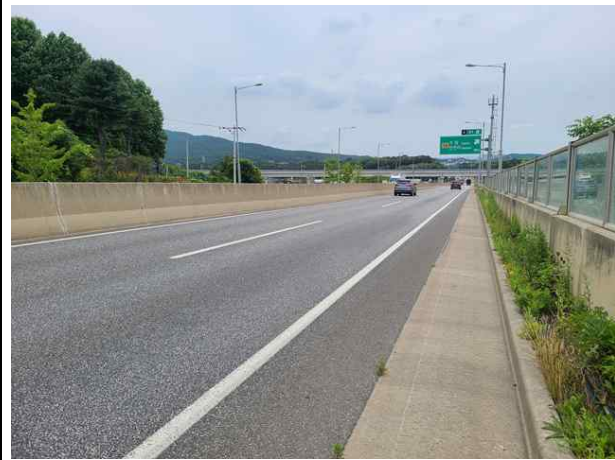
교면포장 전경

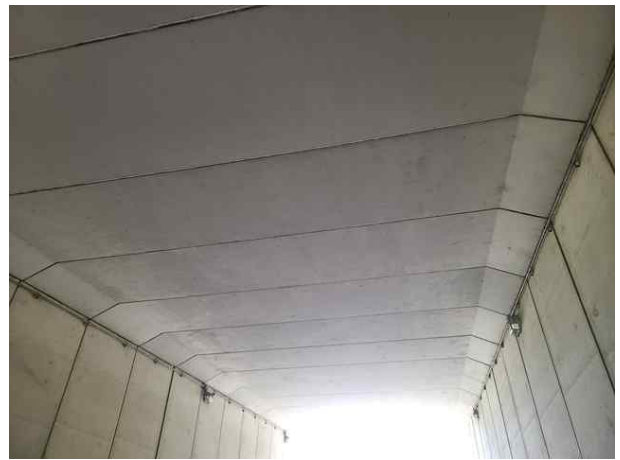
바닥판하면 전경

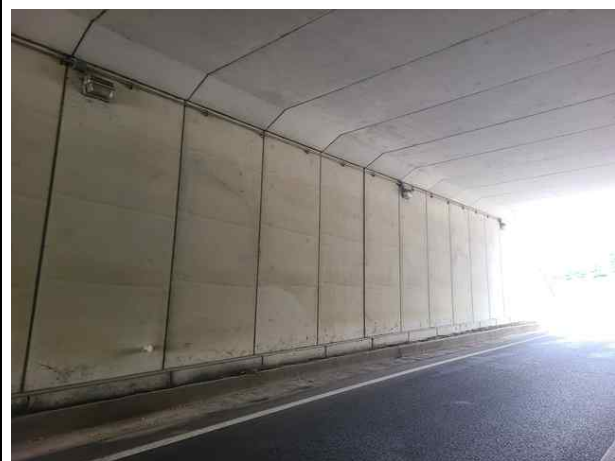
교대 전경

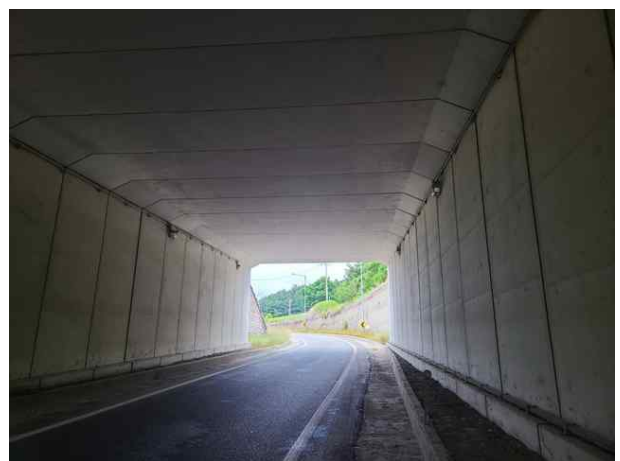
하부 전경

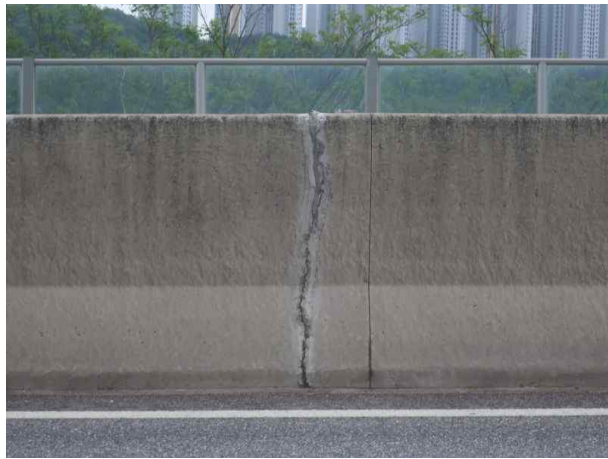
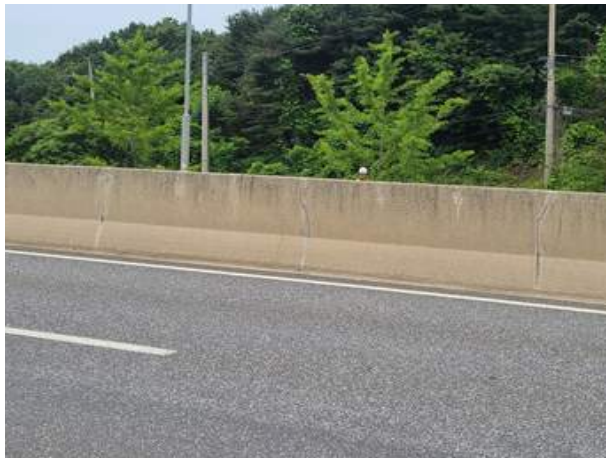
| 01<br>(25년 상반기) | 난간 및 연석(S1) 중분대<br>균열(0.3mm이상) | 01<br>(26년 상반기) | 난간 및 연석(S1) 중분대<br>균열(0.3mm이상) |

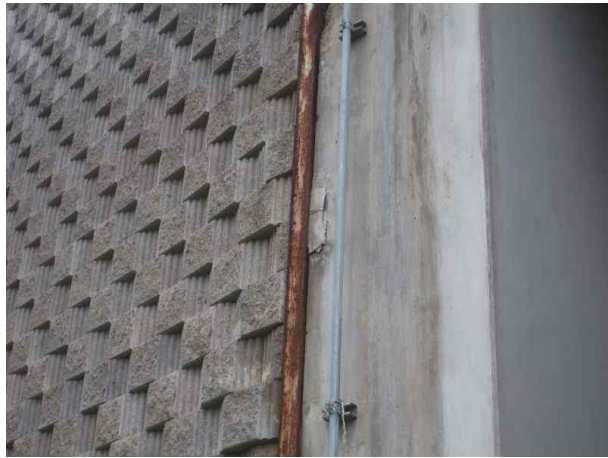
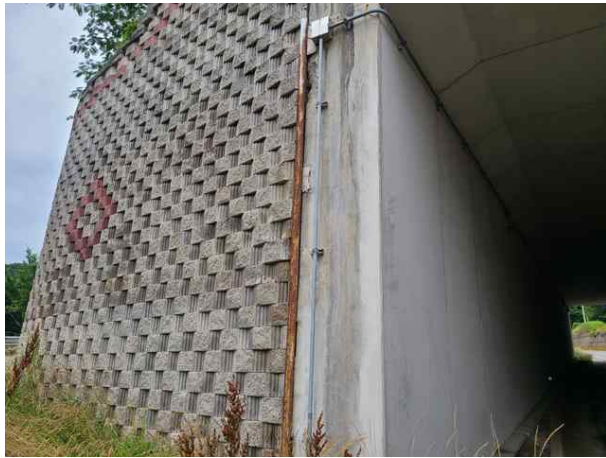
| 02<br>(25년 상반기) | 바닥판하면(S1) 측면 균열 | 02<br>(26년 상반기) | 바닥판하면(S1) 측면 균열 |

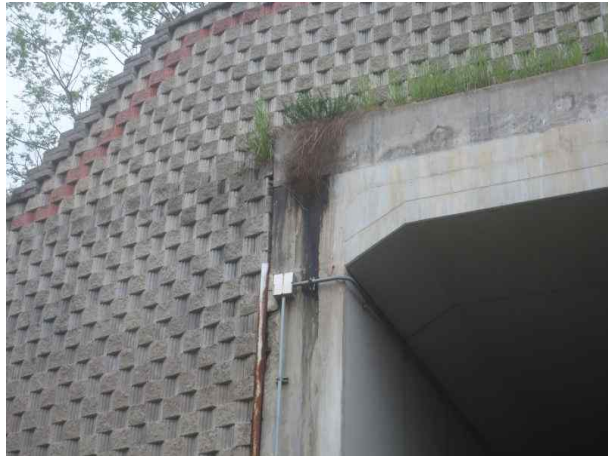
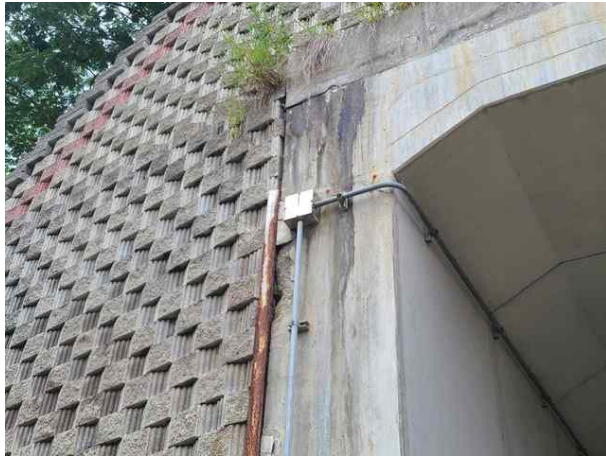
| 03<br>(25년 상반기) | 바닥판하면(S1) 측면 박락 | 03<br>(26년 상반기) | 바닥판하면(S1) 측면 박락 |
