## 2. 샘 내 I C 1 교

# 손상현황

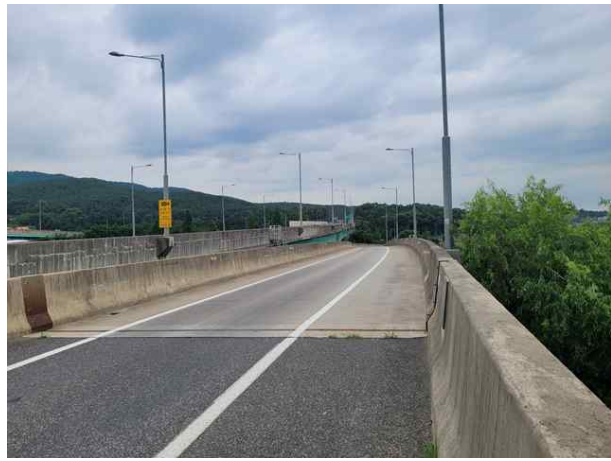
교면포장 전경

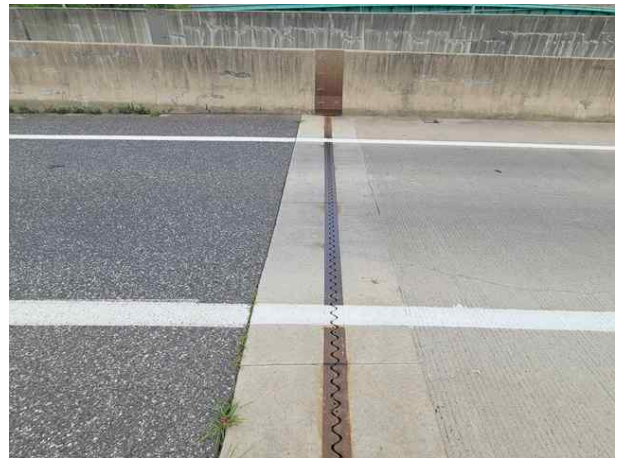
신축이음장치 전경

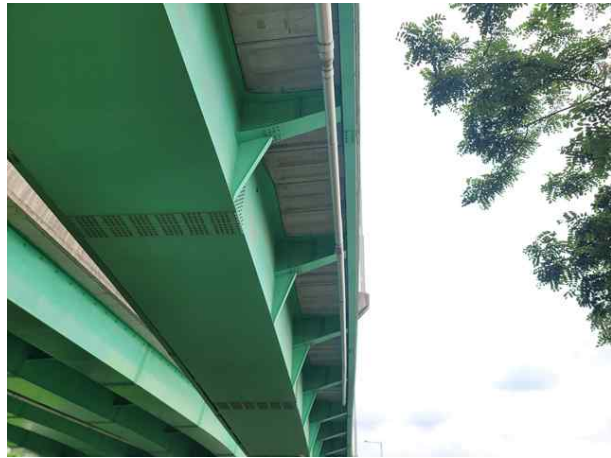
바닥판하면 전경

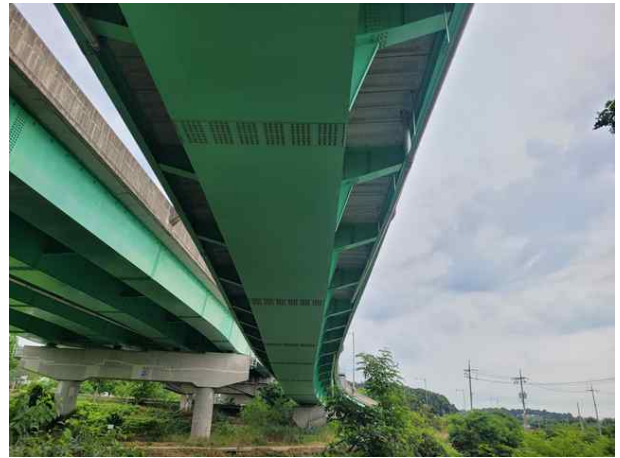
거더 전경

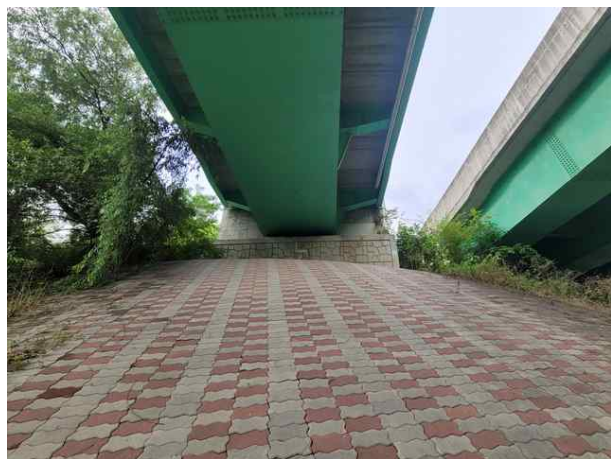
교대 전경

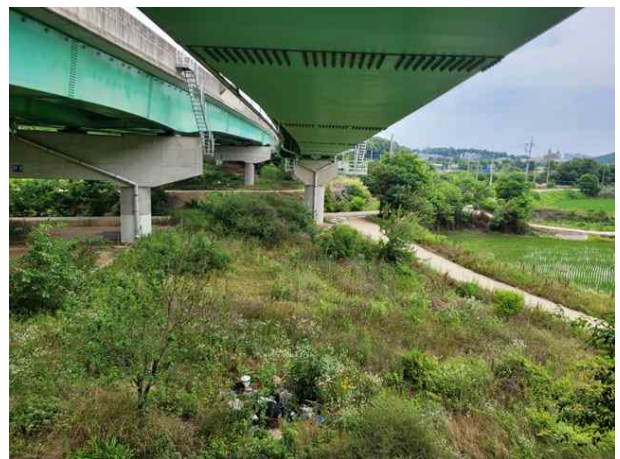
교각 전경

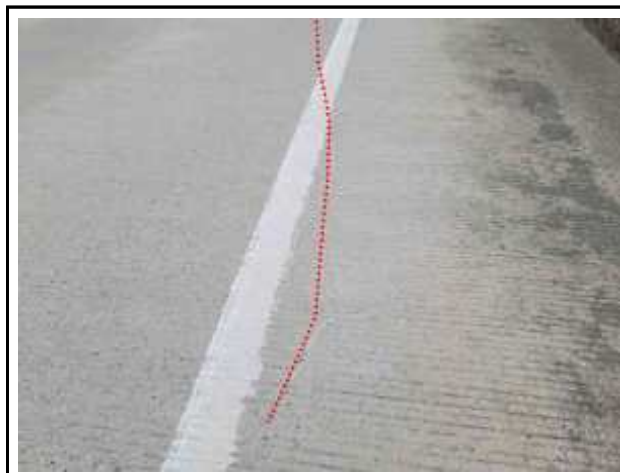
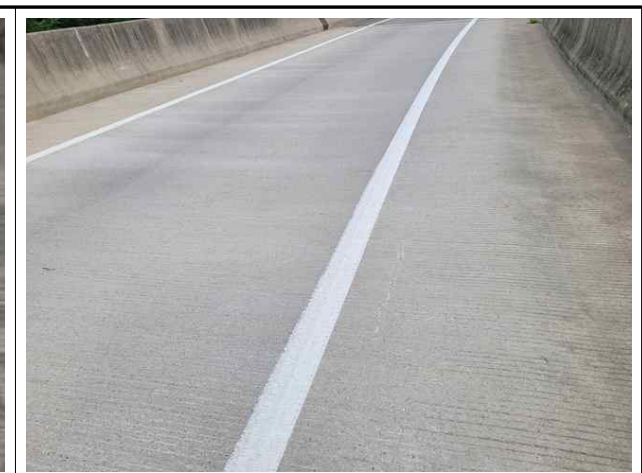
| 01<br>(25년 하반기) | 교면포장(S3) 포장 균열 | 01<br>(26년 상반기) | 교면포장(S3) 포장 균열 |

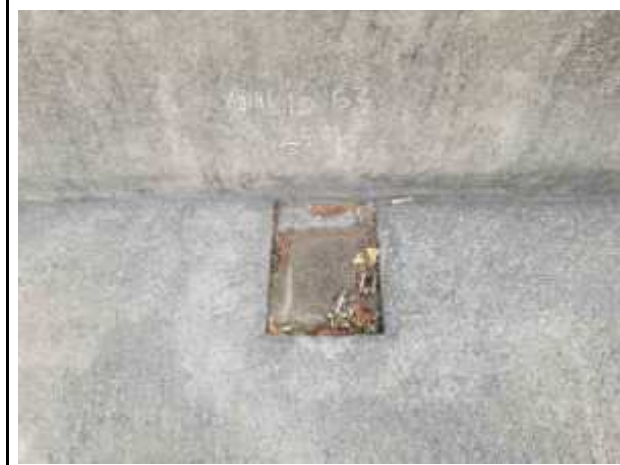
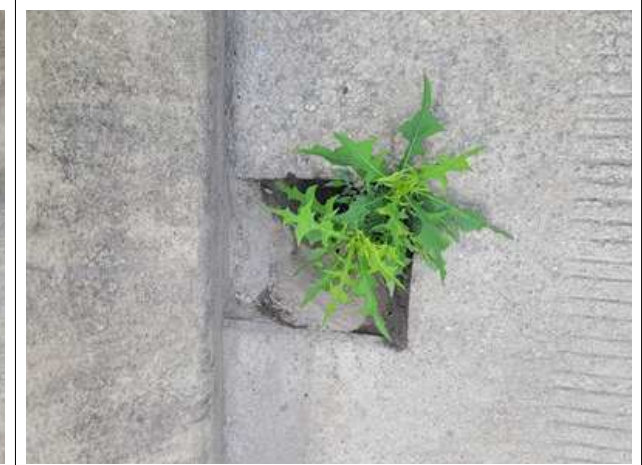
| 02<br>(25년 하반기) | 배수시설(S3) 배수구 막힘 | 02<br>(26년 상반기) | 배수시설(S3) 배수구 막힘 |

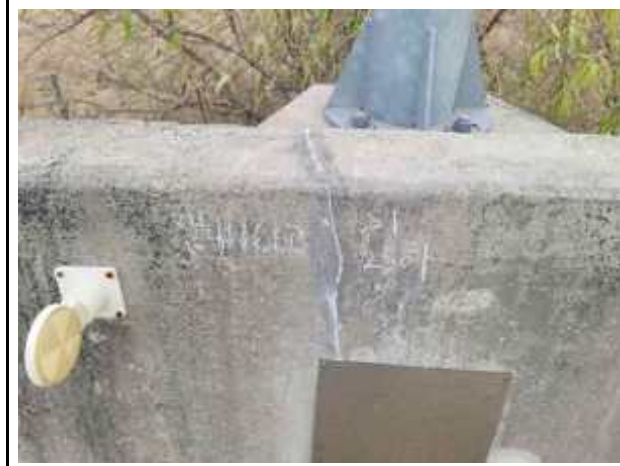
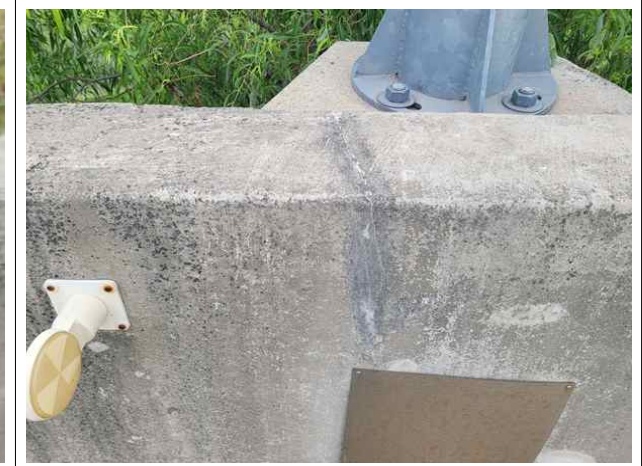
| 03<br>(25년 하반기) | 난간 및 연석(S1) 방호벽 보수부 재균열 | 03<br>(26년 상반기) | 난간 및 연석(S1) 방호벽 보수부 재균열 |

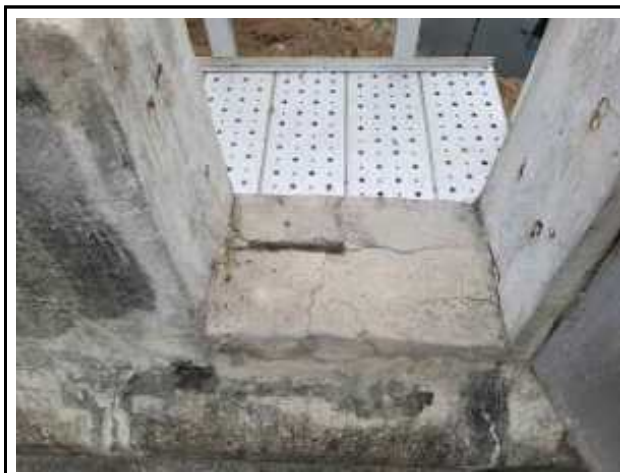
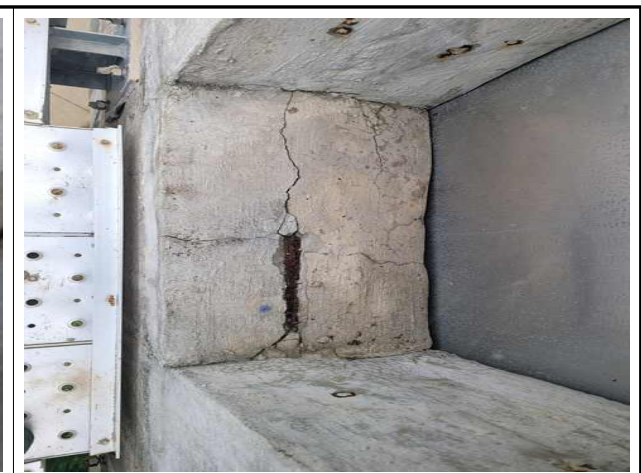
| <div>04</div> <div>(25년 하반기)</div> | <div>04</div> <div>(26년 상반기)</div> |

| 신축이음(A1) 후타재 단차 | 신축이음(A1) 후타재 단차 |

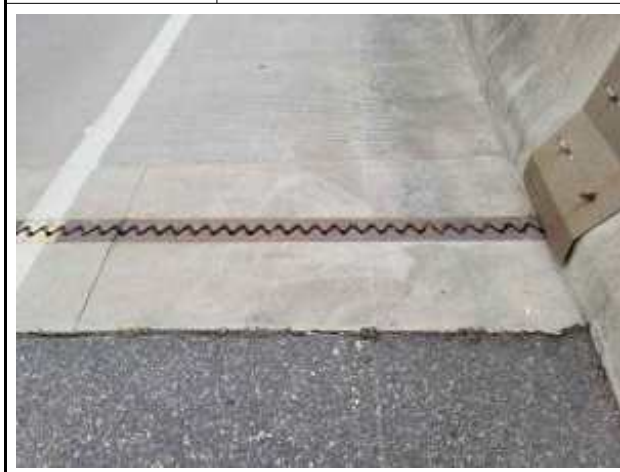
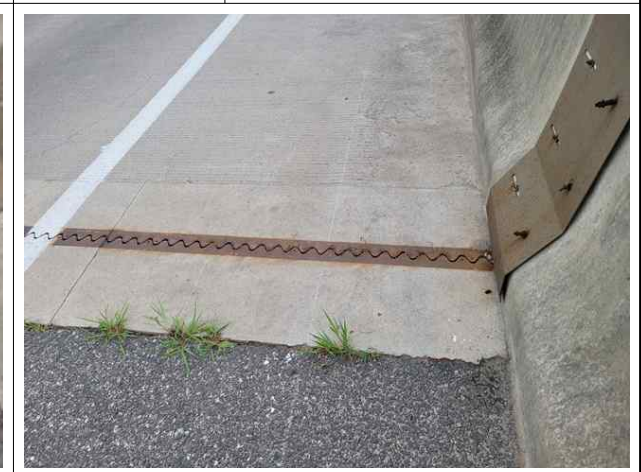
| <div>06</div> <div>(25년 하반기)</div> | <div>06</div> <div>(26년 상반기)</div> |

| 신축이음(A2) 후타재 단차 | 신축이음(A2) 후타재 단차 |

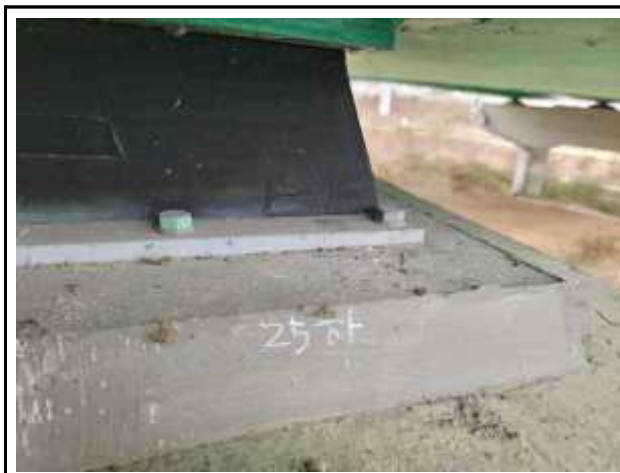
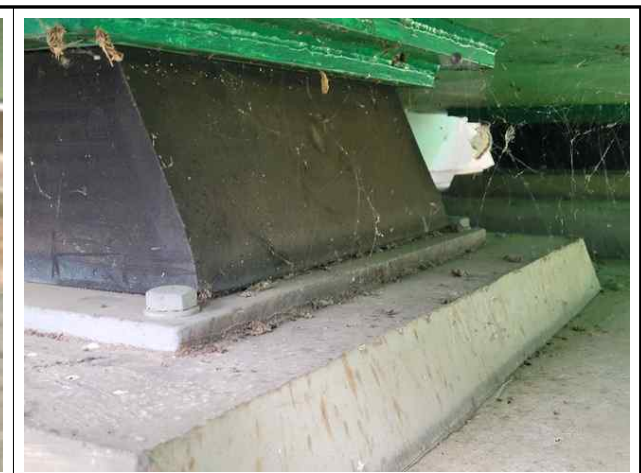
| <p>10<br/>(25년 하반기)</p> | <p>10<br/>(26년 상반기)</p> |

| <p>교량받침(A1-SH2) 받침 고무 들뜸</p> | <p>교량받침(A1-SH2) 받침 고무 들뜸</p> |

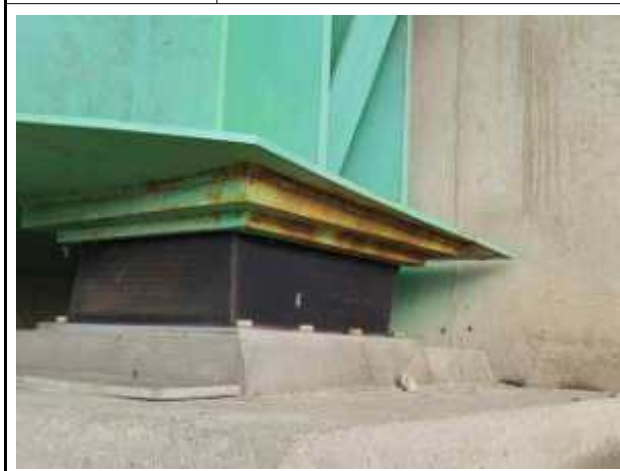
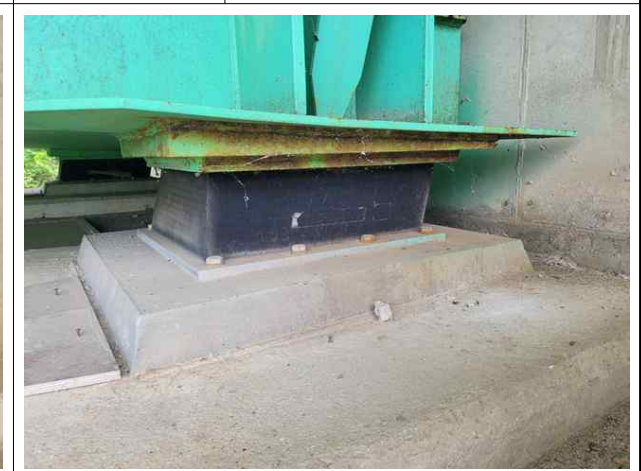
| <p>11<br/>(25년 하반기)</p> | <p>11<br/>(26년 상반기)</p> |

| <p>교량받침(A2-SH2) 받침 플레이트 부식</p> | <p>교량받침(A2-SH2) 받침 플레이트 부식</p> |

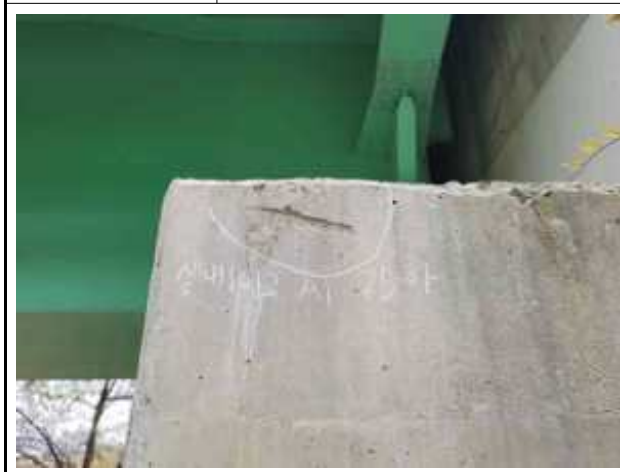
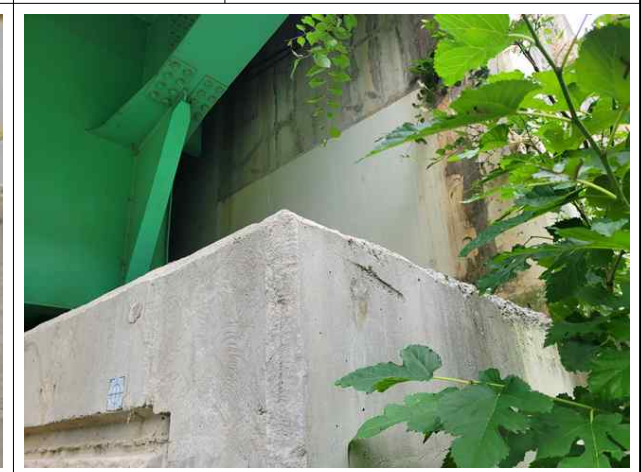
| <p>12<br/>(25년 하반기)</p> | <p>12<br/>(26년 상반기)</p> |

| <p>교대(A1) 파손</p> | <p>교대(A1) 파손</p> |

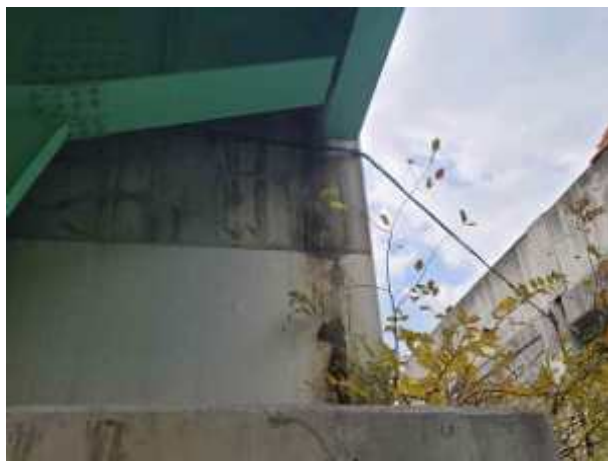
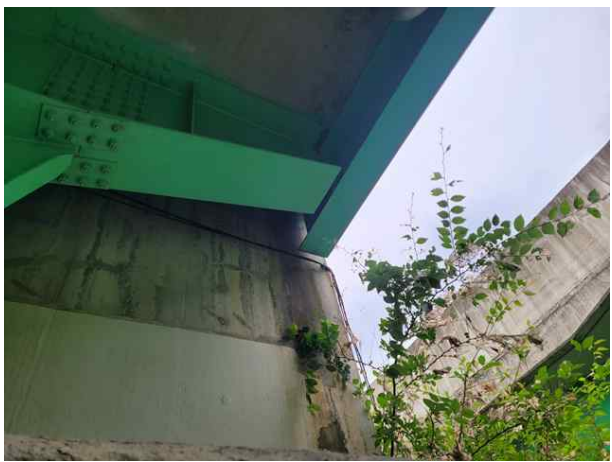
| 13<br>(25년 하반기) | 교대(A1) 표면오염 | 13<br>(26년 상반기) | 교대(A1) 표면오염 |

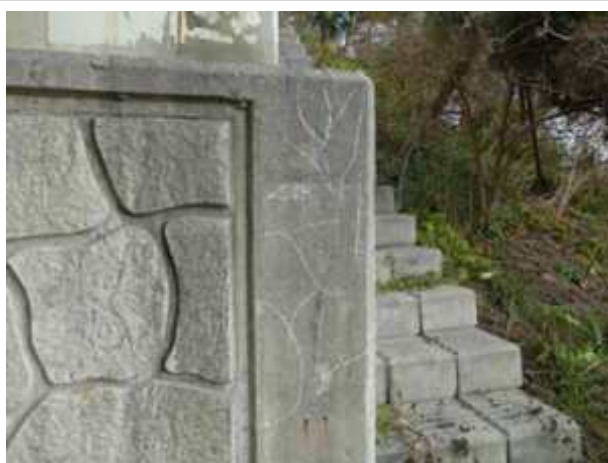
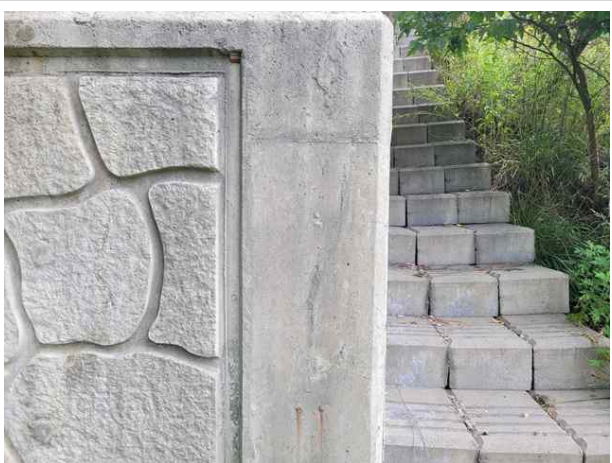
| 14<br>(25년 하반기) | 교대(A2) 망상균열(0.3mm미만) | 14<br>(26년 상반기) | 교대(A2) 망상균열(0.3mm미만) |

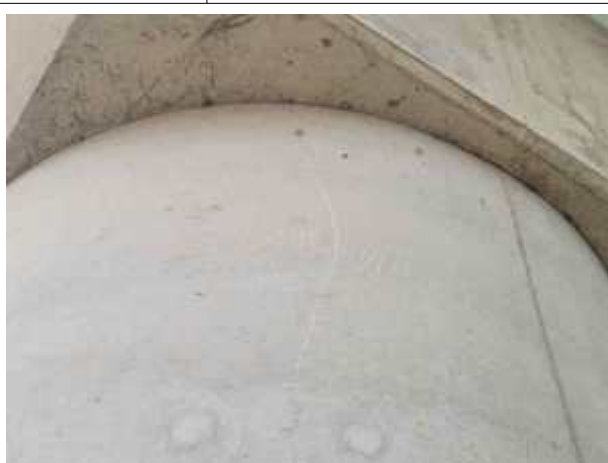
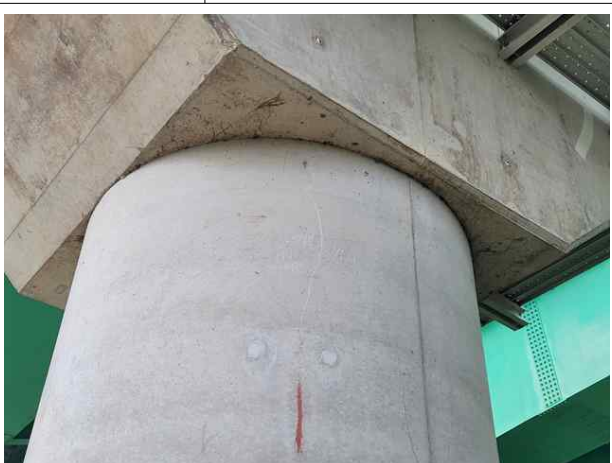
| 15<br>(25년 하반기) | 교각(P1) 균열(0.3mm미만) | 15<br>(26년 상반기) | 교각(P1) 균열(0.3mm미만) |
