4. 천 천 I C 1 교

# 손상현황

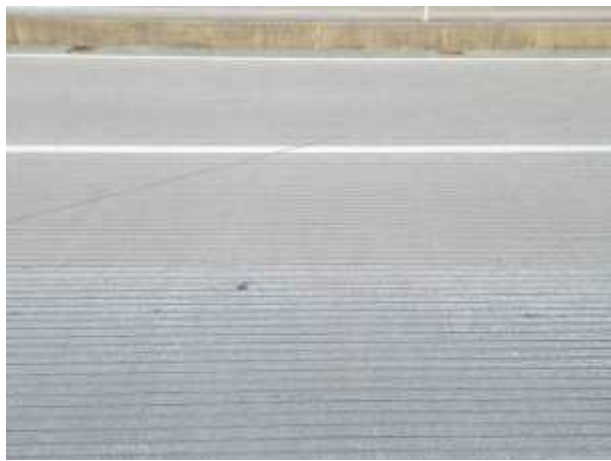
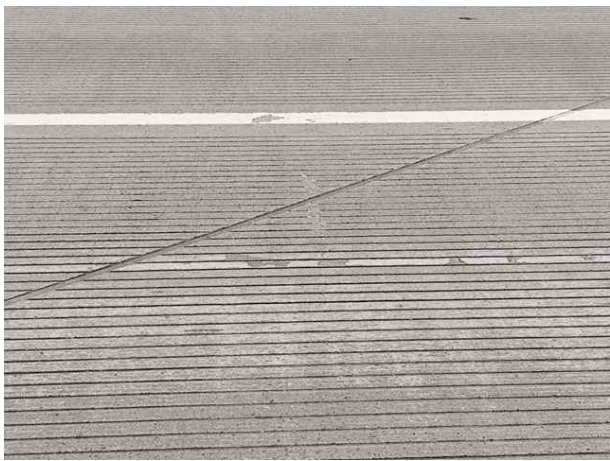
| 01<br>(25년 하반기) | 교면포장(S2) 매송방향 포장 균열 | 01<br>(26년 상반기) | 교면포장(S2) 매송방향 포장 균열 |

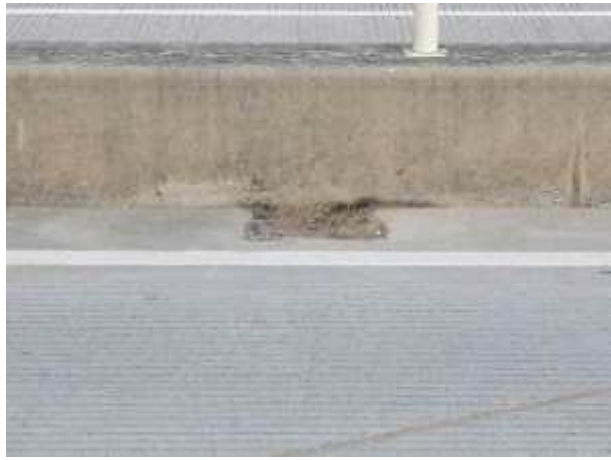
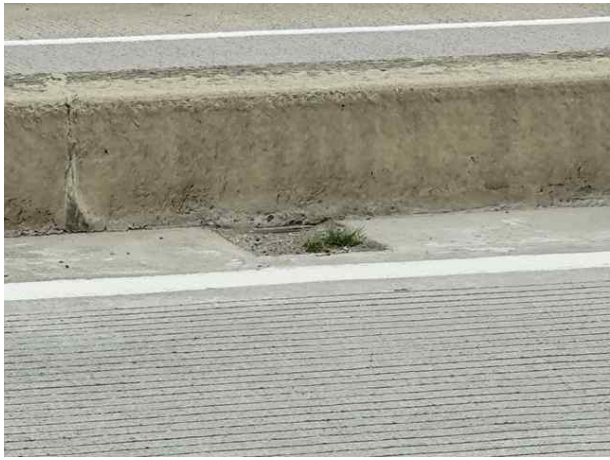
| 02<br>(25년 하반기) | 배수시설(S2) 매송방향 배수구 막힘 | 02<br>(26년 상반기) | 배수시설(S2) 매송방향 배수구 막힘 |

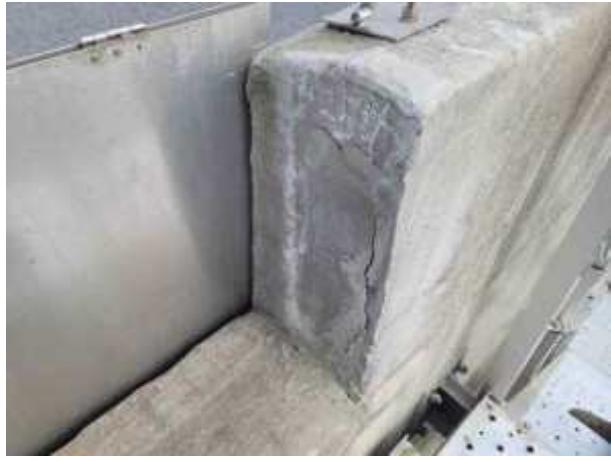
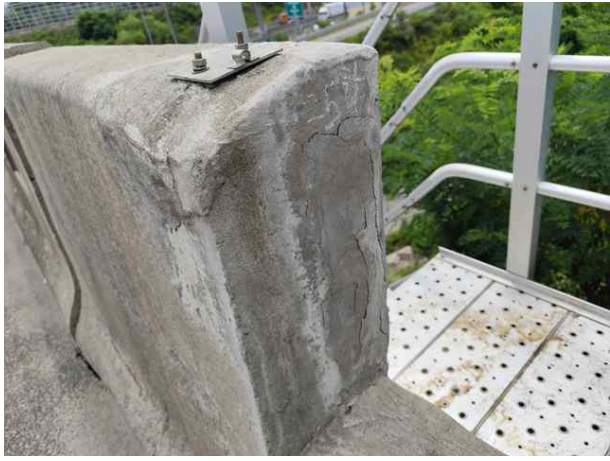
| 03<br>(25년 하반기) | 난간 및 연석(S1) 매송방향 박리 | 03<br>(26년 상반기) | 난간 및 연석(S1) 매송방향 박리 |

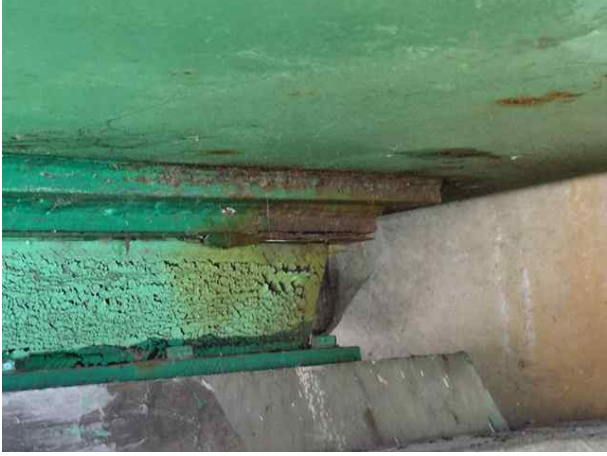
| <p>10<br/>(25년 하반기)</p> <p>교량받침 (A2-SH1) 받침 플레이트 부식</p> | <p>10<br/>(26년 상반기)</p> <p>교량받침 (A2-SH1) 받침 플레이트 부식</p> |

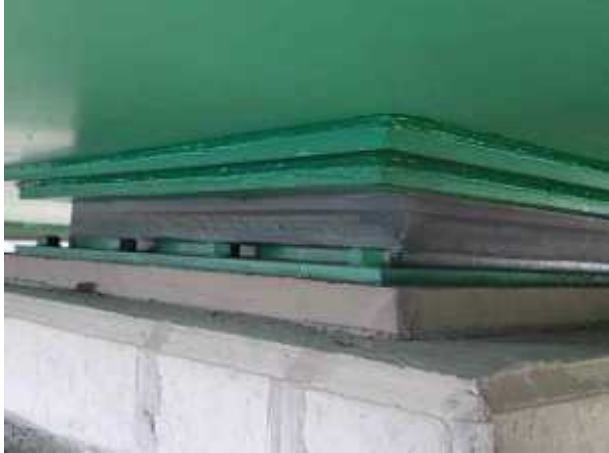
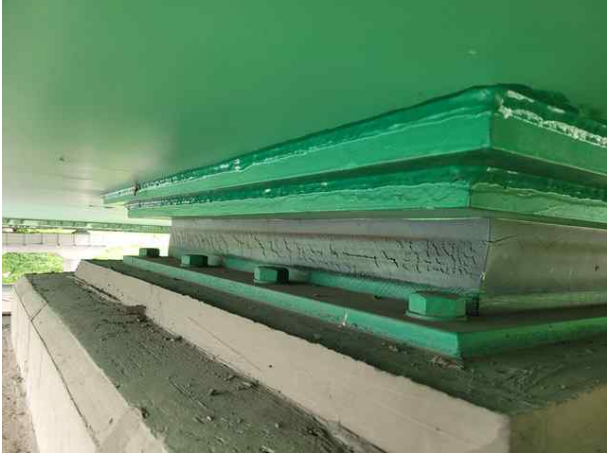
| <p>11<br/>(25년 하반기)</p> <p>교량받침 (P1-SH1) 받침 고무재 갈라짐</p> | <p>11<br/>(26년 상반기)</p> <p>교량받침 (P1-SH1) 받침 고무재 갈라짐</p> |

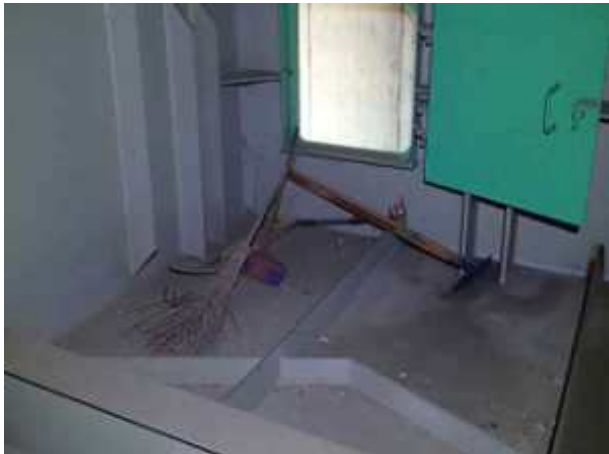
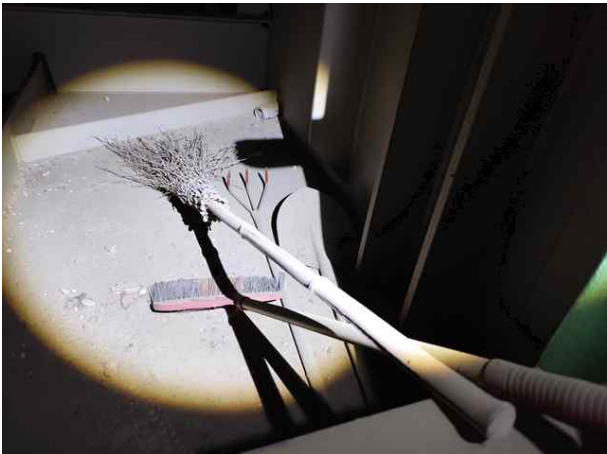
| <p>12<br/>(25년 하반기)</p> <p>거더내부 (S3-G1) 폐기물 적치</p> | <p>12<br/>(26년 상반기)</p> <p>거더내부 (S3-G1) 폐기물 적치</p> |

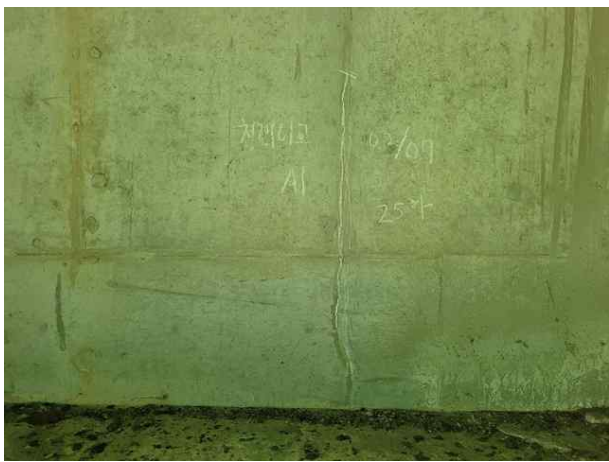
| 13<br>(25년 하반기) | 교대(A1) 균열(0.3mm미만) | 13<br>(26년 상반기) | 교대(A1) 균열(0.3mm미만) |

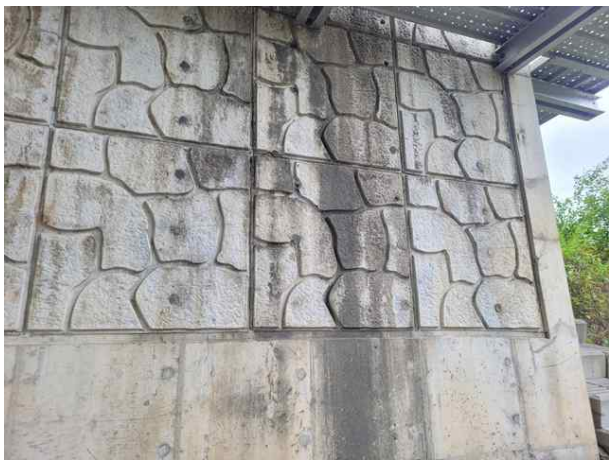
| 14<br>(25년 하반기) | 교대(A1) 표면오염 | 14<br>(26년 상반기) | 교대(A1) 표면오염 |

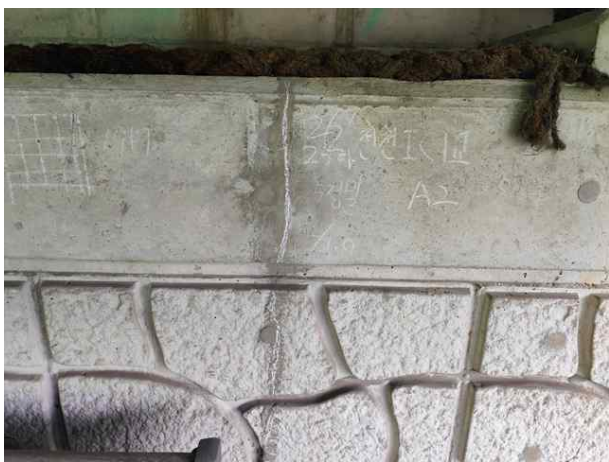
| 15<br>(25년 하반기) | 교각(A2) 보수부 재균열 | 15<br>(26년 상반기) | 교각(A2) 보수부 재균열 |

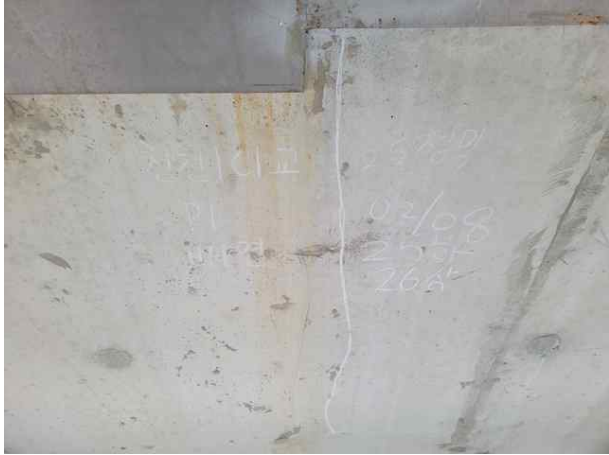
| 16<br>(25년 하반기) | 교각(P1) 균열(0.3mm미만) | 16<br>(26년 상반기) | 교각(P1) 균열(0.3mm미만) |

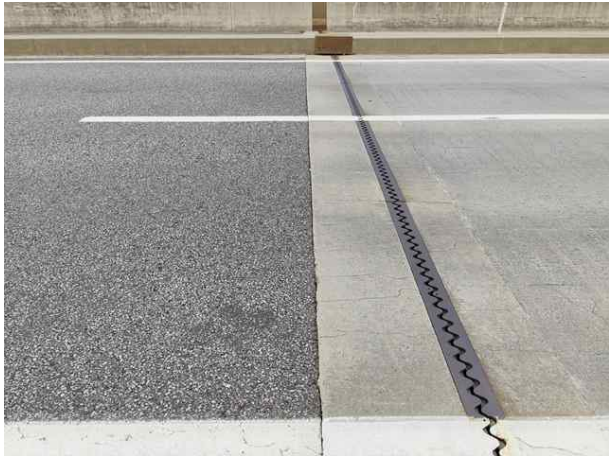
| 17<br>(26년 상반기) | 신축이음(A2) 신축이음 하부 누수 | 18<br>(26년 상반기) | 신축이음(A1) 매송방향 후타재 단차 |

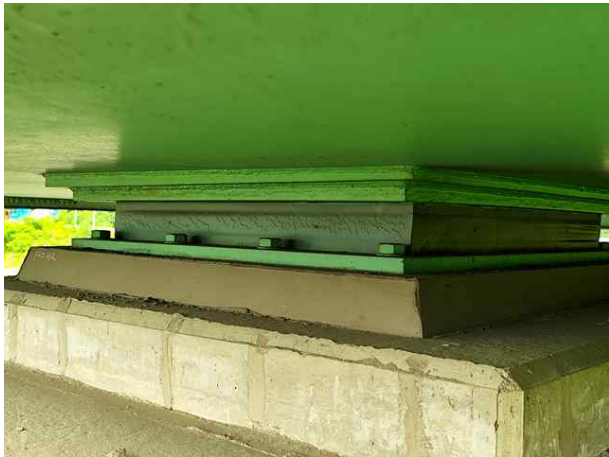
| 19<br>(26년 상반기) | 신축이음(A2) 매송방향 후타재 단차 | 20<br>(26년 상반기) | 교량받침(P2-SH2) 받침 고무재 갈라짐 |
