## 6. 계단식옹벽 (STA.2+040~2+148)

# 손상현황

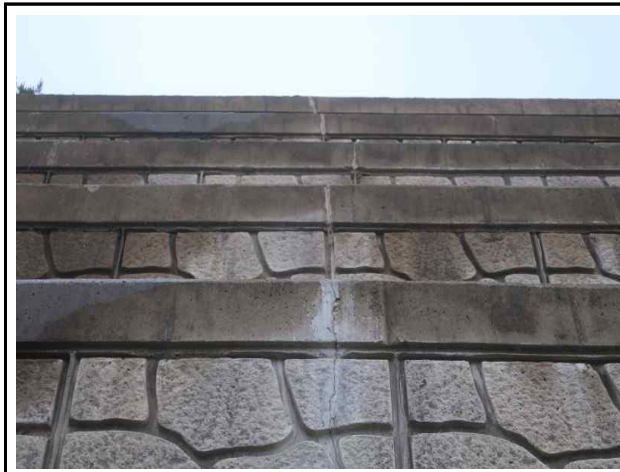
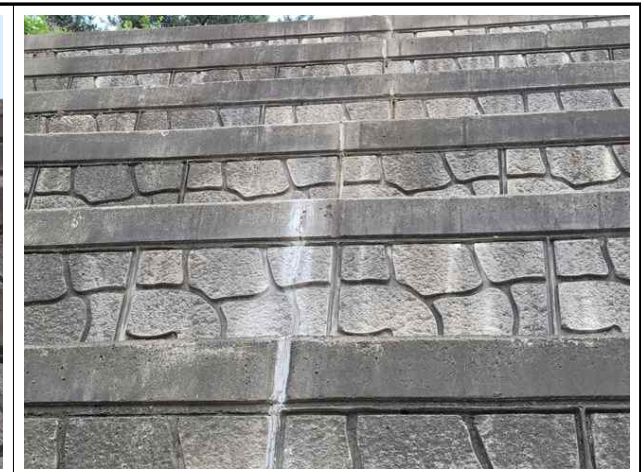
| 01<br>(25년 하반기) | 01<br>(26년 상반기) |

| 전면부(2+050) 균열(0.3mm이상) | 전면부(2+050) 균열(0.3mm이상) |

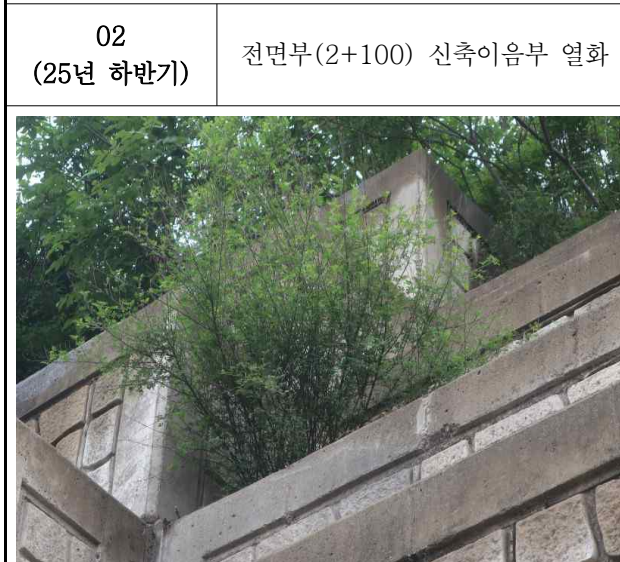
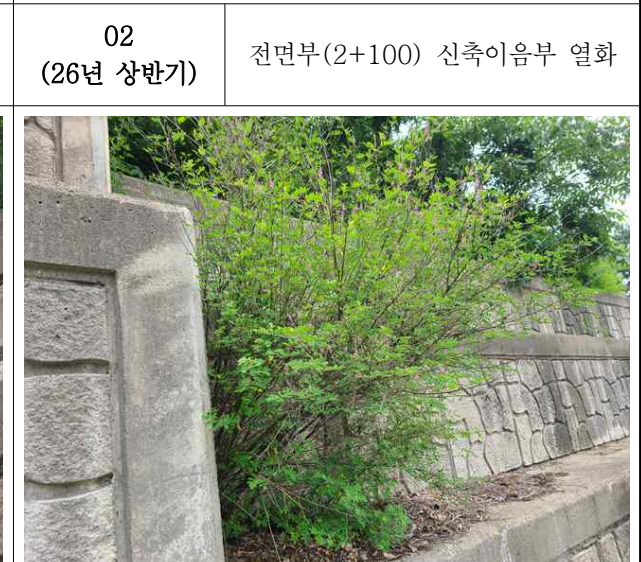
| 02<br>(25년 하반기) | 02<br>(26년 상반기) |

| 전면부(2+100) 신축이음부 열화 | 전면부(2+100) 신축이음부 열화 |
