범안대교

(주)명성엔지니어링

대구 동부순환도로 (주)

2024년 범안로 시설물 정기 및 정밀안전점검 기술용역

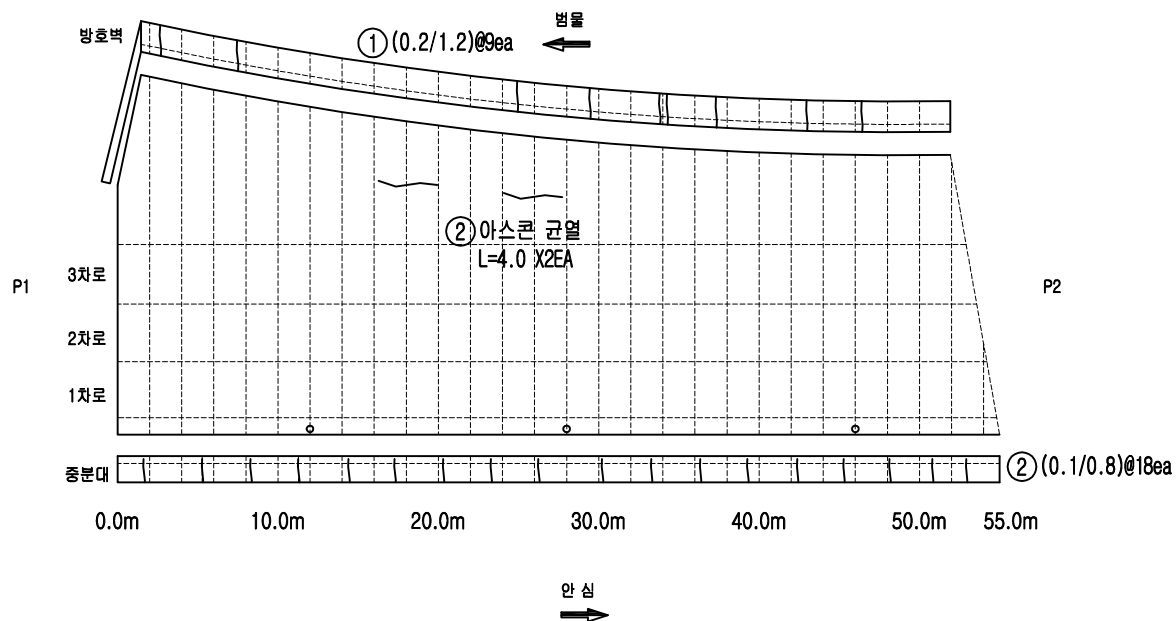
| 번호 | 위치 | 손상내용 | 손상물량 | | | | | 비고 |
|---|---|---|---|---|---|---|---|---|
| 1 | 영호역 | 균열 | 0.2 | 1.2 | 9 | m | 10.80 | |
| 2 | 중원대 | 균열 | 0.1 | 0.8 | 18 | m | 14.40 | |
| 3 | 포장부 | 아스콘 갈열 | - | 4.0 | 2 | m | 8.00 | |

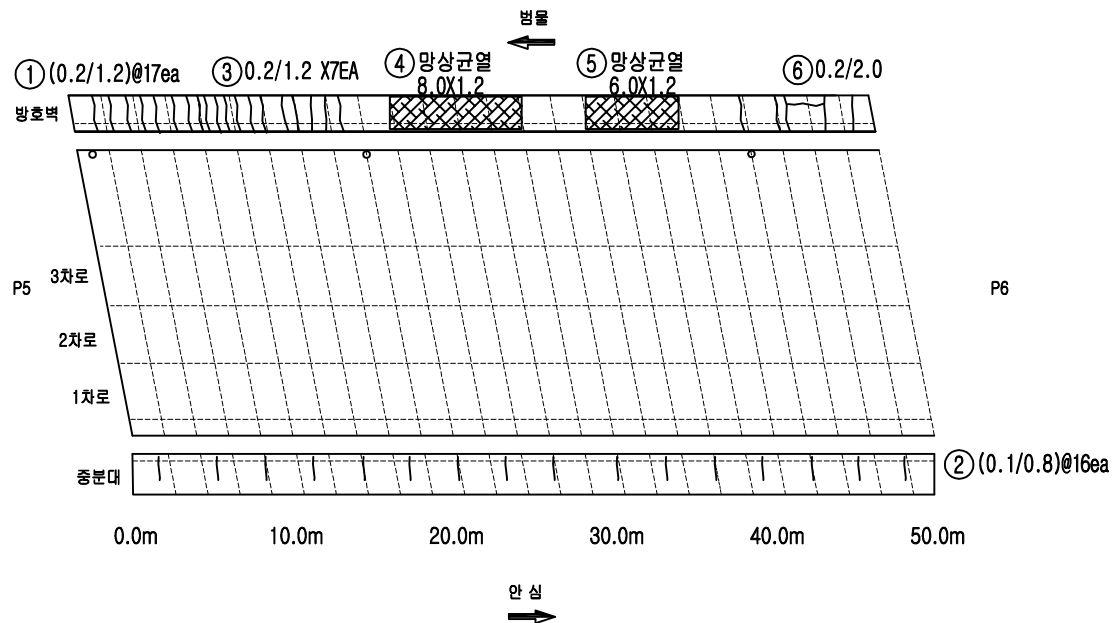
| 번호 | 위치 | 손상내용 | 손상물량 | | | | | 비고 |
|---|---|---|---|---|---|---|---|---|
| 1 | 영호벽 | 균열 | 0.2 | 1.2 | 17 | m | 20.40 | |
| 2 | 동문대 | 균열 | 0.1 | 0.8 | 16 | m | 12.80 | |
| 3 | 방호벽 | 균열 | 0.2 | 1.2 | 7 | m | 8.40 | |
| 4 | 방호벽 | 망상균열 | 8.0 | 1.2 | 1 | m <sup>2</sup> | 9.60 | |
| 5 | 방호벽 | 망상균열 | 6.0 | 1.2 | 1 | m <sup>2</sup> | 7.20 | |
| 6 | 영호벽 | 균열 | 0.2 | 2.0 | 1 | m | 2.00 | |

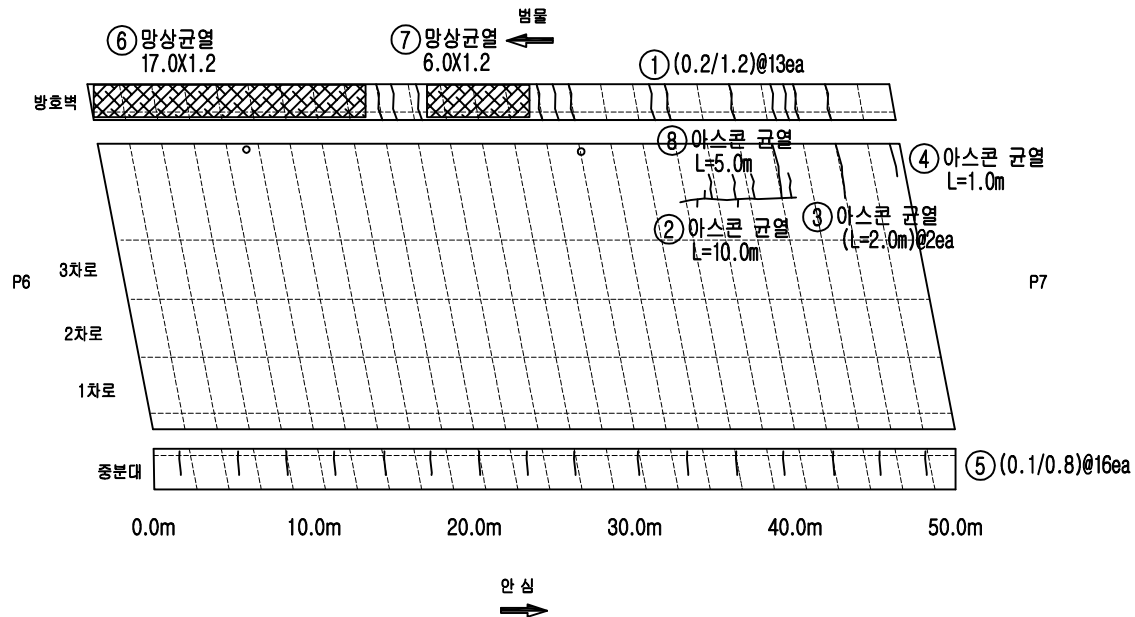
| 번호 | 위치 | 손상내용 | 손상물량 | | | | | 비고 |
|---|---|---|---|---|---|---|---|---|
| 1 | 방호벽 | 균열 | 0.2 | 1.2 | 13 | m | 15.60 | |
| 2 | 포장부 | 아스콘 균열 | - | 10.0 | 1 | m | 10.00 | |
| 3 | 포장부 | 아스콘 균열 | - | 2.0 | 2 | m | 4.00 | |
| 4 | 포장부 | 아스콘 균열 | - | 1.0 | 1 | m | 1.00 | |
| 5 | 중문대 | 균열 | 0.1 | 0.8 | 16 | m | 12.80 | |
| 6 | 방호벽 | 양상균열 | 17.0 | 1.2 | 1 | m | 20.40 | |
| 7 | 방호벽 | 양상균열 | 6.0 | 1.2 | 1 | m | 7.20 | |
| 8 | 포장부 | 아스콘 균열 | - | 5.0 | 1 | m | 5.00 | |

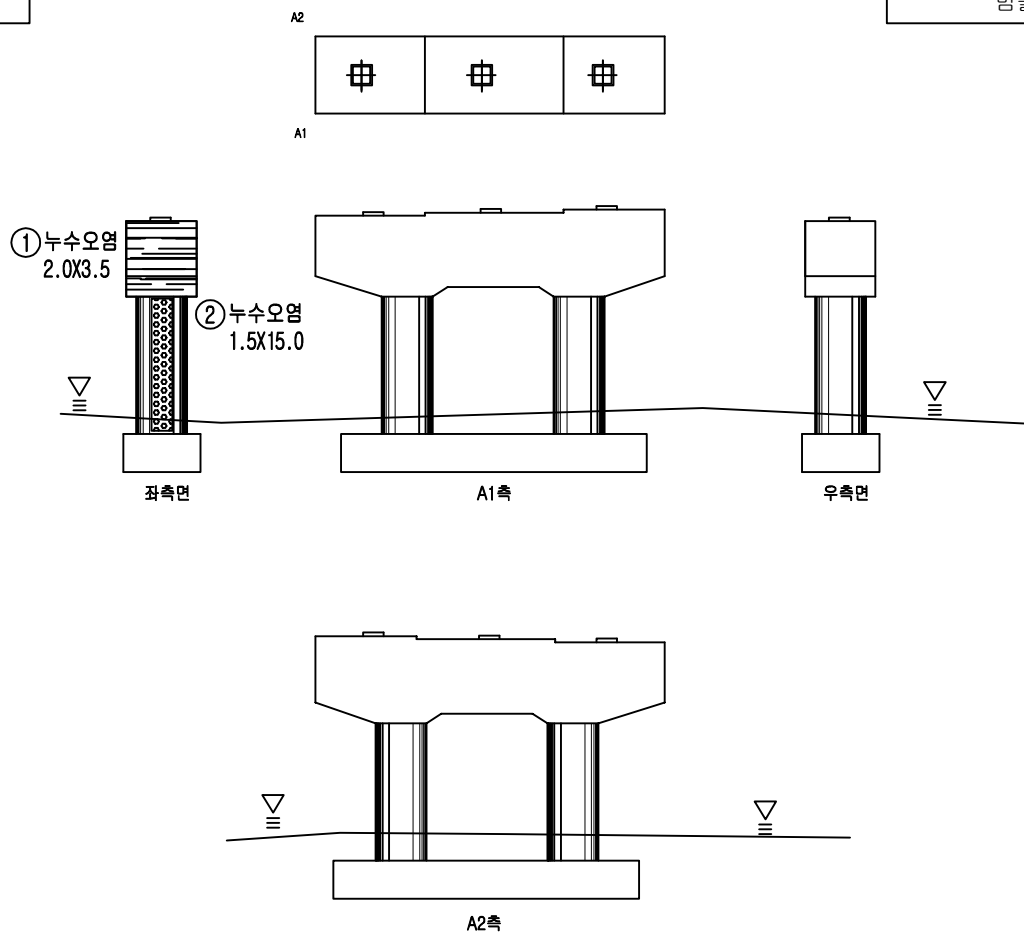
| 순찰물량표 | | | | | | | | |
|---|---|---|---|---|---|---|---|---|
| 1 | 교각 | 누수오염 | 2.0 | 3.5 | 1 | ㎡ | 7.00 | |
| 2 | 교각 | 누수오염 | 1.5 | 15.0 | 1 | ㎡ | 22.50 | |

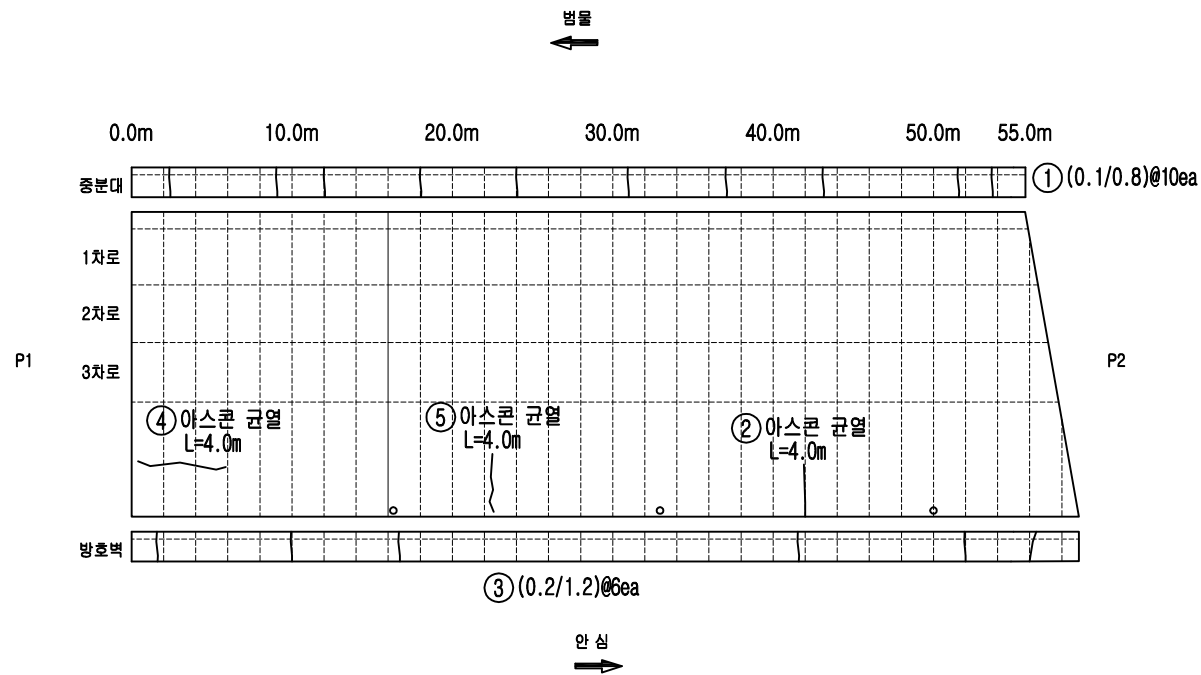
| 번호 | 위치 | 손상내용 | 손상물량 | | | | | 비고 |
|---|---|---|---|---|---|---|---|---|
| 1 | 충문대 | 균열 | 0.1 | 0.8 | 10 | m | 8.00 | |
| 2 | 포장부 | 아스콘 균열 | - | 4.0 | 1 | m | 4.00 | |
| 3 | 방호벽 | 균열 | 0.2 | 1.2 | 6 | m | 7.20 | |
| 4 | 포장부 | 아스콘 균열 | - | 4.0 | 1 | m | 4.00 | |
| 5 | 포장부 | 아스콘 균열 | - | 4.0 | 1 | m | 4.00 | 신규 |

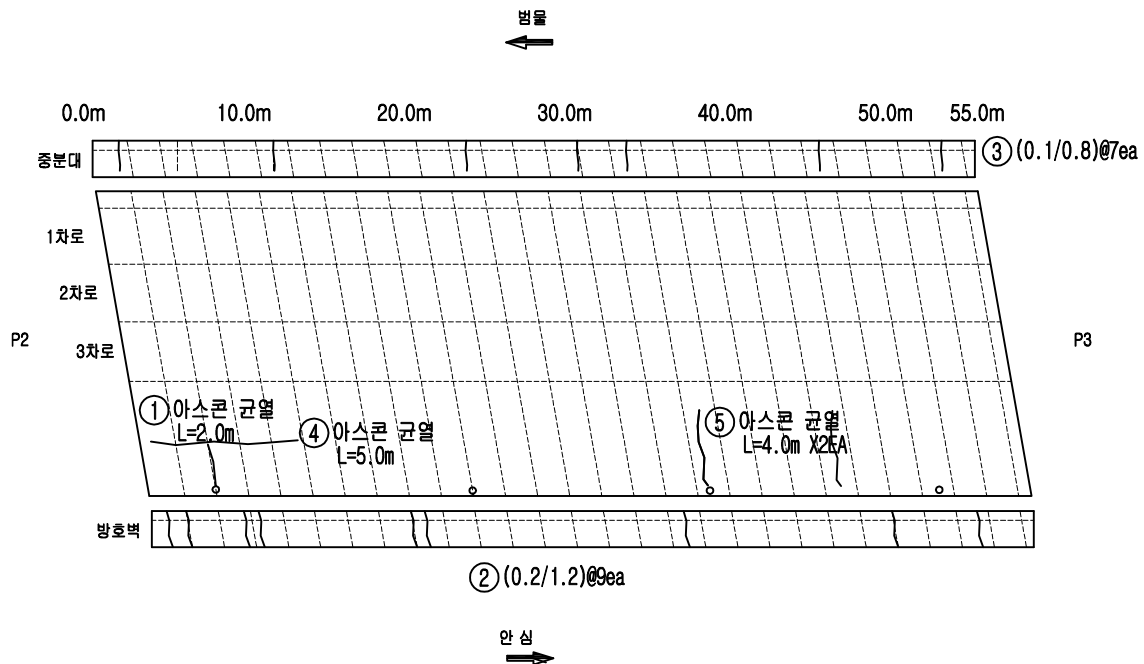
| 번호 | 위치 | 손상내용 | 손상물량 | | | | | 비고 |
|---|---|---|---|---|---|---|---|---|
| 1 | 포장부 | 아스콘 균열 | - | 2.0 | 1 | m | 2.00 | |
| 2 | 방호벽 | 균열 | 0.2 | 1.2 | 9 | m | 10.80 | |
| 3 | 중분대 | 균열 | 0.1 | 0.8 | 7 | m | 5.60 | |
| 4 | 포장부 | 아스콘 균열 | - | 5.0 | 1 | m | 5.00 | 신규 |
| 5 | 포장부 | 아스콘 균열 | - | 4.0 | 2 | m | 8.00 | 신규 |

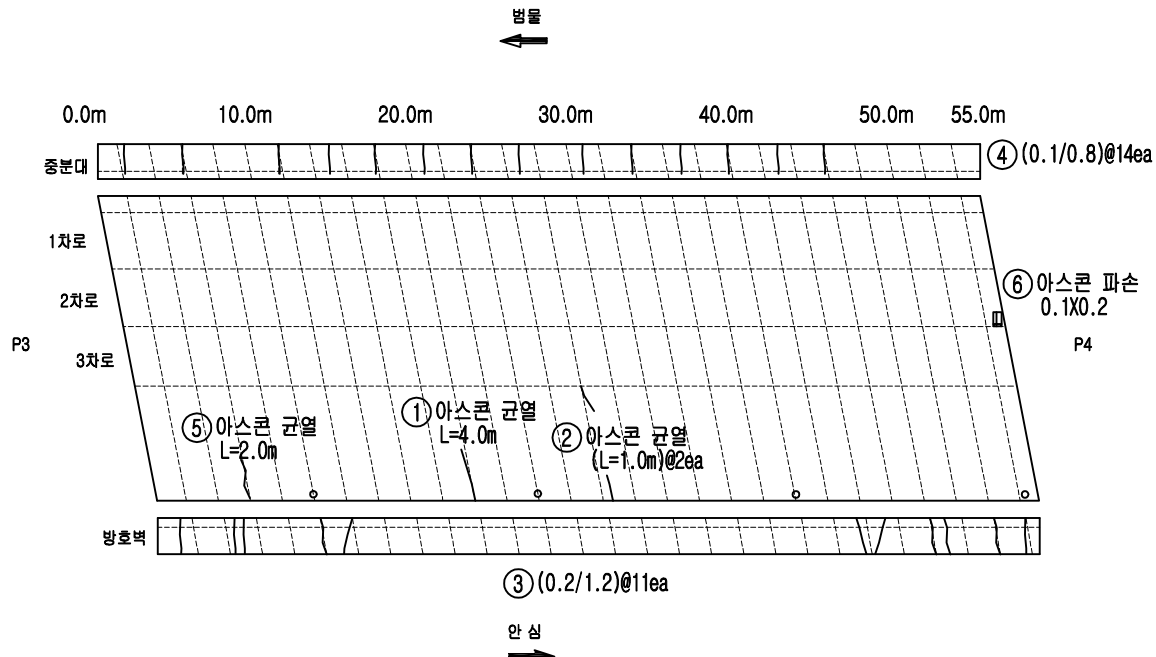
| 번호 | 위치 | 손상내용 | 손상물량 | | | | | 비고 |
|---|---|---|---|---|---|---|---|---|
| 1 | 포장부 | 아스콘 균열 | - | 4.0 | 1 | m | 4.00 | |
| 2 | 포장부 | 아스콘 균열 | - | 1.0 | 2 | m | 2.00 | |
| 3 | 방호벽 | 균열 | 0.2 | 1.2 | 11 | m | 13.20 | |
| 4 | 종분대 | 균열 | 0.1 | 0.8 | 14 | m | 11.20 | |
| 5 | 포장부 | 아스콘 균열 | - | 4.0 | 1 | m | 4.00 | 신규 |

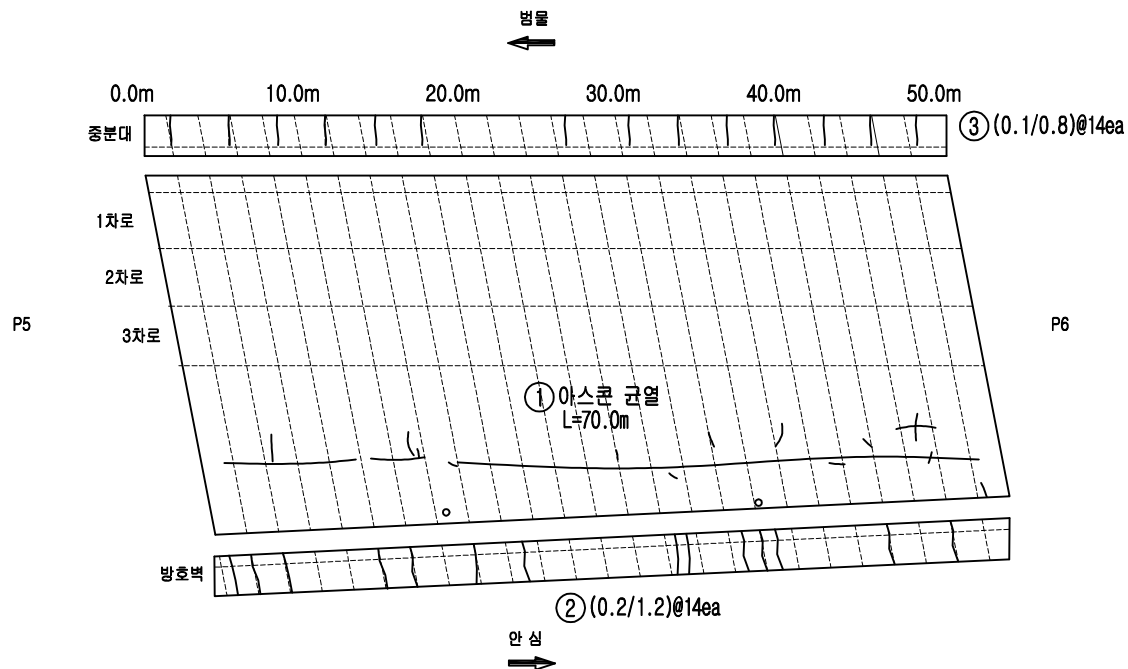
| 번호 | 위치 | 손상내용 | 손상물량 | | | | | 비고 |
|---|---|---|---|---|---|---|---|---|
| 1 | 포장부 | 아스콘 균열 | - | 70.0 | 1 | m | 70.00 | |
| 2 | 양호벽 | 균열 | 0.2 | 1.2 | 14 | m | 16.80 | |
| 3 | 동문대 | 균열 | 0.1 | 0.8 | 14 | m | 11.20 | |

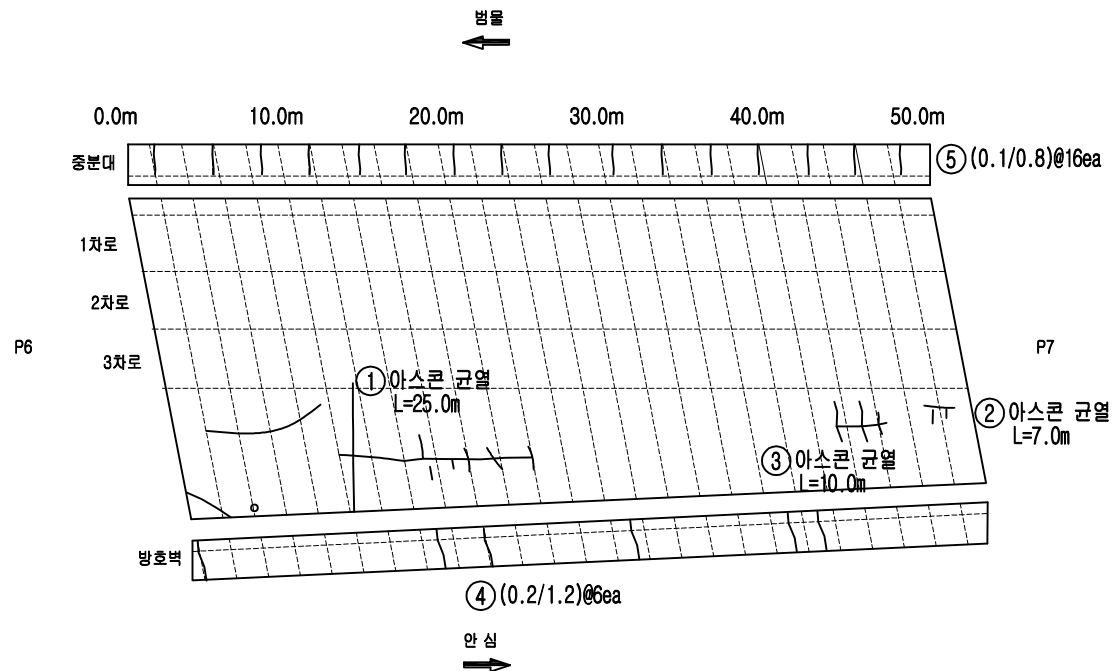
| 번호 | 위치 | 손상내용 | 손상물량 | | | | | 비고 |
|---|---|---|---|---|---|---|---|---|
| 1 | 포장부 | 아스콘 균열 | - | 25.0 | 1 | m | 25.00 | |
| 2 | 포장부 | 아스콘 균열 | - | 7.0 | 1 | m | 7.00 | |
| 3 | 포장부 | 아스콘 균열 | - | 10.0 | 1 | m | 10.00 | |
| 4 | 방호벽 | 균열 | 0.2 | 1.2 | 6 | m | 7.20 | |
| 5 | 측분대 | 균열 | 0.1 | 0.8 | 16 | m | 12.80 | |

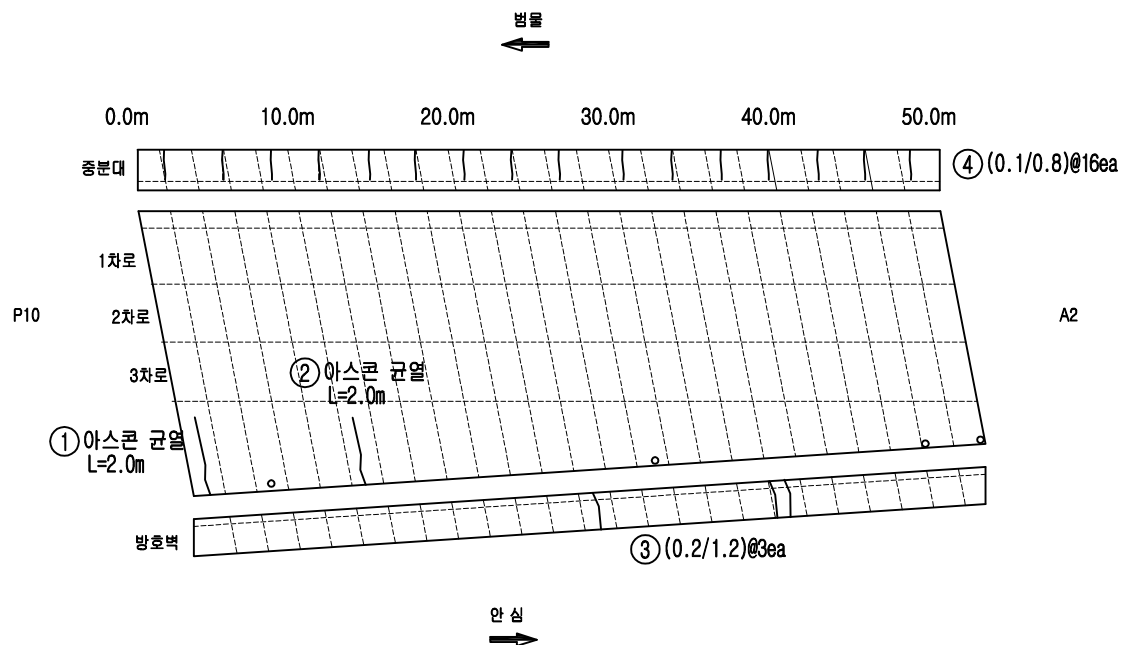
| 번호 | 위치 | 손상내용 | 손상물량 | | | | | 비고 |
|---|---|---|---|---|---|---|---|---|
| 1 | 포장부 | 아스콘 균열 | - | 2.0 | 1 | m | 2.00 | |
| 2 | 포장부 | 아스콘 균열 | - | 2.0 | 1 | m | 2.00 | |
| 3 | 방호벽 | 균열 | 0.2 | 1.2 | 3 | m | 3.60 | |
| 4 | 중분대 | 균열 | 0.1 | 0.8 | 16 | m | 12.80 | |

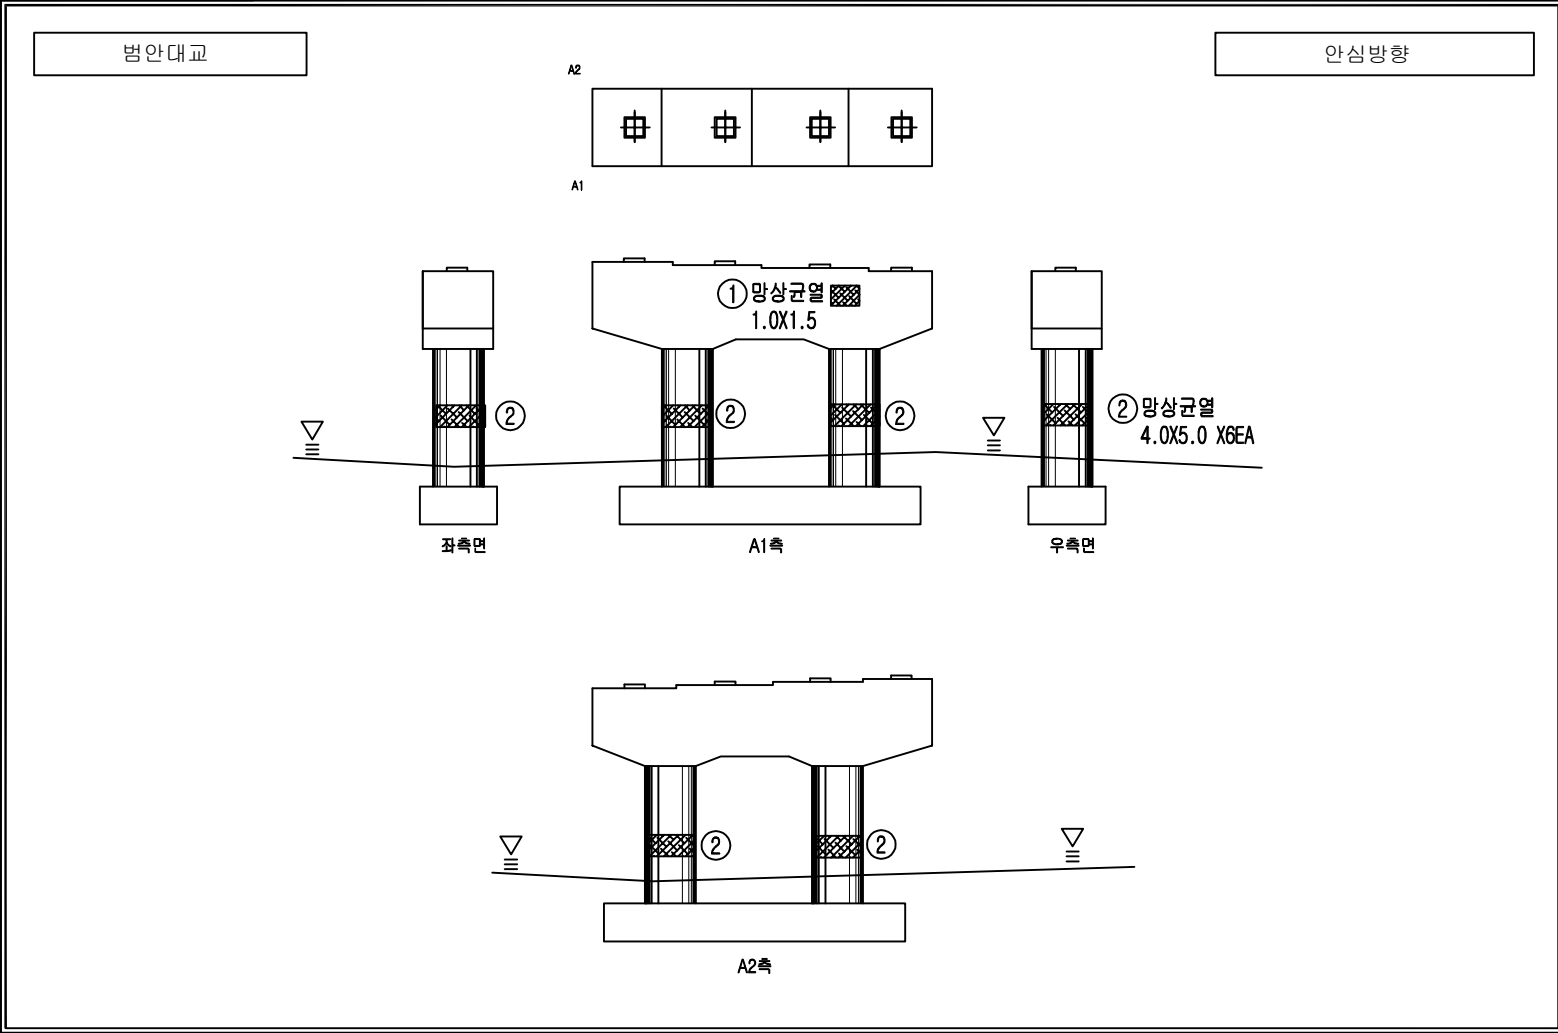
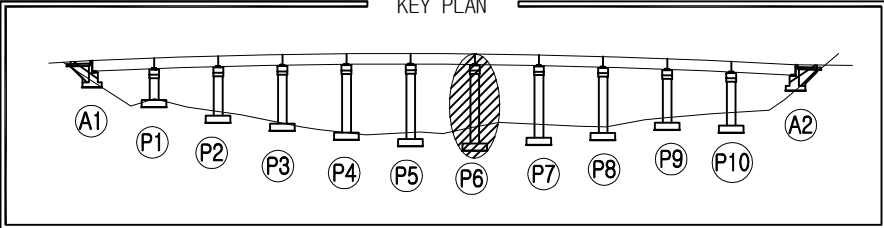
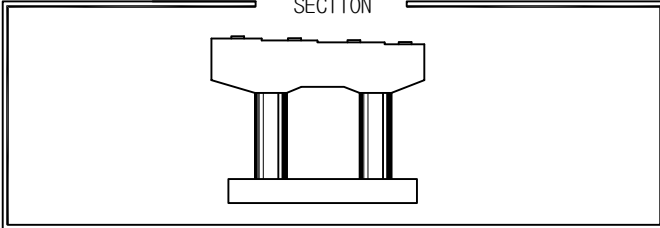
| 번호 | 위치 | 손상내용 | 손상물량 | | | | | 비고 |
|---|---|---|---|---|---|---|---|---|
| 1 | 교각 | 망상균열 | 1.0 | 1.5 | 1 | ㎡ | 1.50 | |
| 2 | 교각 | 망상균열 | 4.0 | 5.0 | 6 | ㎡ | 120.00 | |
