# ID : 복정고가교 본선-상행선 box외부(S1)

## 손상물량표

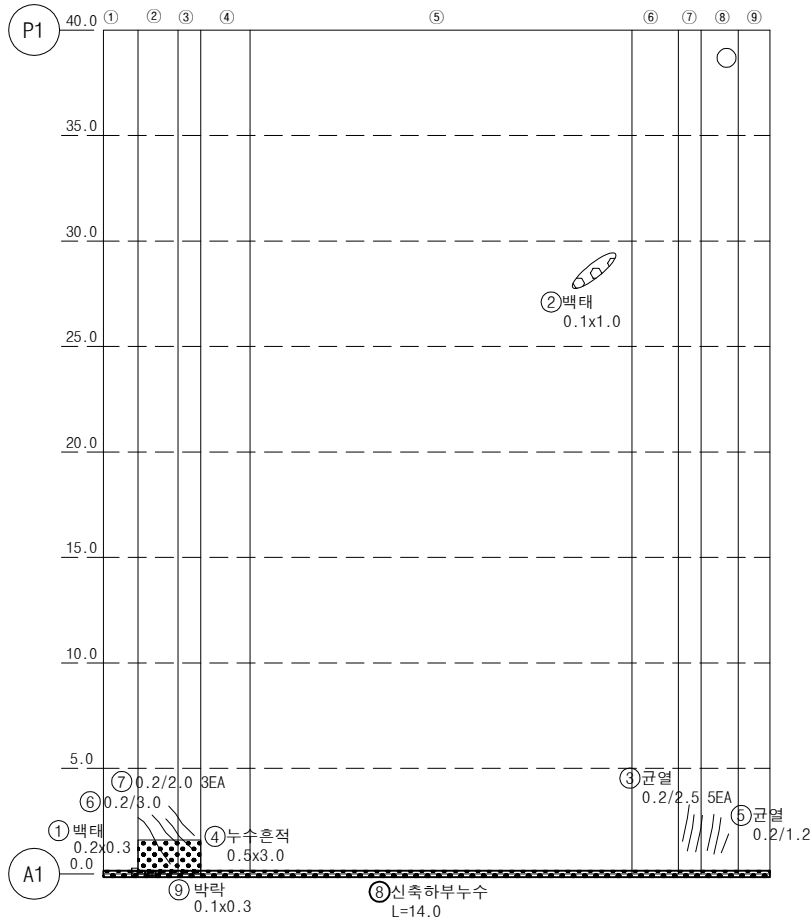
| 번호 | 손상내용 | 손상물량 | | | | | 비고 |
|---|---|---|---|---|---|---|---|
| 1 | 백태 | 0.20 | 0.30 | 0.06 | m² | 1 | |
| 2 | 백태 | 1.00 | 0.10 | 0.10 | m² | 1 | |
| 3 | 균열(0.2mm) | 0.20 | 2.50 | 12.50 | m | 5 | |
| 4 | 표면오염(누수흔적) | 0.50 | 3.00 | 1.50 | m² | 1 | |
| 5 | 균열(0.2mm) | 0.20 | 1.20 | 1.20 | m | 1 | |
| 6 | 균열(0.2mm) | 0.20 | 3.00 | 3.00 | m | 1 | |
| 7 | 균열(0.2mm) | 0.20 | 2.00 | 6.00 | m | 3 | |
| 8 | 신축하부누수 | | 14.00 | 14.00 | m | 1 | |
| 9 | 박락 | 0.10 | 0.30 | 0.03 | m² | 1 | |

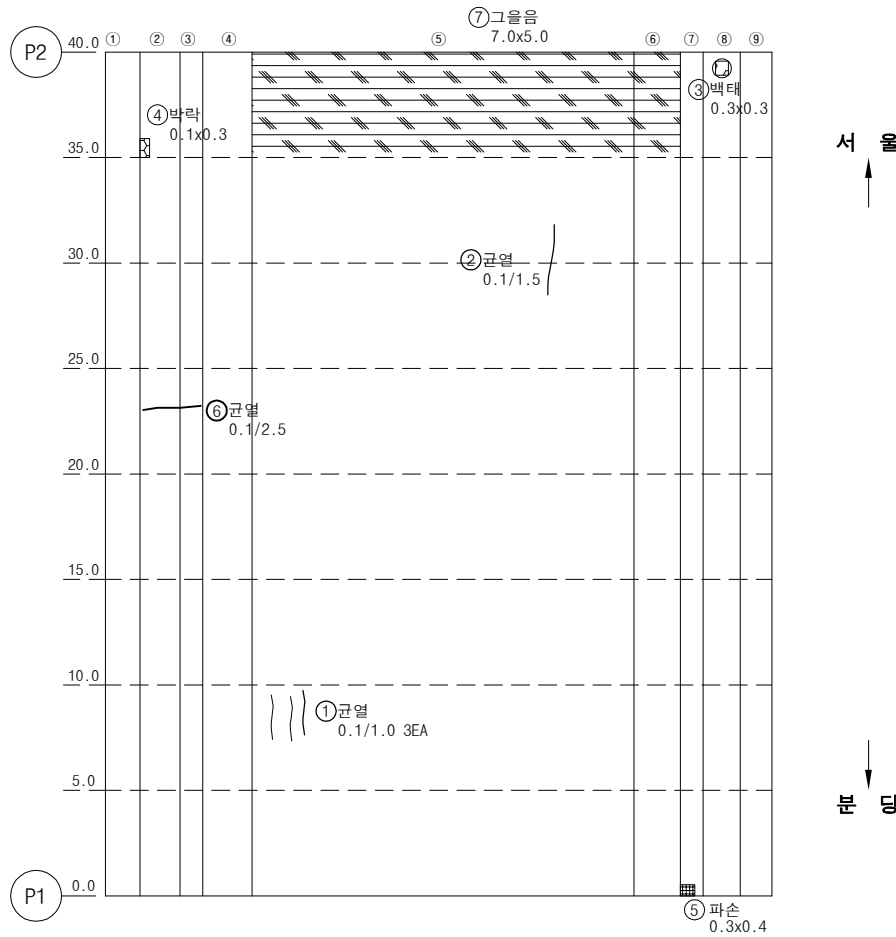
# ID : 복정고가교 본선-상행선 box외부(S2)

| 번호 | 손상내용 | 손상물량 | | | | | 비고 |
|---|---|---|---|---|---|---|---|
| 1 | 균열(0.1mm) | 0.10 | 1.00 | 3.00 | m | 3 | |
| 2 | 균열(0.1mm) | 0.10 | 1.50 | 1.50 | m | 1 | |
| 6 | 균열(0.1mm) | 0.10 | 2.50 | 2.50 | m | 1 | |

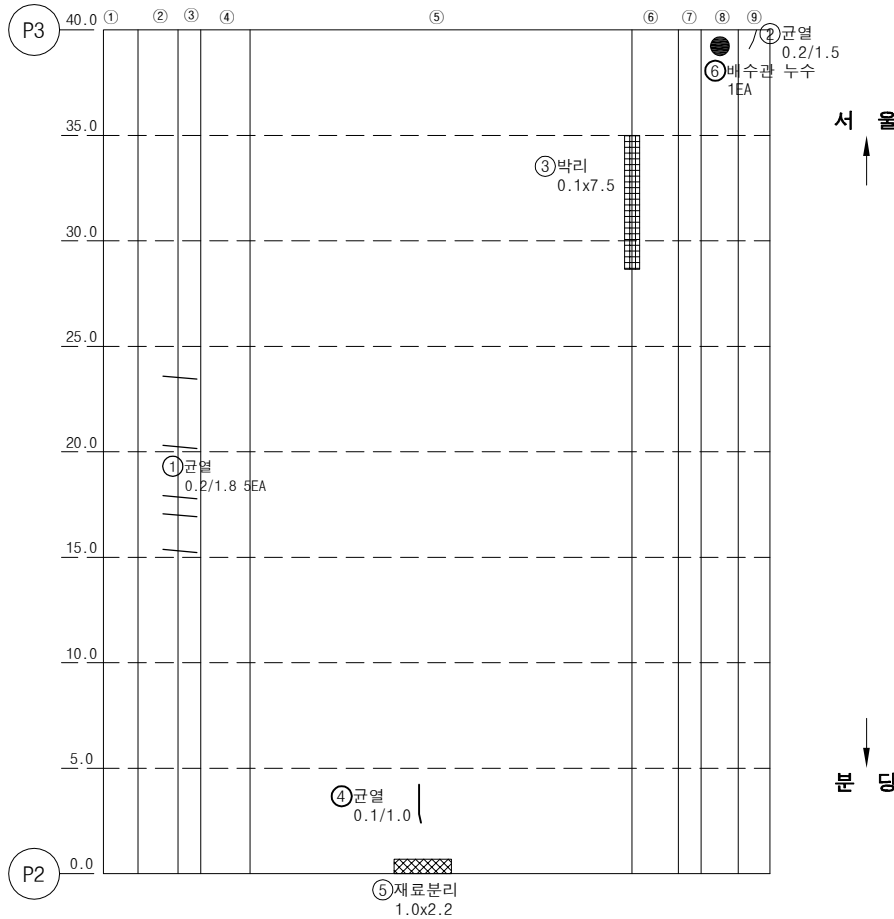
| 번호 | 손상내용 | 손상물량 | | | | | 비고 |
|---|---|---|---|---|---|---|---|
| 1 | 균열(0.2mm) | 0.20 | 1.80 | 9.00 | m | 5 | |
| 2 | 균열(0.2mm) | 0.20 | 1.50 | 1.50 | m | 1 | |
| 4 | 균열(0.1mm) | 0.10 | 1.00 | 1.00 | m | 1 | |
| 6 | 배수관누수 | | | 1.00 | EA | 1 | |

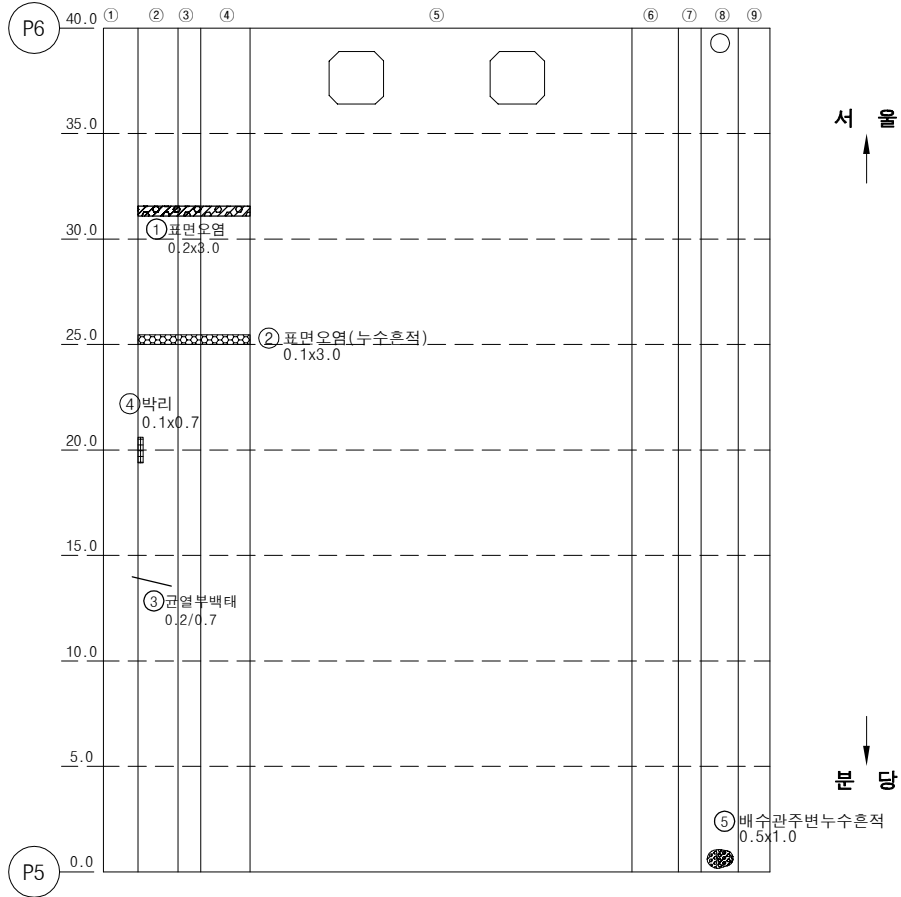
# ID : 복정고가교 본선-상행선 box외부(S6)

| 번호 | 손상내용 | 손상물량 | | | | | 비고 |
|---|---|---|---|---|---|---|---|
| 1 | 누수흔적 | 0.20 | 3.00 | 0.60 | m <sup>2</sup> | 1 | |
| 2 | 표면오염(누수흔적) | 0.10 | 3.00 | 0.30 | m <sup>2</sup> | 1 | |
| 3 | 균열부백태 | 0.20 | 0.70 | 0.70 | m | 1 | |
| 5 | 배수관주변누수흔적 | 0.50 | 1.00 | 0.50 | m <sup>2</sup> | 1 | |

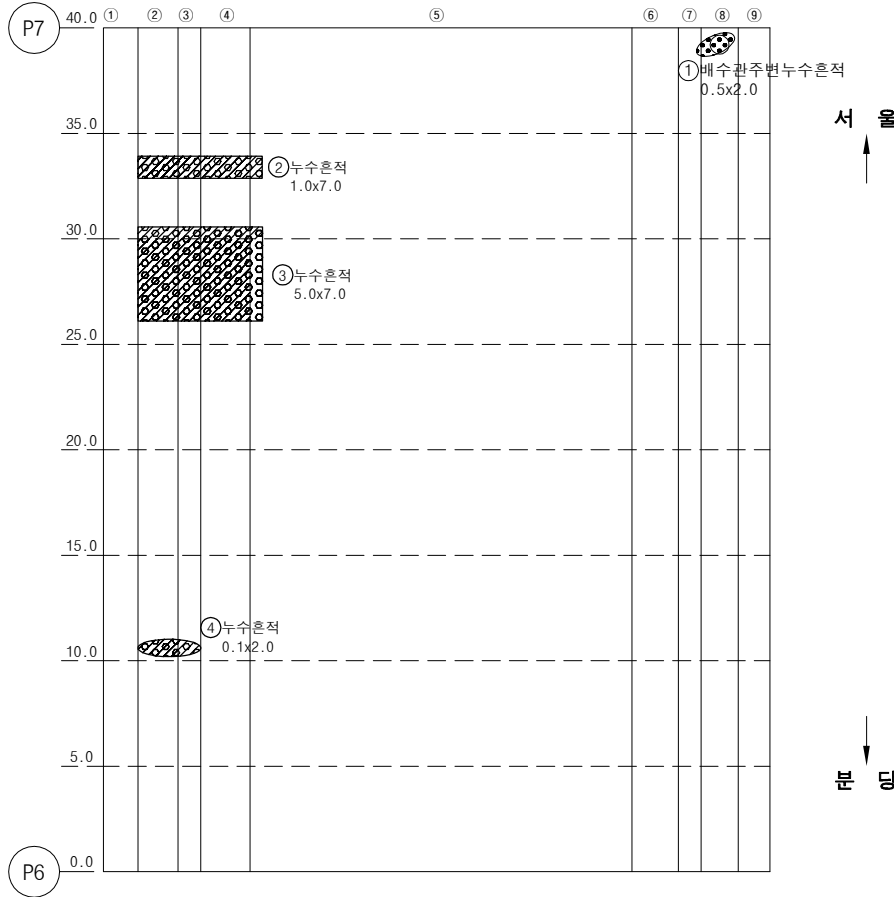
| 번호 | 손상내용 | 손상물량 | | | | | 비고 |
|---|---|---|---|---|---|---|---|
| 1 | 배수관주변누수흔적 | 2.00 | 0.50 | 1.00 | m <sup>2</sup> | 1 | |
| 2 | 누수흔적 | 1.00 | 7.00 | 7.00 | m <sup>2</sup> | 1 | |
| 3 | 누수흔적 | 5.00 | 7.00 | 35.00 | m <sup>2</sup> | 1 | |
| 4 | 표면오염(누수흔적) | 0.10 | 2.00 | 0.20 | m <sup>2</sup> | 1 | |

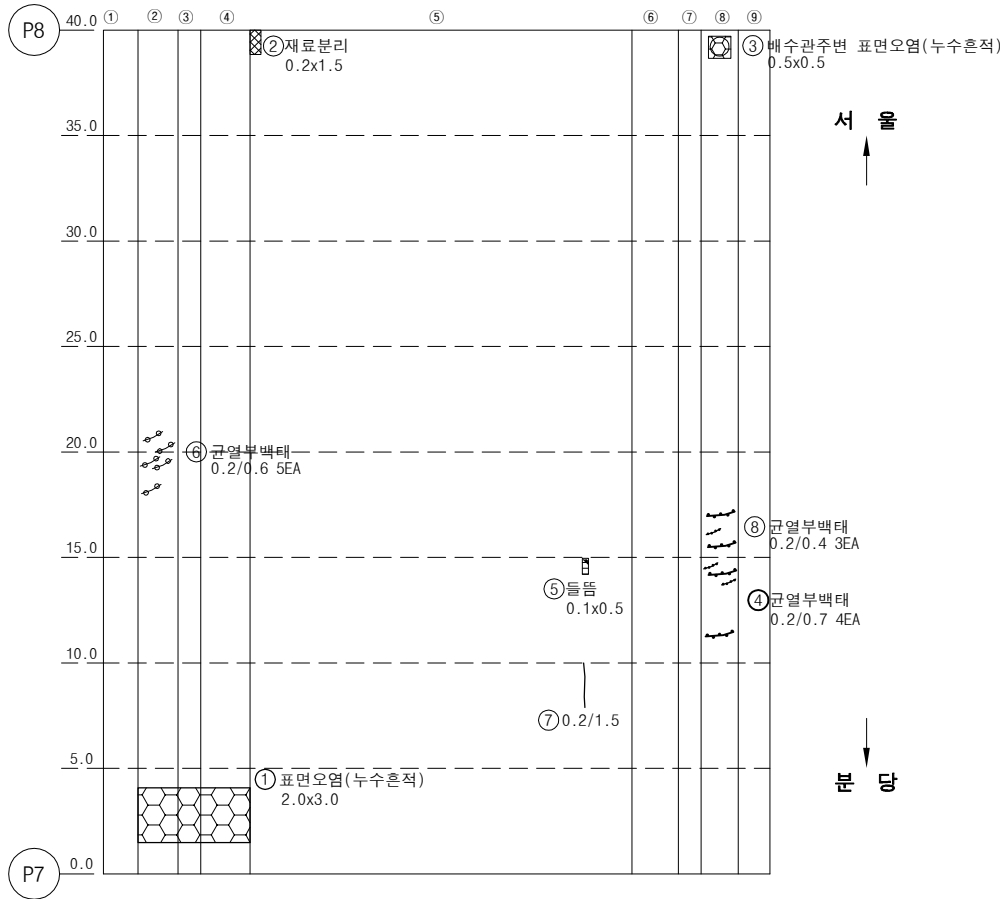
| 번호 | 손상내용 | 손상물량 | | | | | 비고 |
|---|---|---|---|---|---|---|---|
| 1 | 표면오염(누수흔적) | 2.00 | 3.00 | 6.00 | m² | 1 | |
| 3 | 배수관주변누수흔적 | 0.50 | 0.50 | 0.25 | m² | 1 | |
| 4 | 균열부백태 | 0.20 | 0.70 | 2.80 | m | 4 | |
| 6 | 균열부백태 | 0.20 | 0.60 | 3.00 | m | 5 | |
| 7 | 균열(0.2mm) | 0.20 | 1.50 | 1.50 | m | 1 | |
| 8 | 균열부백태 | 0.20 | 0.40 | 1.20 | m | 3 | |

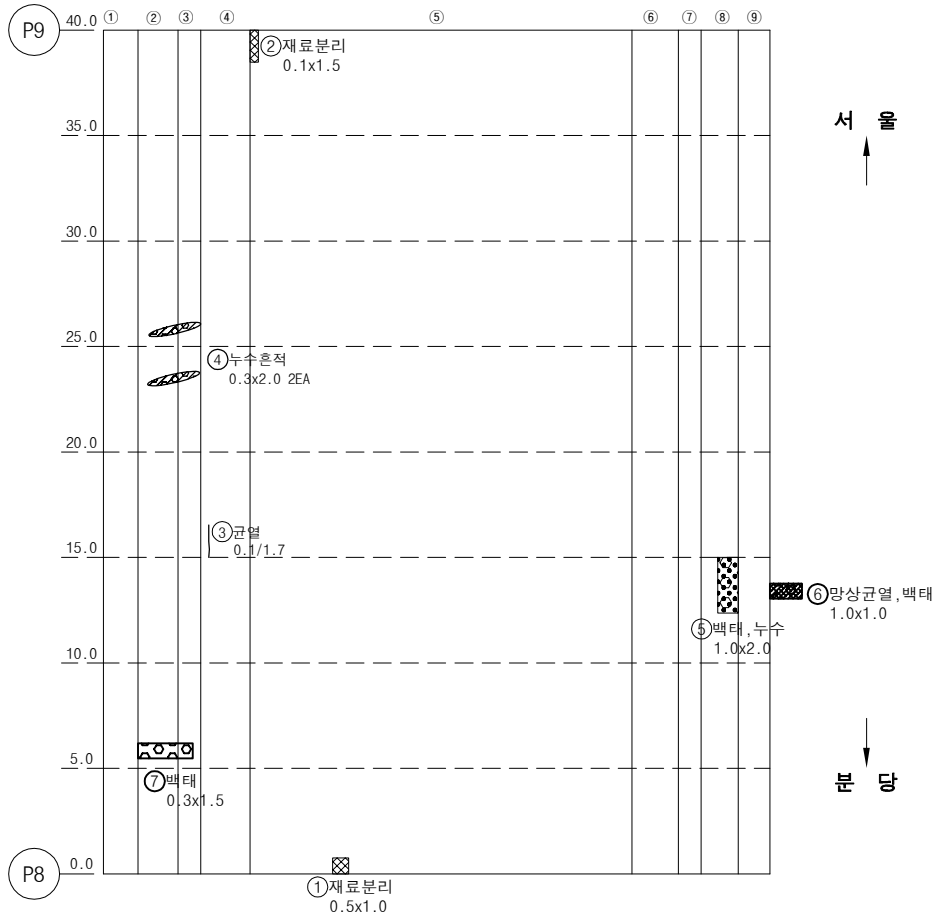
| 번호 | 손상내용 | 손상물량 | | | | | 비고 |
|---|---|---|---|---|---|---|---|
| 3 | 균열(0.1mm) | 0.10 | 1.70 | 1.70 | m | 1 | |
| 4 | 표면오염(누수흔적) | 0.30 | 2.00 | 1.20 | m <sup>2</sup> | 2 | |
| 5 | 누수, 백태 | 2.00 | 1.00 | 2.00 | m <sup>2</sup> | 1 | |
| 6 | 망상균열, 백태 | 1.00 | 1.00 | 1.00 | m <sup>2</sup> | 1 | |

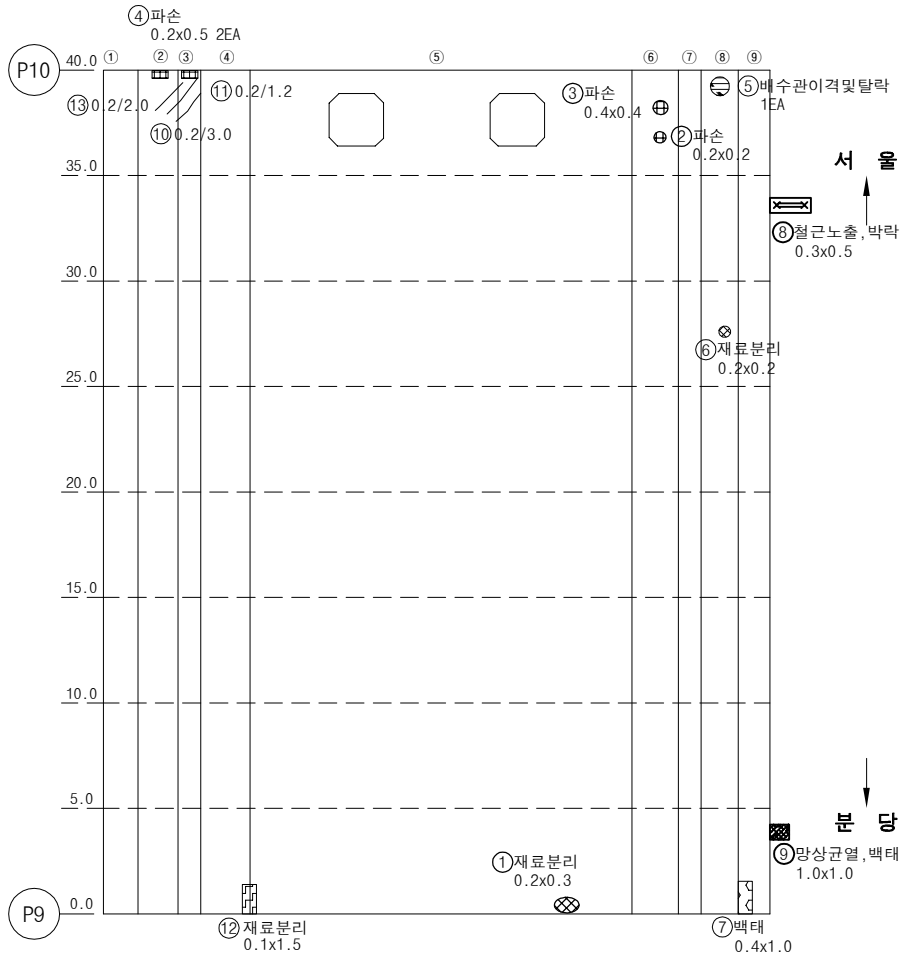
# ID : 복정고가교 본선-상행선 box외부(S10)

| 번호 | 손상내용 | 손상물량 | | | | | 비고 |
|---|---|---|---|---|---|---|---|
| 9 | 망상균열, 백태 | 1.00 | 1.00 | 1.00 | m² | 1 | |
| 10 | 균열(0.2mm) | 0.20 | 3.00 | 3.00 | m | 1 | |
| 11 | 균열(0.2mm) | 0.20 | 1.20 | 1.20 | m | 1 | |

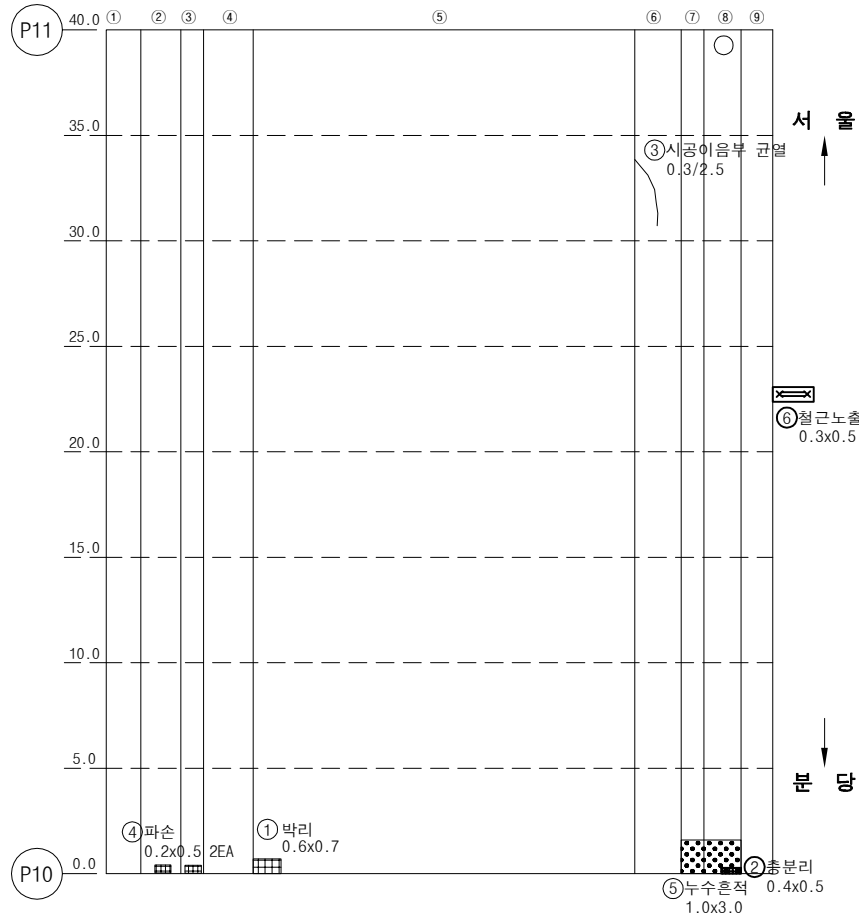
| 번호 | 손상내용 | 손상물량 | | | | | 비고 |
|---|---|---|---|---|---|---|---|
| 3 | 시공이음부균열 | 0.30 | 2.50 | 2.50 | m | 1 | |
| 5 | 표면오염(누수흔적) | 3.00 | 1.00 | 3.00 | m <sup>2</sup> | 1 | |

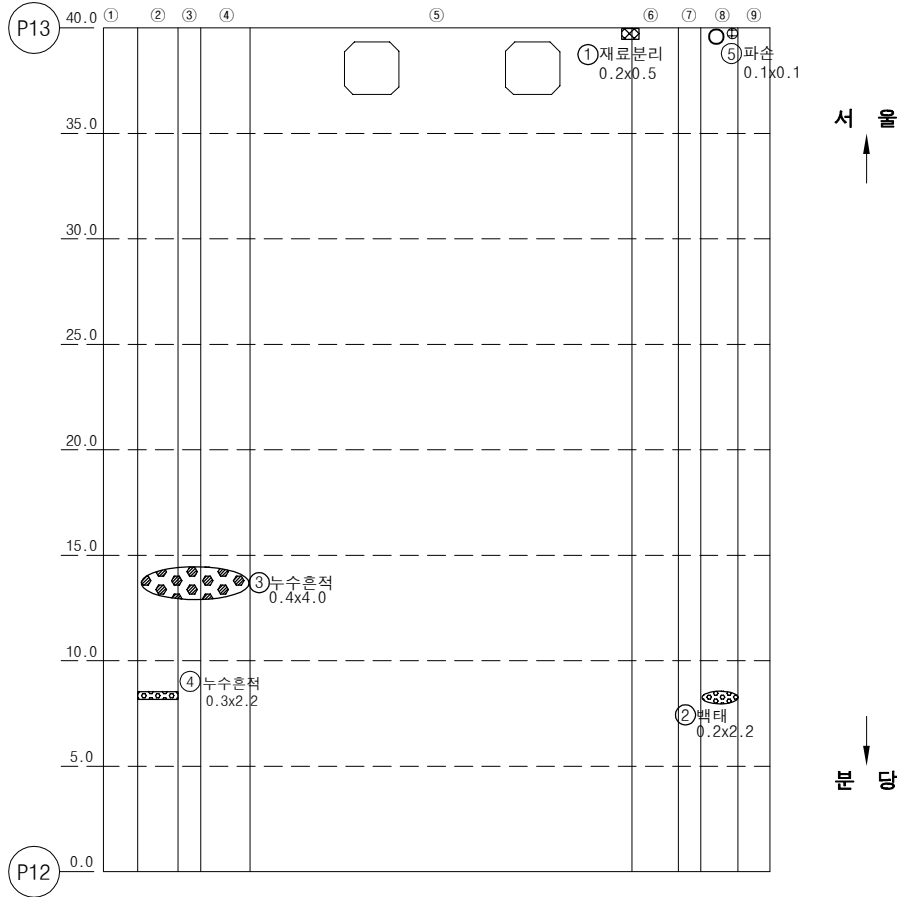
# ID : 복정고가교 본선-상행선 box외부(S13)

| 번호 | 손상내용 | 손상물량 | | | | | 비고 |
|---|---|---|---|---|---|---|---|
| 3 | 표면오염(누수흔적) | 0.40 | 4.00 | 1.60 | m <sup>2</sup> | 1 | |
| 4 | 표면오염(누수흔적) | 0.30 | 2.20 | 0.66 | m <sup>2</sup> | 1 | |

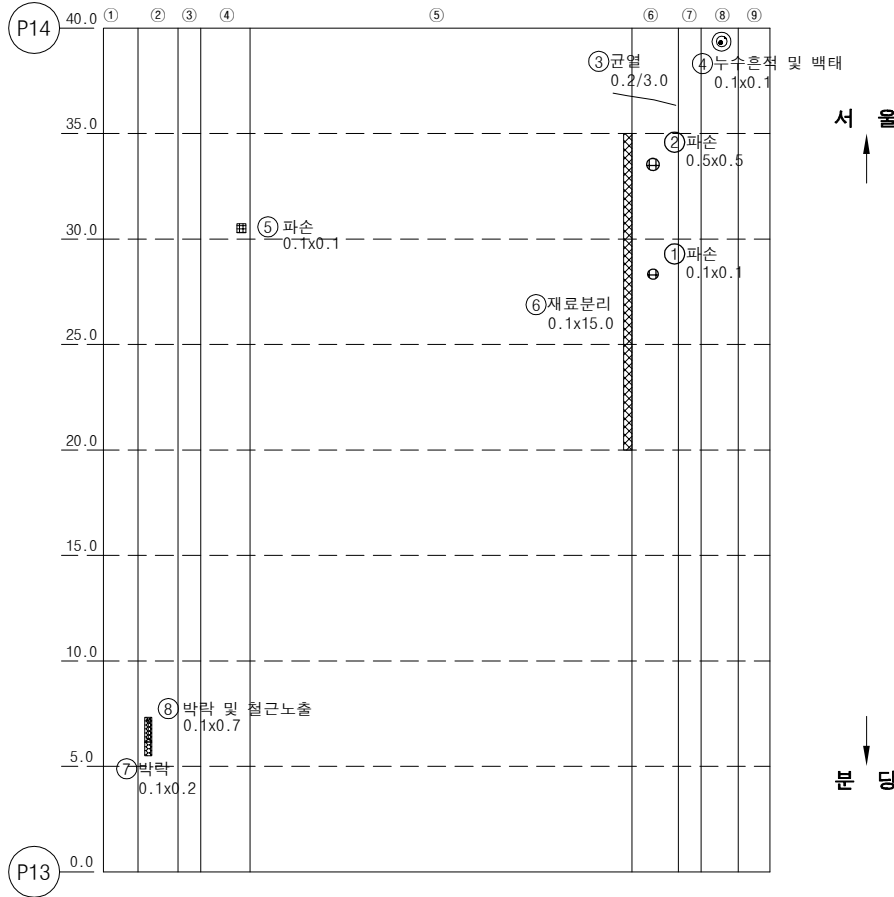
# ID : 복정고가교 본선-상행선 box외부(S14)

| 번호 | 손상내용 | 손상물량 | | | | | 비고 |
|---|---|---|---|---|---|---|---|
| 3 | 균열(0.2mm) | 0.20 | 3.00 | 3.00 | m | 1 | |
| 4 | 배수관주변누수흔적및백태 | 0.10 | 0.10 | 0.01 | m <sup>2</sup> | 1 | |

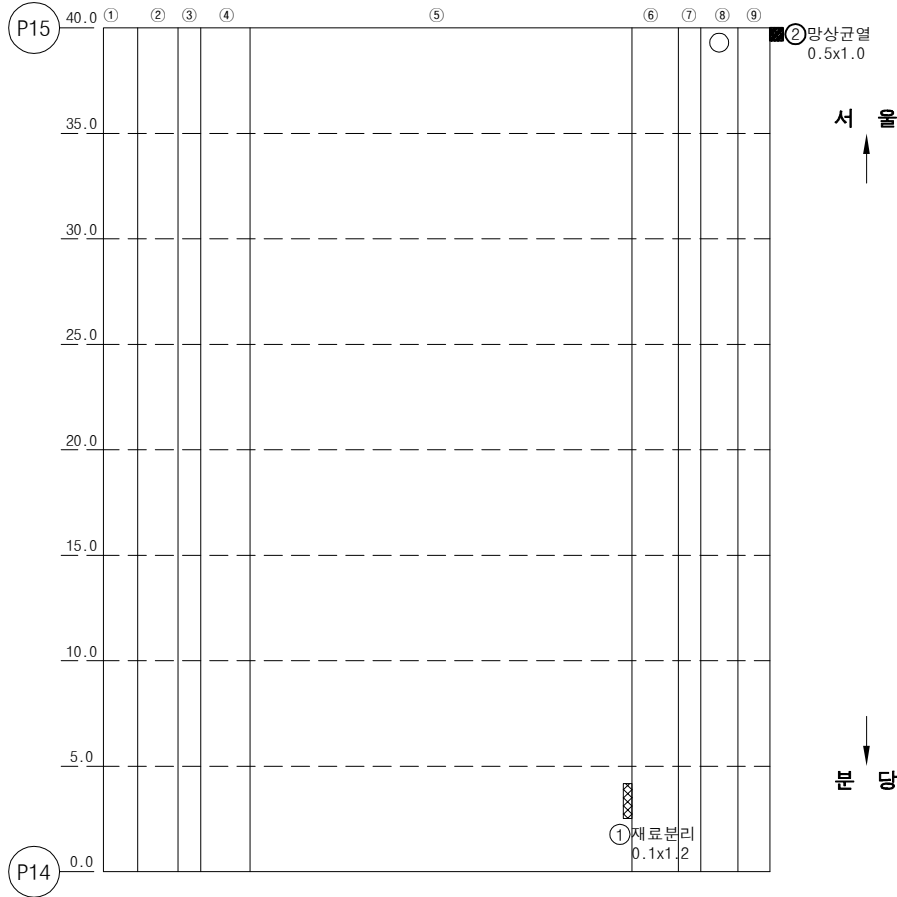
| 번호 | 손상내용 | 손상물량 | | | | | 비고 |
|---|---|---|---|---|---|---|---|
| 2 | 망상균열 | 0.50 | 1.00 | 0.50 | m <sup>2</sup> | 1 | |

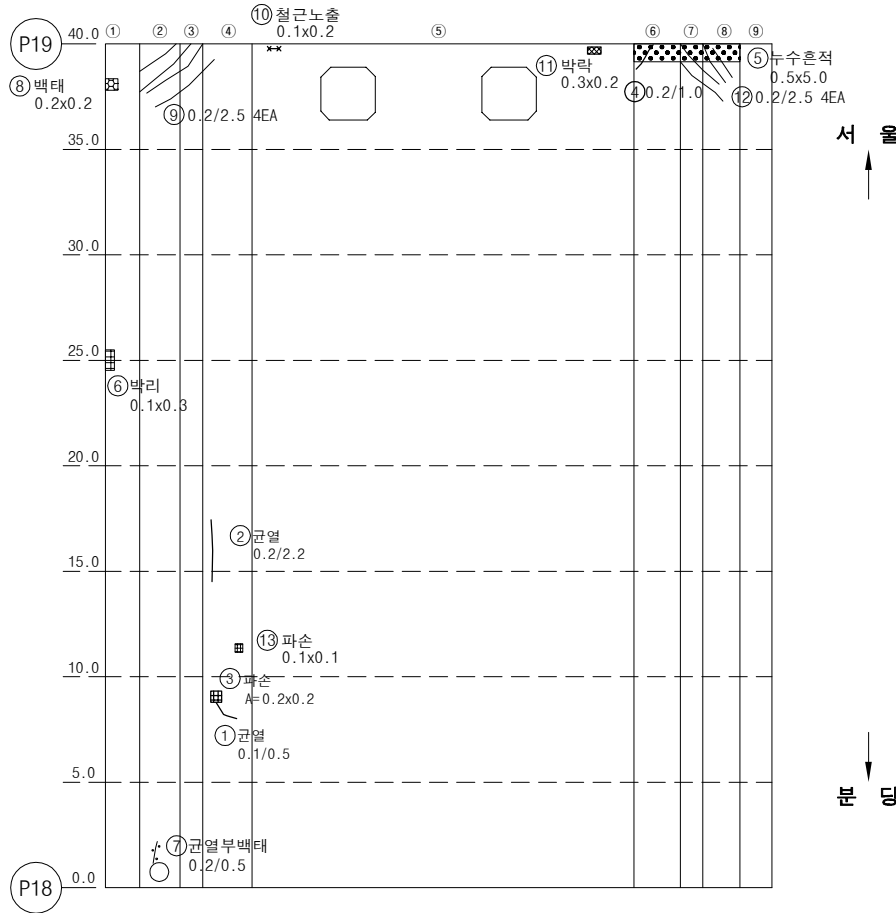
# ID : 복정고가교 본선-상행선 box외부(S19)

| 번호 | 손상내용 | 손상물량 | | | | | 비고 |
|---|---|---|---|---|---|---|---|
| 1 | 균열(0.1mm) | 0.1 | 0.5 | 0.50 | m | 1 | |
| 2 | 균열(0.2mm) | 0.2 | 2.2 | 2.20 | m | 1 | |
| 4 | 균열(0.2mm) | 0.2 | 1 | 1.00 | m | 1 | |
| 5 | 표면오염(누수흔적) | 0.5 | 5 | 2.50 | m <sup>2</sup> | 1 | |
| 7 | 균열부백태 | 0.2 | 0.5 | 0.50 | m | 1 | |
| 9 | 균열(0.2mm) | 0.2 | 2.5 | 10.00 | m | 4 | |
| 12 | 균열(0.2mm) | 0.2 | 2.5 | 10.00 | m | 4 | |

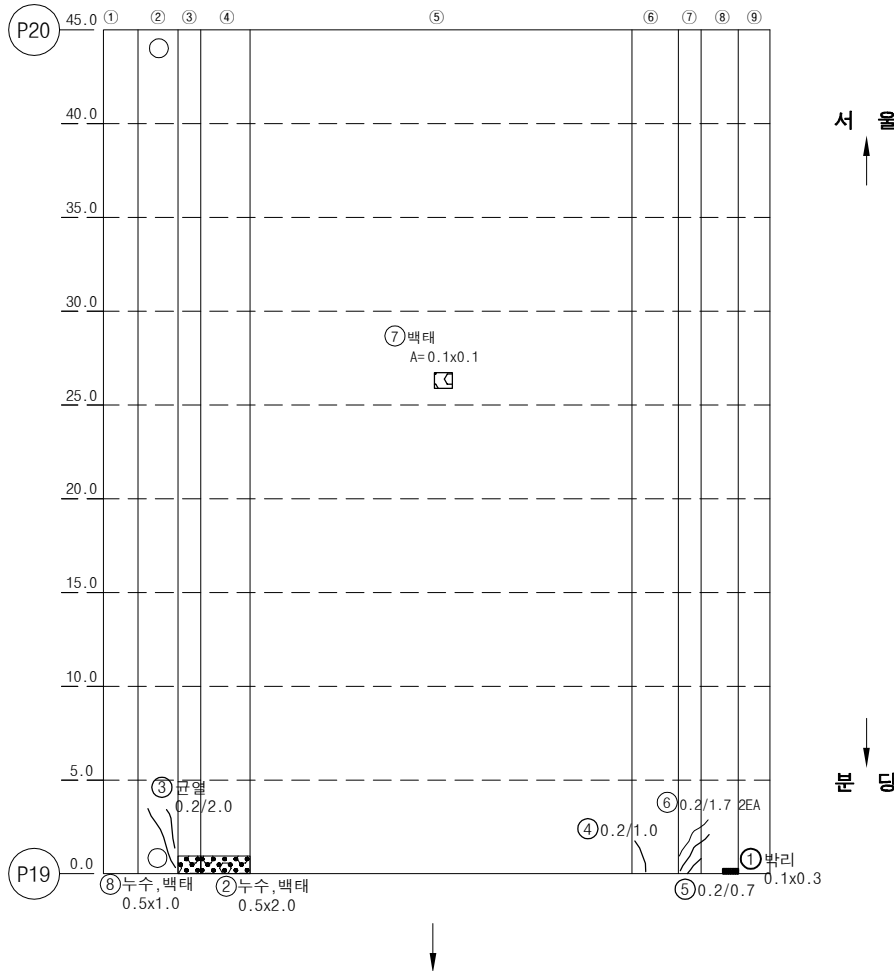
| 번호 | 손상내용 | 손상물량 | | | | | 비고 |
|---|---|---|---|---|---|---|---|
| 2 | 누수, 백태 | 0.5 | 3 | 1.50 | m <sup>2</sup> | 1 | |
| 3 | 균열(0.2mm) | 0.2 | 2 | 2.00 | m | 1 | |
| 4 | 균열(0.2mm) | 0.2 | 1 | 1.00 | m | 1 | |
| 5 | 균열(0.2mm) | 0.2 | 0.7 | 0.70 | m | 1 | |
| 6 | 균열(0.2mm) | 0.2 | 1.7 | 3.40 | m | 2 | |
| 8 | 누수, 백태 | 0.5 | 1 | 0.50 | m <sup>2</sup> | 1 | |

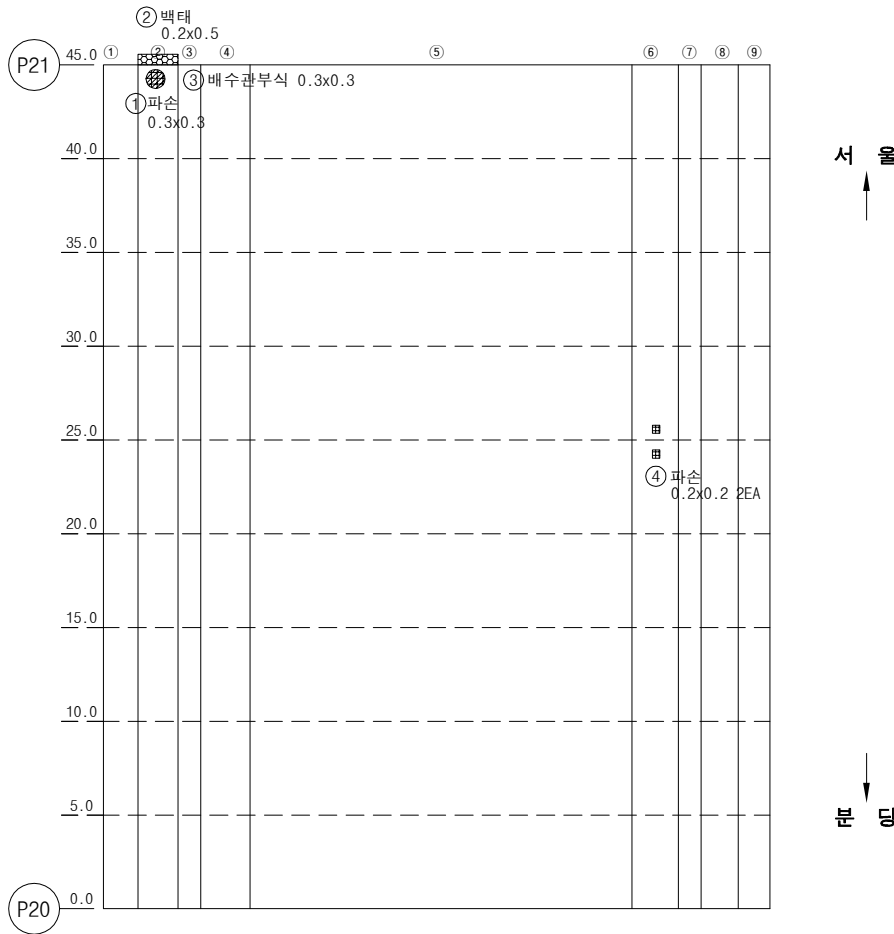
# ID : 복정고가교 본선-상행선 box외부(S21)

| 번호 | 손상내용 | 손상물량 | | | | | 비고 |
|---|---|---|---|---|---|---|---|
| 3 | 배수관부식 | 0.3 | 0.3 | 1 | EA | 1 | |

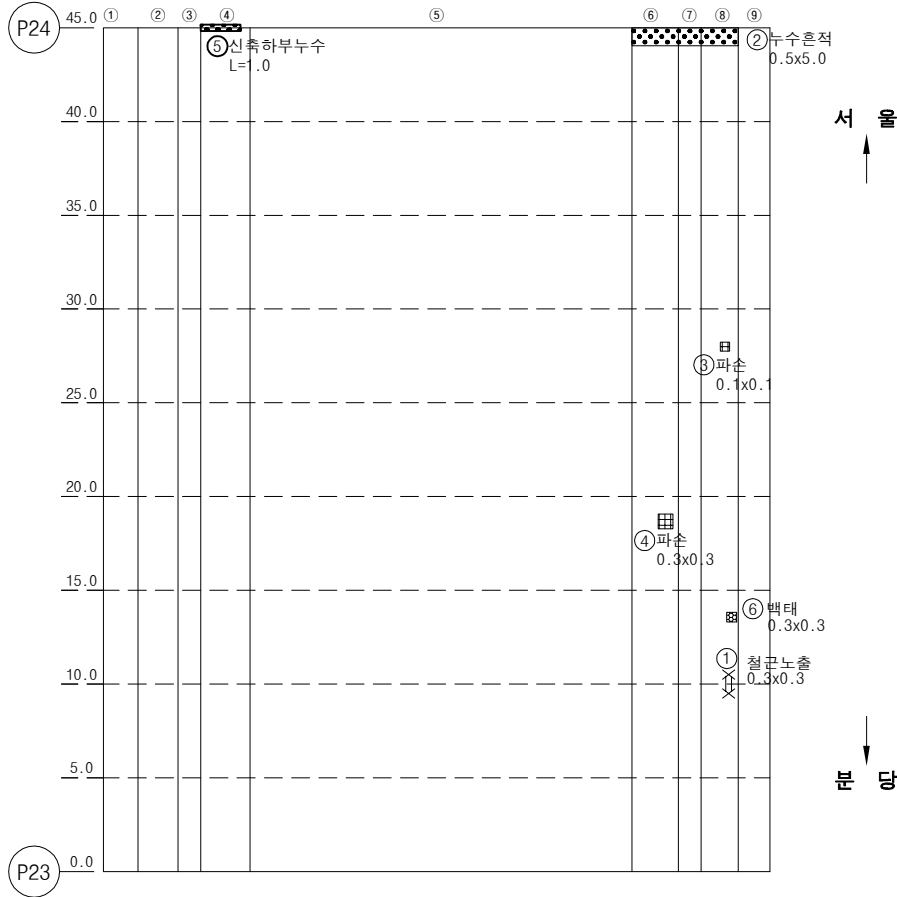
# ID : 복정고가교 본선-상행선 box외부(S24)

| 번호 | 손상내용 | 손상물량 | | | | | 비고 |
|---|---|---|---|---|---|---|---|
| 2 | 표면오염(누수흔적) | 0.5 | 5 | 2.50 | m <sup>2</sup> | 1 | |
| 5 | 신축하부누수 | | 1 | 1.00 | m | 1 | |

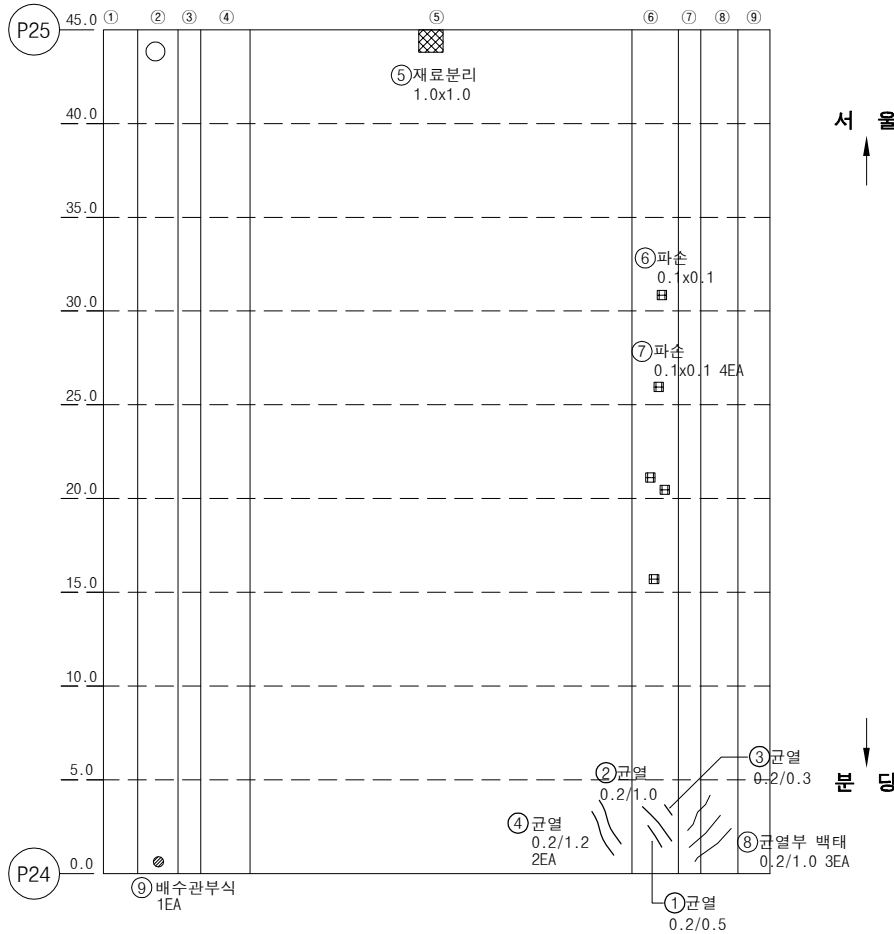
| 번호 | 손상내용 | 손상물량 | | | | | 비고 |
|---|---|---|---|---|---|---|---|
| 1 | 균열(0.2mm) | 0.2 | 0.5 | 0.50 | m | 1 | |
| 2 | 균열(0.2mm) | 0.2 | 1 | 1.00 | m | 1 | |
| 3 | 균열(0.2mm) | 0.2 | 0.3 | 0.30 | m | 1 | |
| 4 | 균열(0.2mm) | 0.2 | 1.2 | 2.40 | m | 2 | |
| 8 | 균열부백태 | 0.2 | 1 | 3.00 | m | 3 | |
| 9 | 배수관부식 | | | 1 | EA | 1 | |

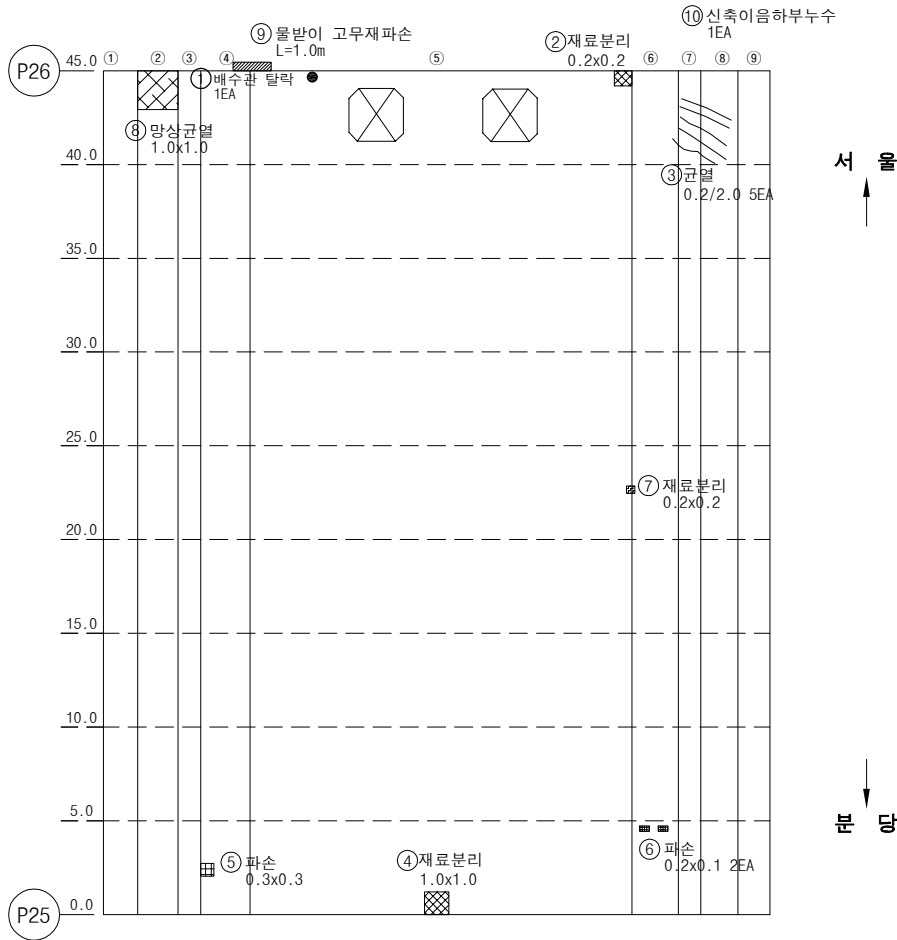
# ID : 복정고가교 본선-상행선 box외부(S26)

| 번호 | 손상내용 | 손상물량 | | | | | 비고 |
|---|---|---|---|---|---|---|---|
| 3 | 균열(0.2mm) | 0.2 | 2 | 10.00 | m | 5 | |
| 8 | 망상균열 | 1 | 1 | 1.00 | m <sup>2</sup> | 1 | |
| 10 | 신축하부누수 | | | 0.00 | EA | 1 | |

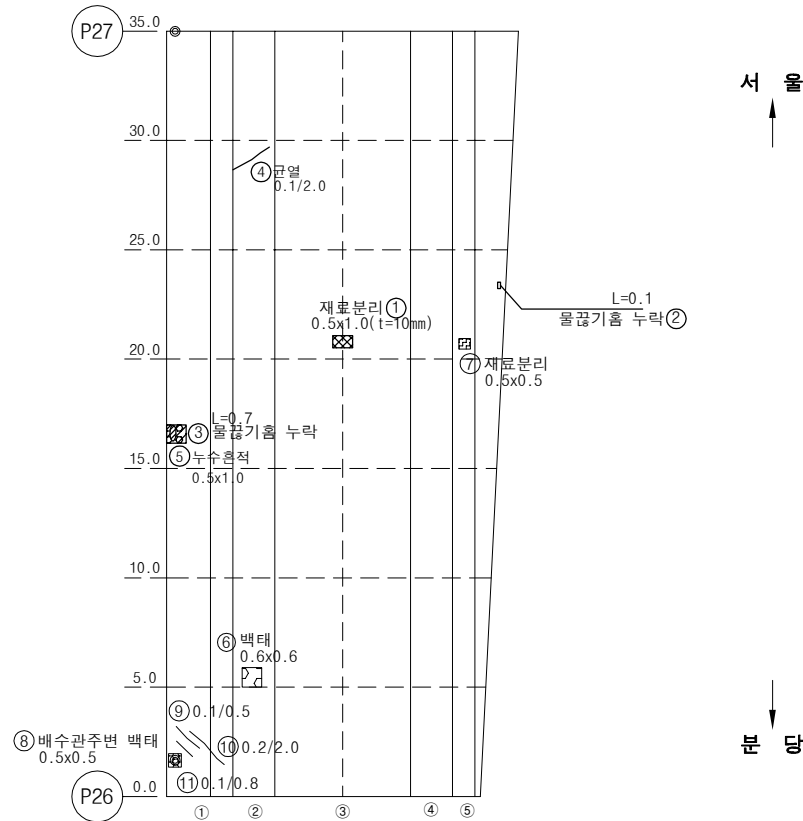
| 번호 | 손상내용 | 손상물량 | | | | | 비고 |
|---|---|---|---|---|---|---|---|
| 4 | 균열(0.1mm) | 0.1 | 2 | 2.00 | m | 1 | |
| 5 | 표면오염(누수흔적) | 0.5 | 1 | 0.50 | m <sup>2</sup> | 1 | |
| 9 | 균열(0.1mm) | 0.1 | 0.5 | 0.50 | m | 1 | |
| 10 | 균열(0.2mm) | 0.2 | 2 | 2.00 | m | 1 | |
| 11 | 균열(0.1mm) | 0.1 | 0.8 | 0.80 | m | 1 | |

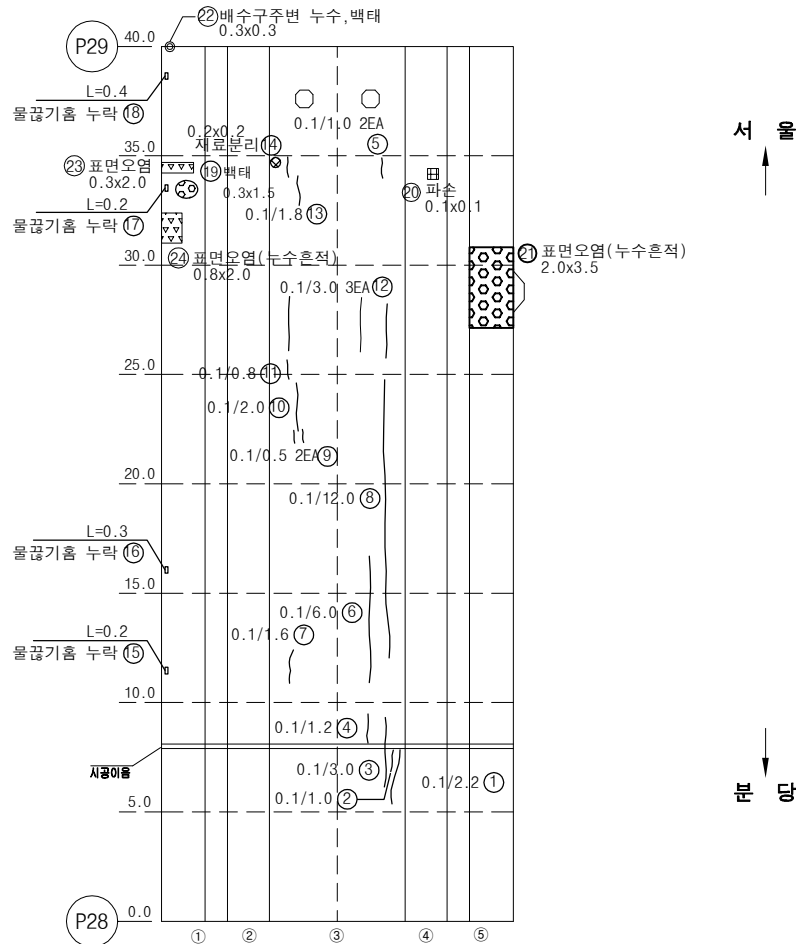
| 번호 | 손상내용 | 손상물량 | | | | | 비고 |
|---|---|---|---|---|---|---|---|
| 1 | 균열(0.1mm) | 0.1 | 2.2 | 2.20 | m | 1 | |
| 2 | 균열(0.1mm) | 0.1 | 1 | 1.00 | m | 1 | |
| 3 | 균열(0.1mm) | 0.1 | 3 | 3.00 | m | 1 | |
| 4 | 균열(0.1mm) | 0.1 | 1.2 | 1.20 | m | 1 | |
| 5 | 균열(0.1mm) | 0.1 | 1 | 2.00 | m | 2 | |
| 6 | 균열(0.1mm) | 0.1 | 6 | 6.00 | m | 1 | |
| 7 | 균열(0.1mm) | 0.1 | 1.6 | 1.60 | m | 1 | |
| 8 | 균열(0.1mm) | 0.1 | 12 | 12.00 | m | 1 | |
| 9 | 균열(0.1mm) | 0.1 | 0.5 | 1.00 | m | 2 | |
| 10 | 균열(0.1mm) | 0.1 | 2 | 2.00 | m | 1 | |
| 11 | 균열(0.1mm) | 0.1 | 0.8 | 0.80 | m | 1 | |
| 21 | 표면오염(누수흔적) | 2 | 3.5 | 7.00 | m <sup>2</sup> | 1 | |
| 22 | 배수관 주변 누수 및 백태 | 0.3 | 0.3 | 0.09 | m <sup>2</sup> | 1 | |
| 23 | 표면오염(누수흔적) | 0.3 | 2 | 0.60 | m <sup>2</sup> | 1 | |
| 24 | 표면오염(누수흔적) | 0.8 | 2 | 1.60 | m <sup>2</sup> | 1 | |

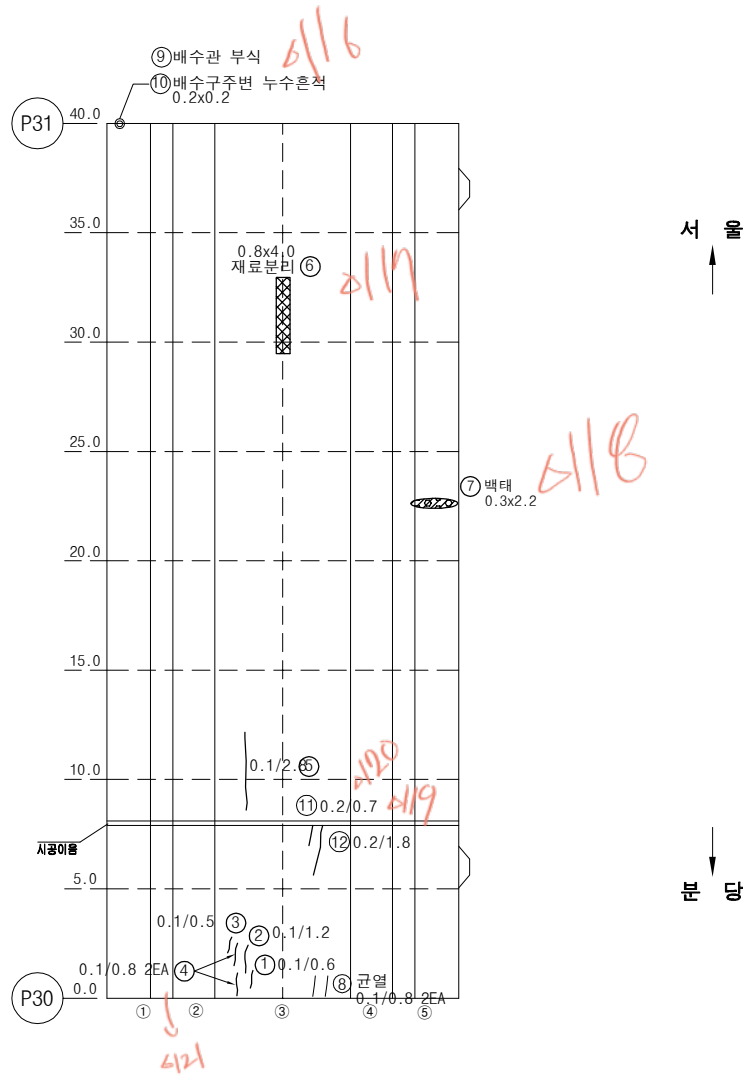
# ID : 복정고가교 본선-상행선 box외부(S31)

| 번호 | 손상내용 | 손상물량 | | | | | 비고 |
|---|---|---|---|---|---|---|---|
| 1 | 균열(0.1mm) | 0.1 | 0.6 | 0.60 | m | 1 | |
| 2 | 균열(0.1mm) | 0.1 | 1.2 | 1.20 | m | 1 | |
| 3 | 균열(0.1mm) | 0.1 | 0.5 | 0.50 | m | 1 | |
| 4 | 균열(0.1mm) | 0.1 | 0.8 | 1.60 | m | 2 | |
| 5 | 균열(0.1mm) | 0.1 | 2.8 | 2.80 | m | 1 | |
| 8 | 균열(0.1mm) | 0.1 | 0.8 | 1.60 | m | 2 | |
| 9 | 배수관부식 | | | 1 | EA | 1 | |
| 10 | 배수구주변누수흔적 | 0.2 | 0.2 | 0.04 | m <sup>2</sup> | 1 | |
| 11 | 균열(0.2mm) | 0.2 | 0.7 | 0.70 | m | 1 | |
| 12 | 균열(0.2mm) | 0.2 | 1.8 | 1.80 | m | 1 | |

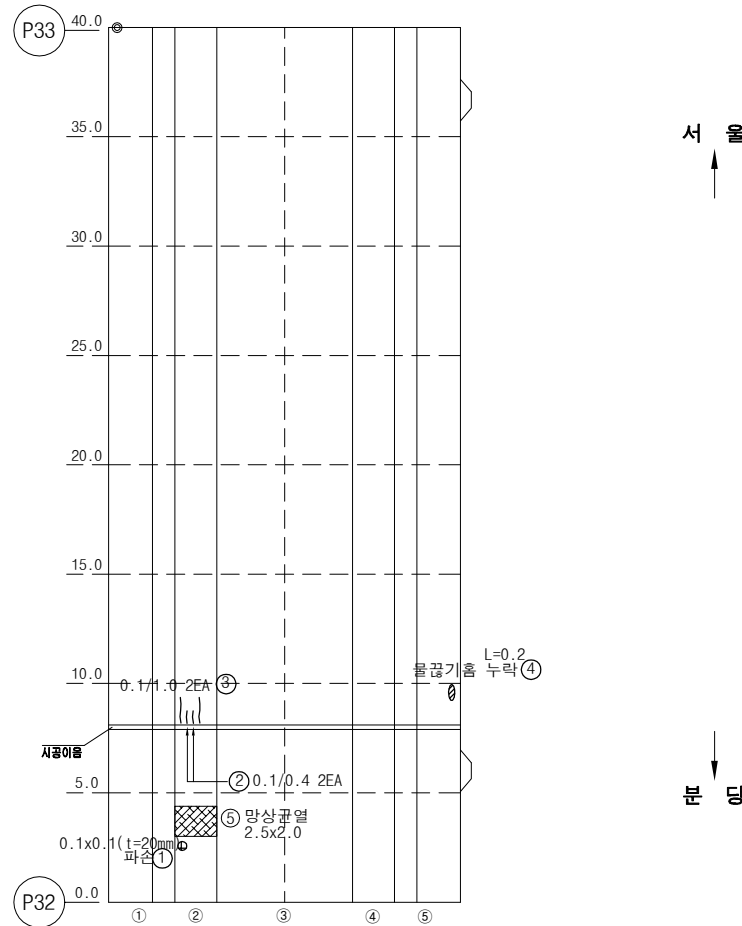
| 번호 | 손상내용 | 손상물량 | | | | | 비고 |
|---|---|---|---|---|---|---|---|
| 2 | 균열(0.1mm) | 0.1 | 0.4 | 0.80 | m | 2 | |
| 3 | 균열(0.1mm) | 0.1 | 1 | 2.00 | m | 2 | |
| 5 | 망상균열 | 2 | 2.5 | 5.00 | m² | 1 | |

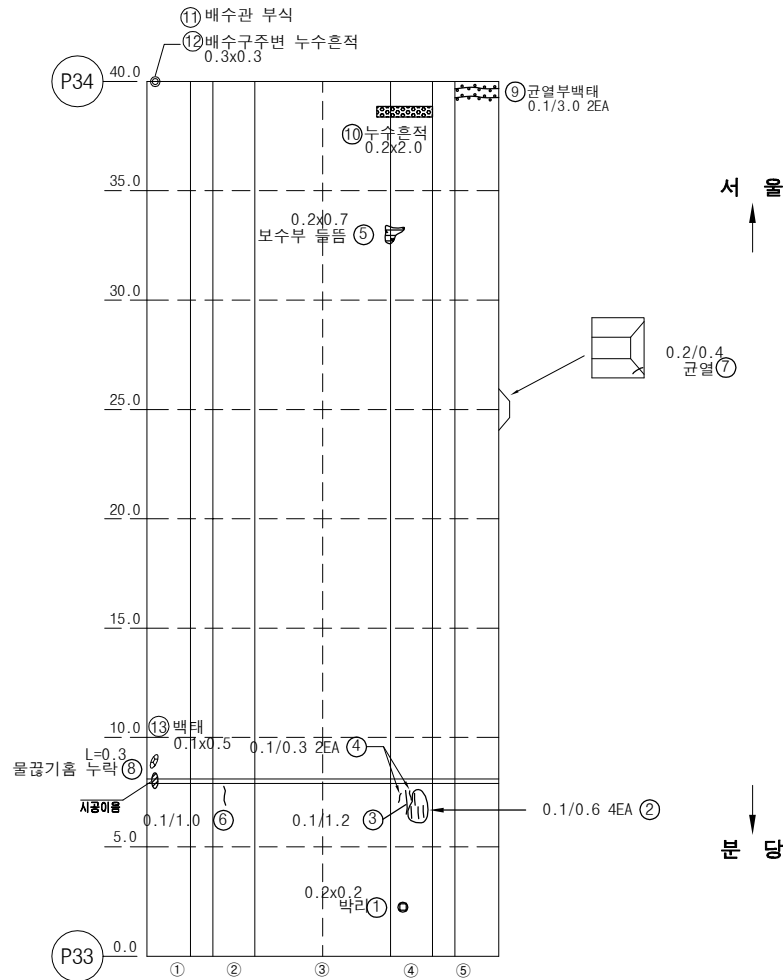
# ID : 복정고가교 본선-상행선 box외부(S34)

| 번호 | 손상내용 | 손상물량 | | | | | 비고 |
|---|---|---|---|---|---|---|---|
| 2 | 균열(0.1mm) | 0.1 | 0.6 | 2.40 | m | 4 | |
| 3 | 균열(0.1mm) | 0.1 | 1.2 | 1.20 | m | 1 | |
| 4 | 균열(0.1mm) | 0.1 | 0.3 | 0.60 | m | 2 | |
| 6 | 균열(0.1mm) | 0.1 | 1 | 1.00 | m | 1 | |
| 7 | 균열(0.2mm) | 0.2 | 0.4 | 0.40 | m | 1 | |
| 9 | 균열부백태 | 0.1 | 3 | 6.00 | m | 2 | |
| 10 | 누수흔적 | 2 | 0.2 | 0.40 | m <sup>2</sup> | 1 | |
| 11 | 배수관부식 | | | 1 | EA | 1 | |
| 12 | 배수관 주변 누수흔적 | 0.3 | 0.3 | 0.09 | m <sup>2</sup> | 1 | |
