삼정천교(울산) 교면포장 S1

손 상 물 량 표

| 용역명 | | 2023년 부산울산고속도로 정밀안전점검 및 성능평가용역 | | | |

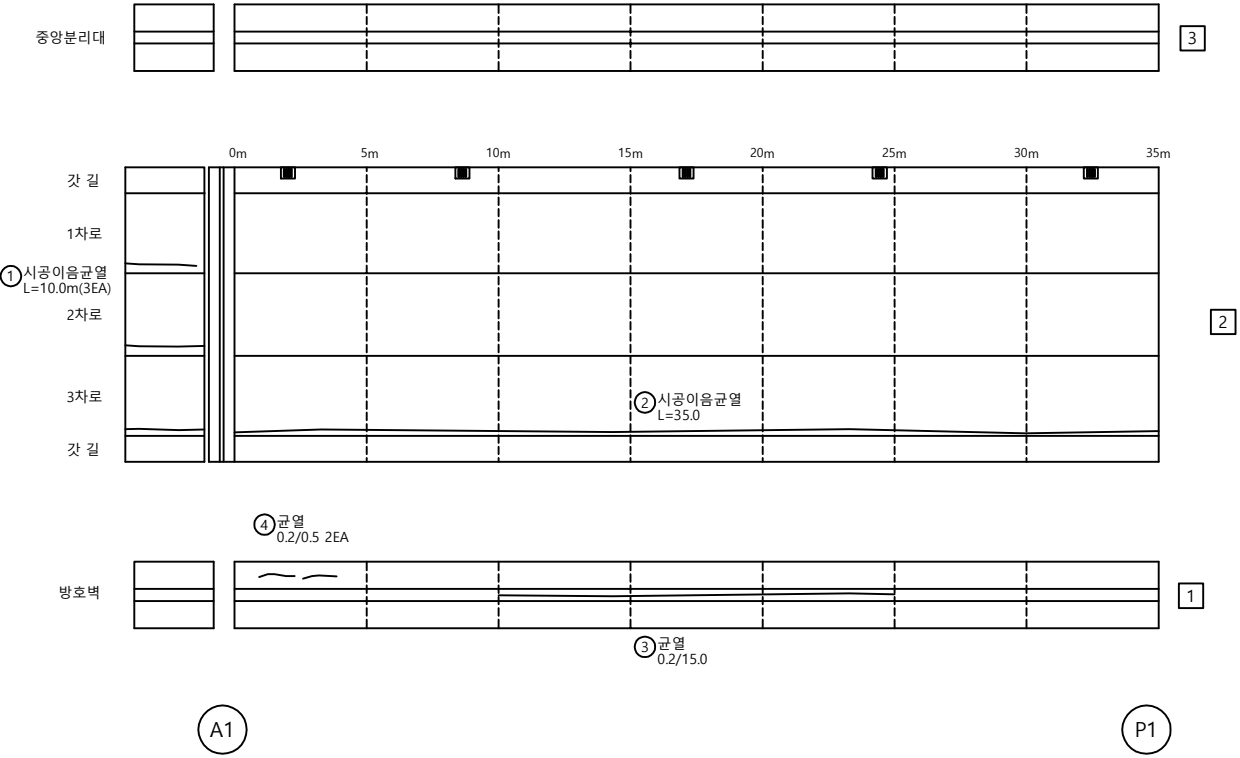
| 번호 | 선/구 | 부재명 | 손 상 현 황 | 손 상 규 모 | | | | | 비고 |
|---|---|---|---|---|---|---|---|---|---|
| 1 | 구 | 교면포장 | 시공이음 균열 | 1.0 | 10.0 | | 3 | m | 30.00 |
| 2 | 구 | 교면포장 | 시공이음 균열 | 1.0 | 35.0 | | 1 | m | 35.00 |
| 3 | 구 | 방호벽 | 균열 | 0.2 | 15.0 | | 1 | m | 15.00 |
| 4 | 신 | 방호벽 | 균열 | 0.2 | 0.5 | | 2 | m | 1.00 |

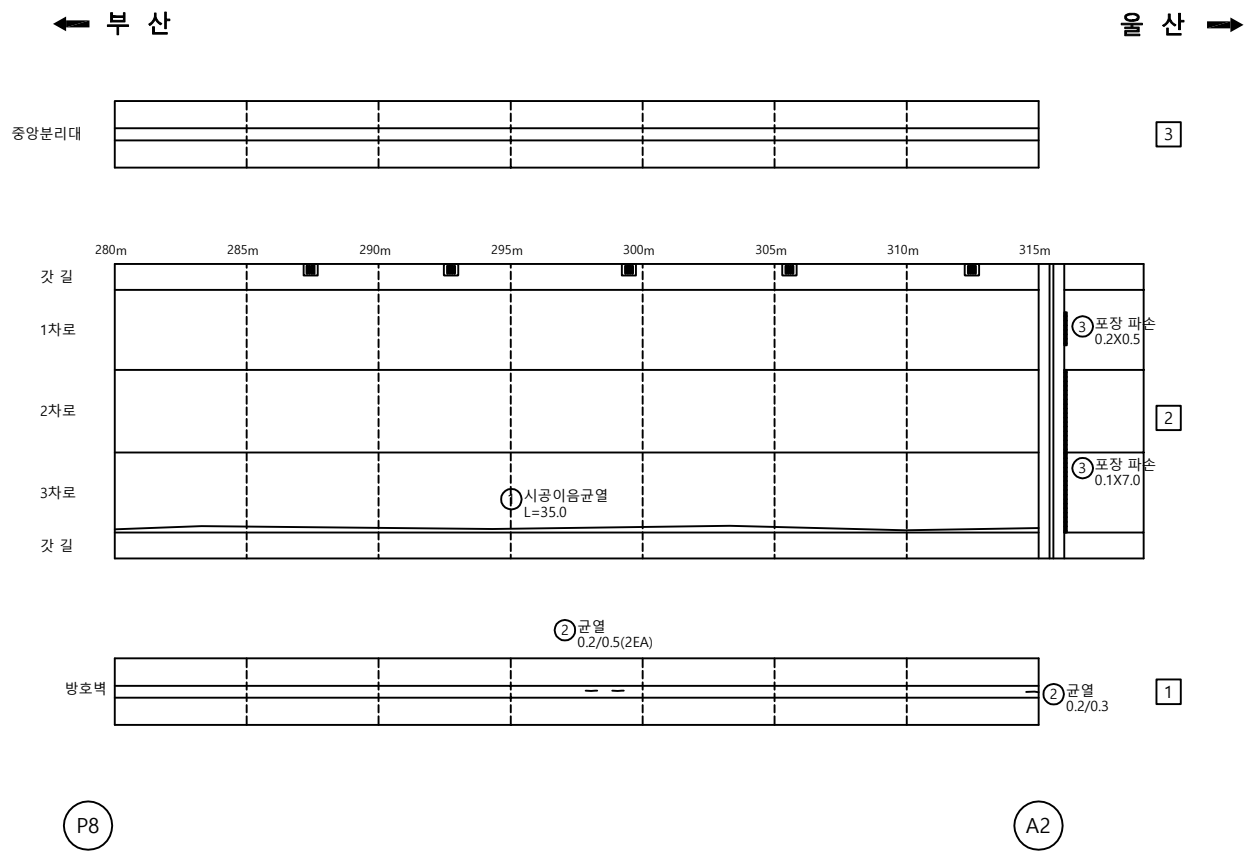
삼정천교(울산) 교면포장 S9

| 교면포장 | | | | | | | | | |
|---|---|---|---|---|---|---|---|---|---|
| 1 | 구 | 교면포장 | 시공이음 균열 | 1.0 | 35.0 | | 1 | m | 35.00 |
| 2 | 구 | 방호벽 | 균열 | 0.2 | 0.5 | | 1 | m | 0.50 |
| 5 | 신 | 방호벽 | 균열 | 0.2 | 0.5 | | 1 | m | 0.50 |

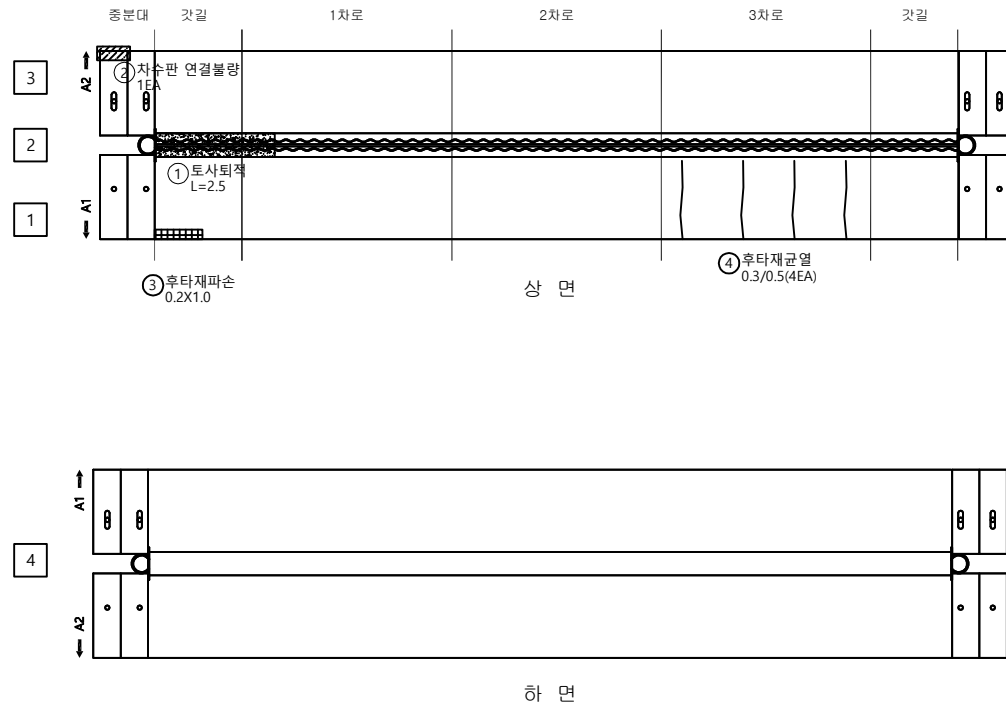
| 신축이음 | | | | | | | | | |
|---|---|---|---|---|---|---|---|---|---|
| 4 | 구 | 신축이음 | 후타재 균열 | 0.3 | 0.5 | | 4 | m | 2.00 |

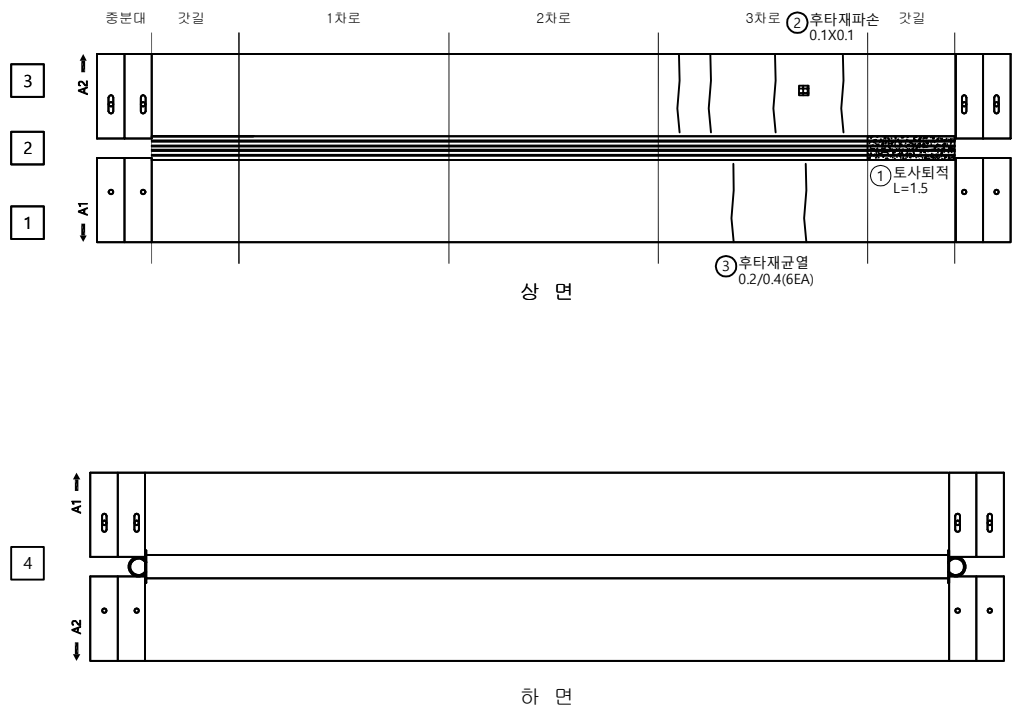
| 신축이음 | | | | | | | | | | |
|---|---|---|---|---|---|---|---|---|---|---|
| P6 | | | | | | | | | | |

| 신축이음 | | | | | | | | | | |
|---|---|---|---|---|---|---|---|---|---|---|
| 3 | 구 | 신축이음 | 후타재 균열 | 0.2 | 0.4 | | 6 | m | 2.40 | |

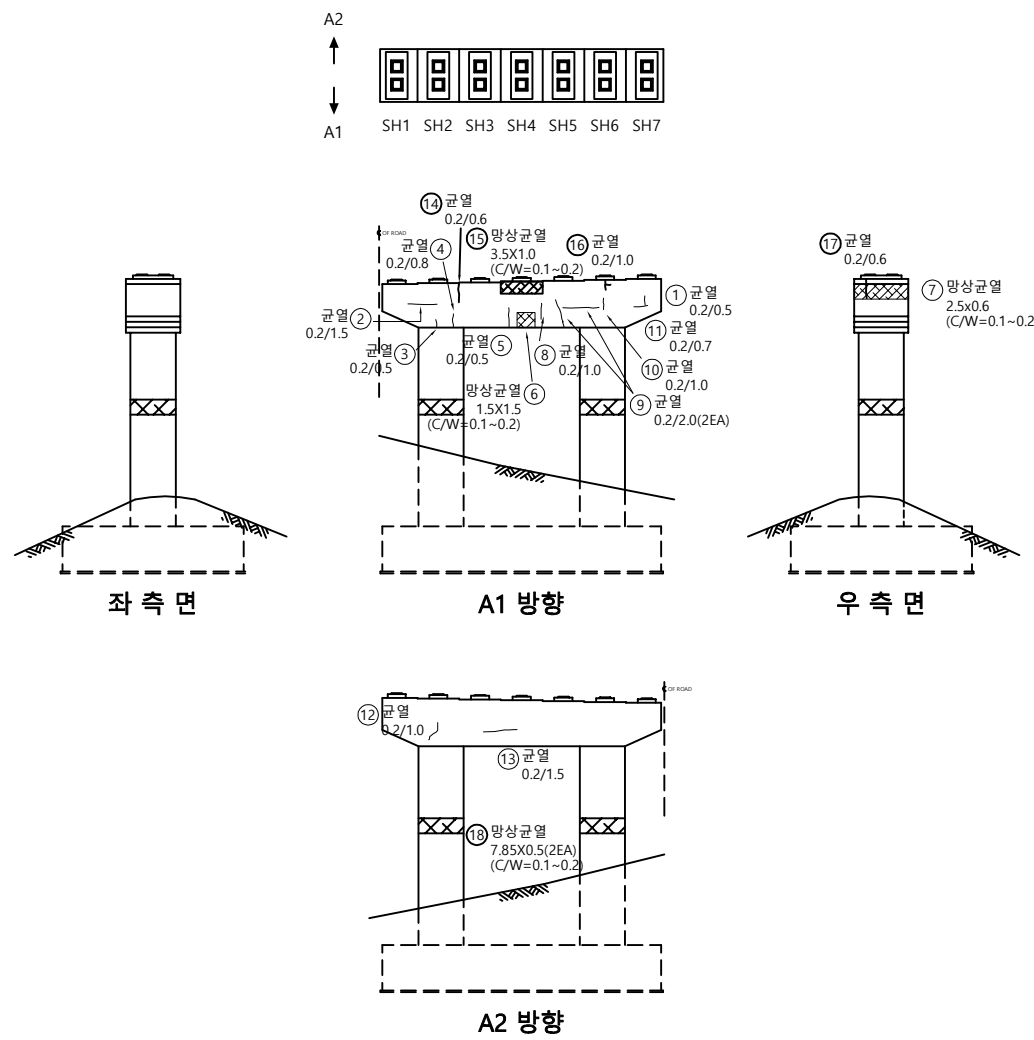
| 교각<br>P1 | | | | | | | | | |

| 교각<br>P1 | | | | | | | | | |
|---|---|---|---|---|---|---|---|---|---|
| 1 | 구 | 교각 | 균열 | 0.2 | 0.5 | | 1 | m | 0.50 |
| 2 | 구 | 교각 | 균열 | 0.2 | 1.5 | | 1 | m | 1.50 |
| 3 | 구 | 교각 | 균열 | 0.2 | 0.5 | | 1 | m | 0.50 |
| 4 | 구 | 교각 | 균열 | 0.2 | 0.8 | | 1 | m | 0.80 |
| 5 | 구 | 교각 | 균열 | 0.2 | 0.5 | | 1 | m | 0.50 |
| 6 | 구 | 교각 | 망상균열 | 0.2 | 1.5 | 1.5 | 1 | ㎡ | 2.25 |
| 7 | 구 | 교각 | 망상균열 | 0.2 | 2.5 | 0.6 | 1 | ㎡ | 1.50 |
| 8 | 구 | 교각 | 균열 | 0.2 | 1.0 | | 1 | m | 1.00 |
| 9 | 구 | 교각 | 균열 | 0.2 | 2.0 | | 2 | m | 4.00 |
| 10 | 구 | 교각 | 균열 | 0.2 | 1.0 | | 1 | m | 1.00 |
| 11 | 구 | 교각 | 균열 | 0.2 | 0.7 | | 1 | m | 0.70 |
| 12 | 구 | 교각 | 균열 | 0.2 | 1.0 | | 1 | m | 1.00 |
| 13 | 구 | 교각 | 균열 | 0.2 | 1.5 | | 1 | m | 1.50 |
| 14 | 구 | 교각 | 균열 | 0.2 | 0.6 | | 1 | m | 0.60 |
| 15 | 구 | 교각 | 망상균열 | 0.2 | 3.5 | 1.0 | 1 | ㎡ | 3.50 |
| 16 | 구 | 교각 | 균열 | 0.2 | 1.0 | | 1 | m | 1.00 |
| 17 | 구 | 교각 | 균열 | 0.2 | 0.6 | | 1 | m | 0.60 |
| 18 | 구 | 교각 | 망상균열 | 0.2 | 7.9 | 0.5 | 2 | ㎡ | 7.85 |
