# 용소교(부산) 교면포장 S1

| 용역명 | | 2023년 부산울산고속도로 정밀안전점검 및 성능평가용역 | | | |

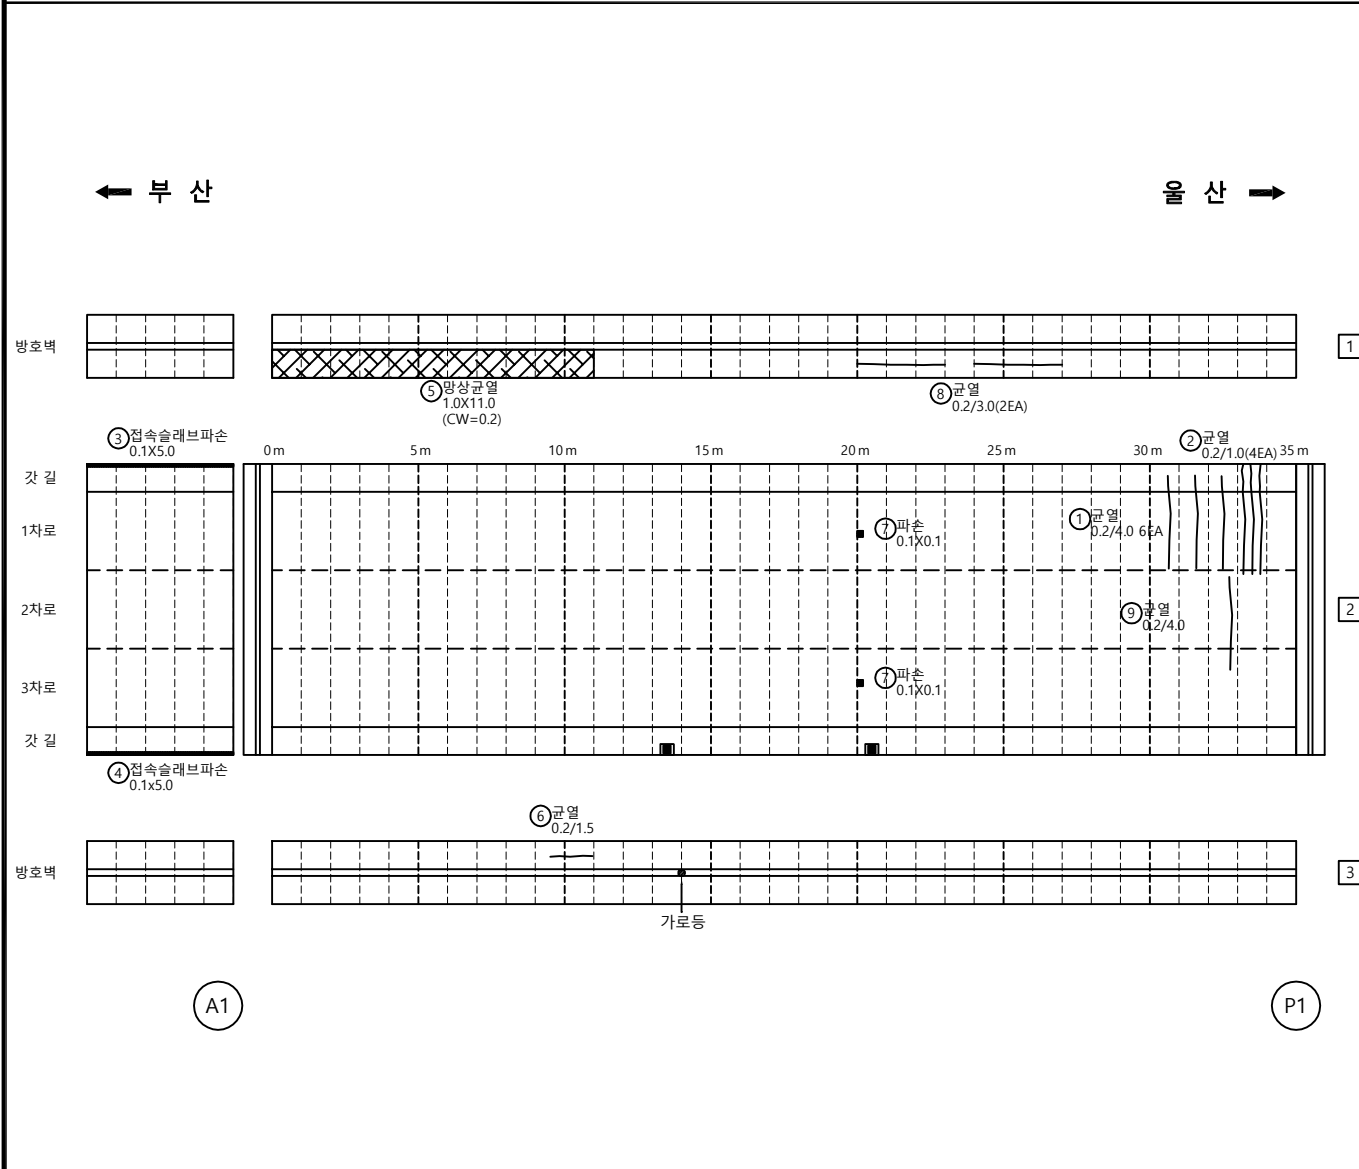
| 교면포장 S1 | | | | | | | | | |
|---|---|---|---|---|---|---|---|---|---|
| 1 | 신 | 교면포장 | 포장균열 | 0.2 | 4.0 | | 6 | m | 24.00 |
| 2 | 구 | 교면포장 | 포장균열 | 0.2 | 1.0 | | 4 | m | 4.00 |
| 3 | 구 | 교면포장 | 철근콘크리트 파손 | | 0.1 | 5.0 | 1 | m | 0.50 |
| 4 | 구 | 교면포장 | 철근콘크리트 파손 | | 0.1 | 5.0 | 1 | m | 0.50 |
| 5 | 신 | 방수벽 | 방수층균열 | 0.2 | 11.0 | 1.0 | 1 | m | 11.00 |
| 6 | 구 | 방수벽 | 균열 | 0.2 | 1.5 | | 1 | m | 1.50 |
| 7 | 구 | 교면포장 | 포장파손 | | 0.1 | 0.1 | 1 | m | 0.01 |
| 8 | 구 | 방수벽 | 균열 | 0.2 | 3.0 | | 2 | m | 6.00 |
| 9 | 구 | 교면포장 | 포장균열 | 0.2 | 4.0 | | 1 | m | 4.00 |
| 10 | 신 | 교면포장 | 포장파손 | | 0.1 | 0.1 | 1 | m | 0.01 |

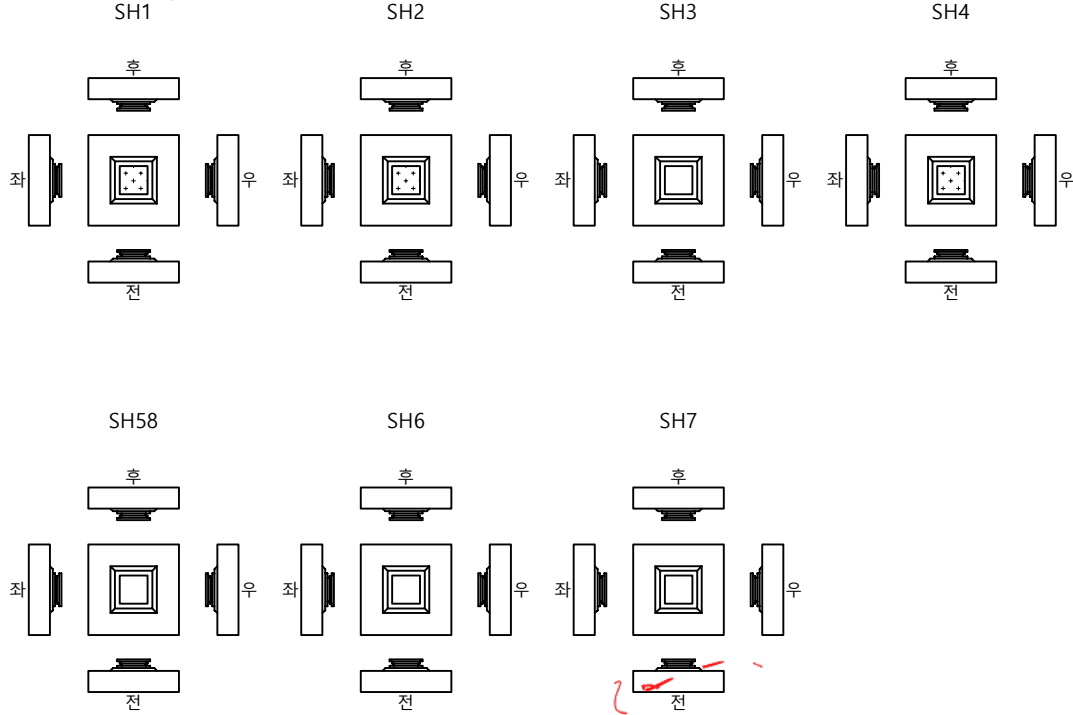
○플레이트 부식  
3EA

| 번호 | 선/구 | 부재명 | 손 상 현 황 | 손 상 규 모 | | | | | | 비고 |
|---|---|---|---|---|---|---|---|---|---|---|
| 1 | 구 | 교량받침 | 플레이트 부식 | | | | 3 | EA | 3.00 | |
