| 별<br>례 | CW(0.2) 균열 | 망상균열 | 철근노출 | 용역명 | 2024년 국도3호선 기타시설물<br>전입2교 등 31개소 정기안전점검 용역 |
| | 파손, 탈락 | 재료분리 | 백태 | 구조물명 | 오천교차1교 |

ID : 바닥판 하면 (S1) 외관조사망도

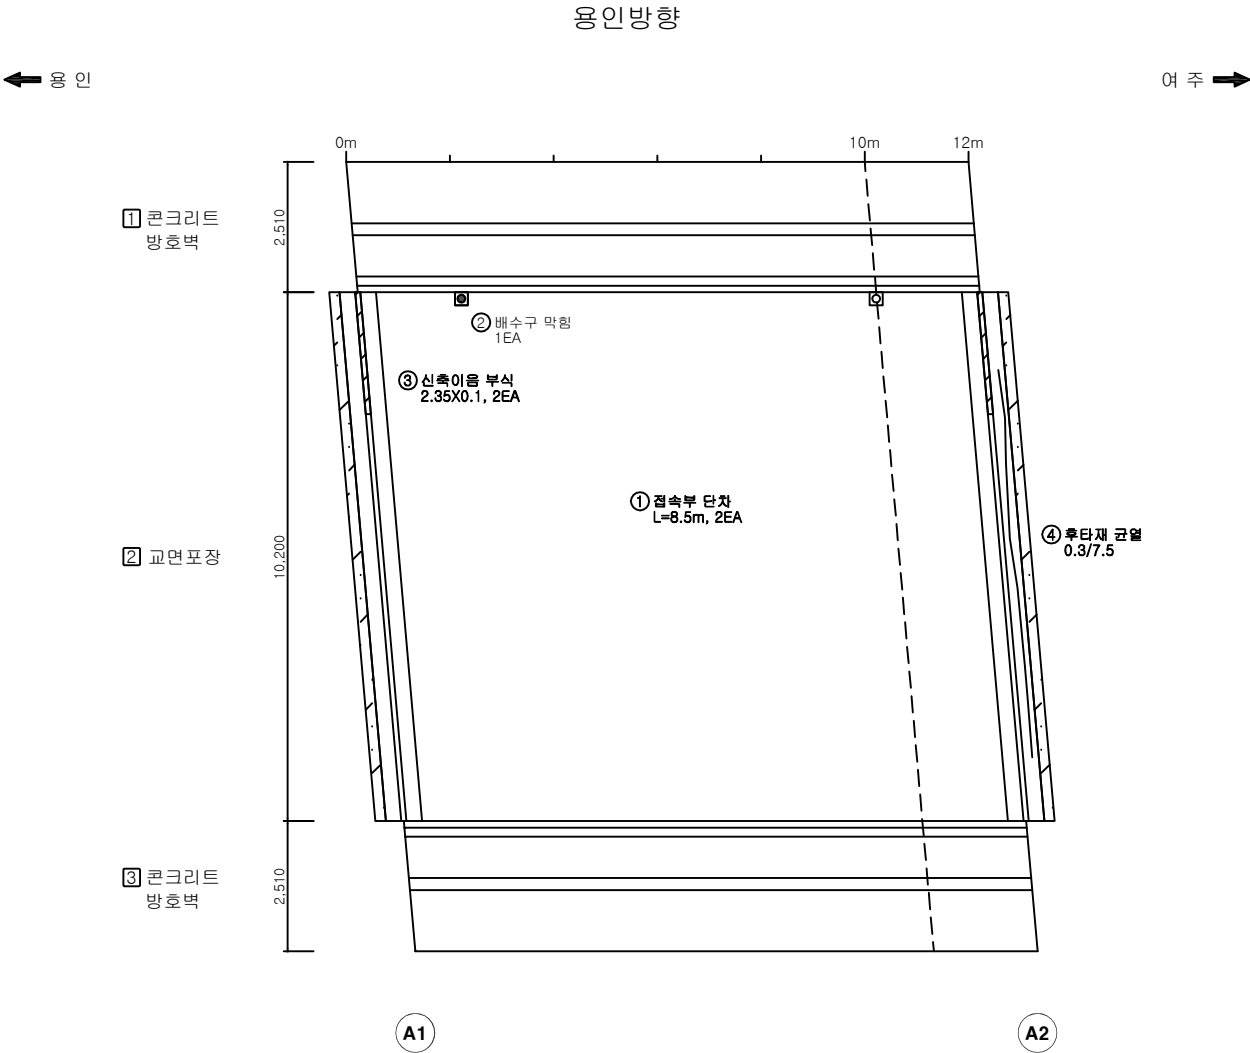
| No. | 손상내용 | 2024년 정기점검 | | | | | | | 비고 |
|---|---|---|---|---|---|---|---|---|---|
| 1 | 접속부 단차 | - | - | 8.5 | - | 2 | 17.00 | m | |
| 2 | 배수구 막힘 | - | - | - | - | 1 | 1.00 | EA | |
| 3 | 신축이음 부식 | - | - | 2.35 | 0.1 | 2 | 0.47 | m² | |
| 4 | 후타재 균열 | - | 0.3 | 7.5 | - | 1 | 7.50 | m | |

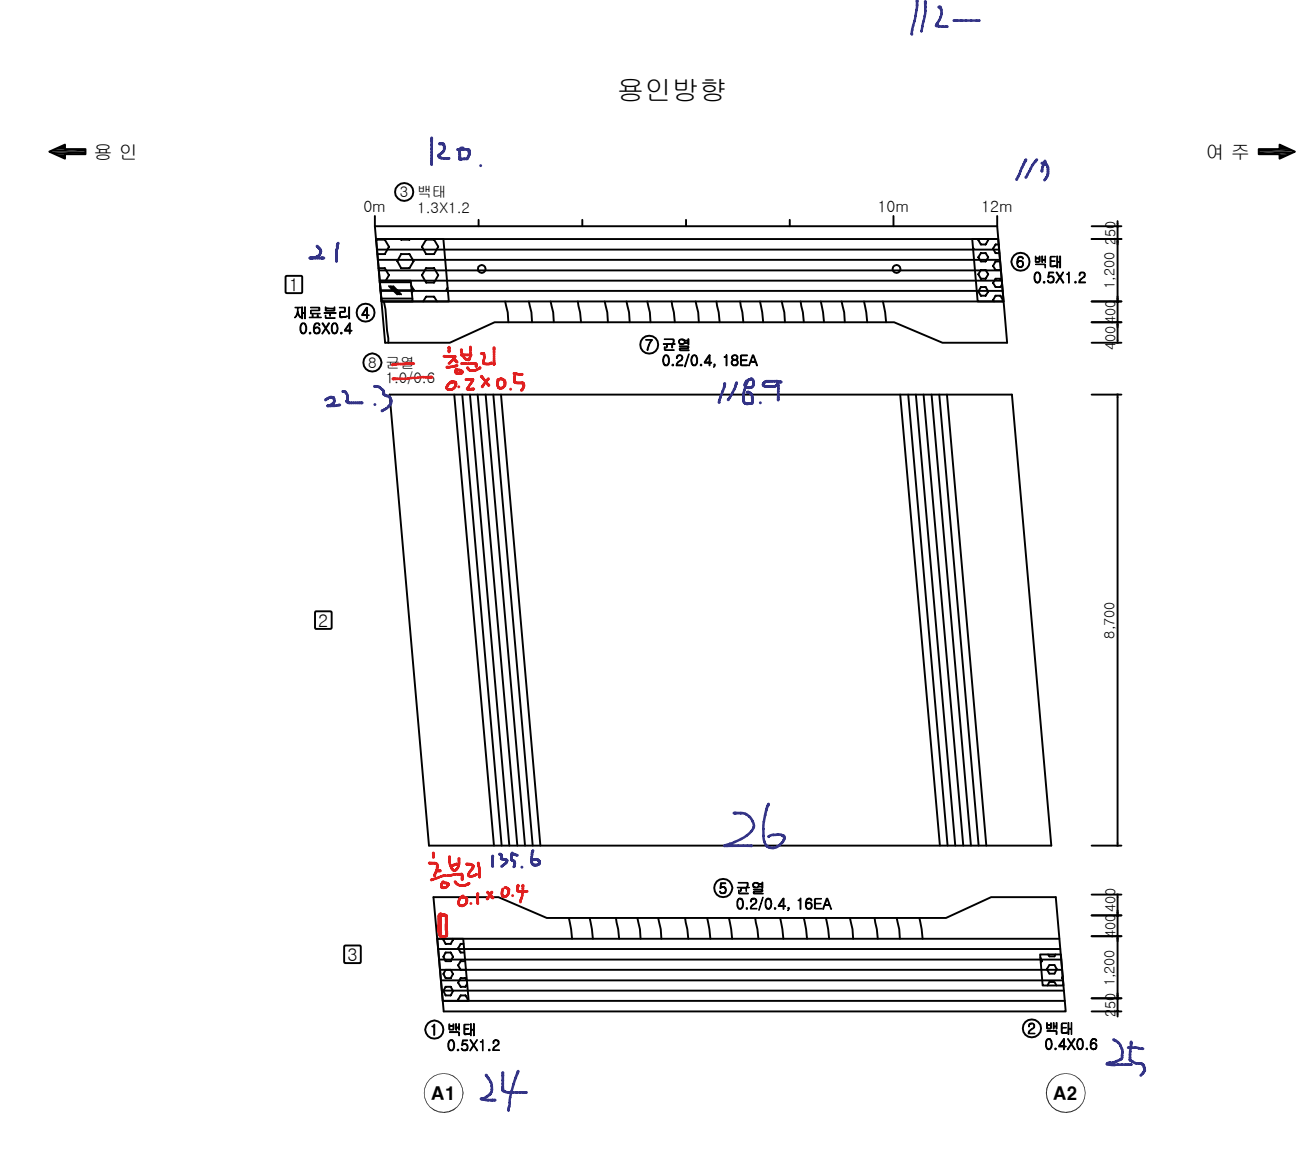
ID : 교대 (A1) 외관조사망도

| No. | 손상내용 | 2024년 정기점검 | | | | | | | 비고 |
|---|---|---|---|---|---|---|---|---|---|
| 1 | 백태 | - | - | 0.5 | 1.2 | 1 | 0.60 | m² | |
| 2 | 백태 | - | - | 0.4 | 0.6 | 1 | 0.24 | m² | |
| 3 | 백태 | - | - | 1.3 | 1.2 | 1 | 1.56 | m² | |
| 4 | 재료분리 | - | - | 0.6 | 0.4 | 1 | 0.24 | m² | |
| 5 | 균열 | - | 0.2 | 0.4 | - | 16 | 6.40 | m | |
| 6 | 백태 | - | - | 0.5 | 1.2 | 1 | 0.60 | m² | |
| 7 | 균열 | - | 0.2 | 0.4 | - | 18 | 7.20 | m | |
| 8 | 균열 | - | 1.0 | 0.6 | - | 1 | 0.60 | m | |

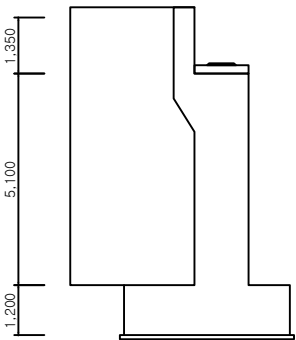
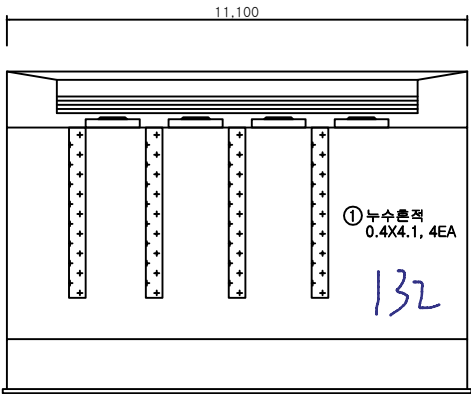
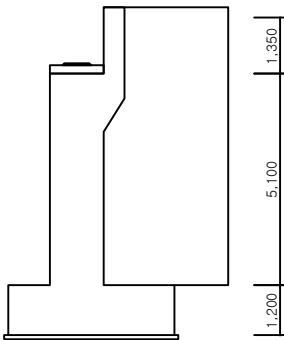
ID : 교대 (A2) 외관조사망도

| No. | 손상내용 | 2024년 정기점검 | | | | | | | 비고 |
|---|---|---|---|---|---|---|---|---|---|
| 1 | 누수흔적 | - | - | 0.4 | 4.1 | 4 | 6.56 | m² | |

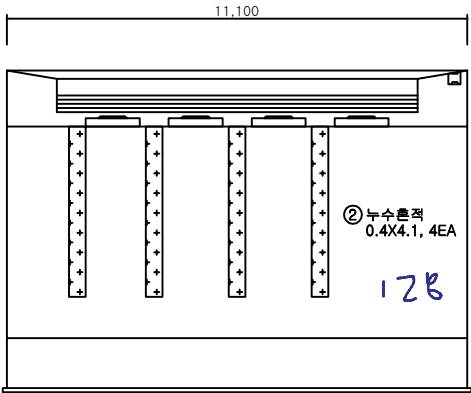
① 백태  
0.3X0.3

② 누수흔적  
0.4X4.1, 4EA

| No. | 손상내용 | 2024년 정기점검 | | | | | | | 비고 |
|---|---|---|---|---|---|---|---|---|---|
| 1 | 백태 | - | - | 0.3 | 0.3 | 1 | 0.09 | m | |
| 2 | 누수흔적 | - | - | 0.4 | 4.1 | 4 | 6.56 | m² | |
