상주영천고속도로 2024~2025년 시설물 안전점검 용역  
(2025년 상반기 정기안전점검)

# 외 관 조 사 망 도

양지교

ID : 양지교(상주방향) 교면포장 S1

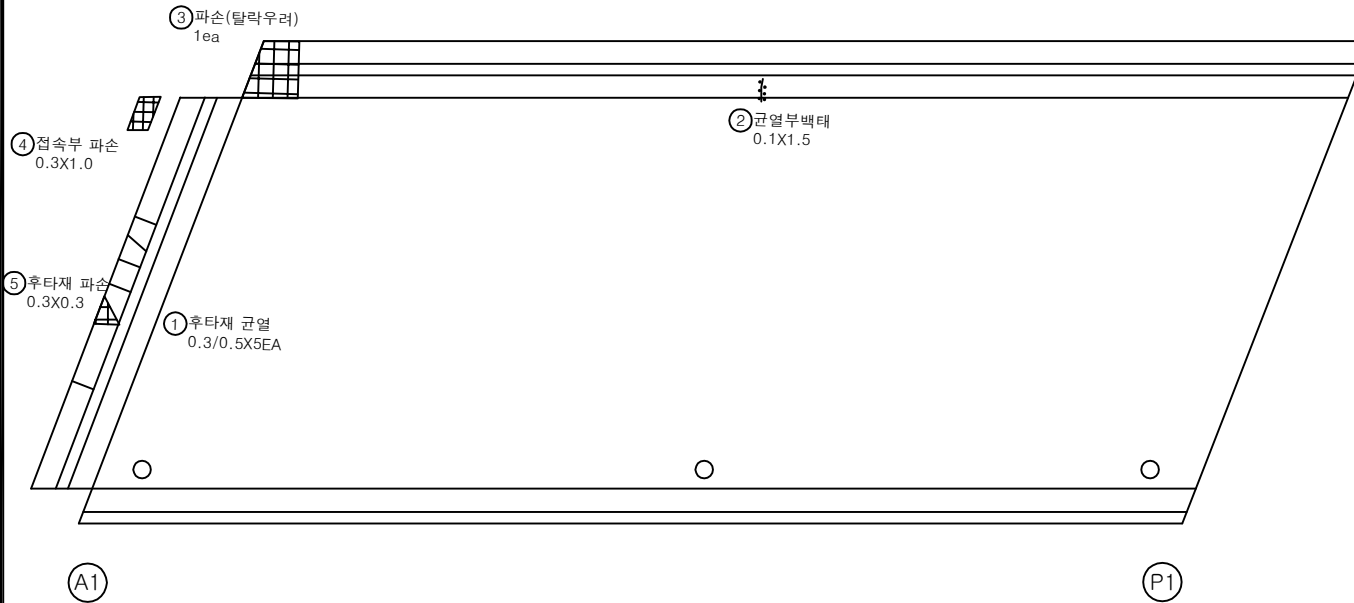
| 번호 | 구분 | 부재 | 손상내용 | 손상현황 | | | | | | 비고 |
|---|---|---|---|---|---|---|---|---|---|---|
| 1 | 19하 | 신축이음 | 후타재 균열 | 0.3 | 0.5 | | 2.50 | m | 5 | |
| 2 | 19하 | 방호벽 | 균열부백태 | | 0.1 | 1.5 | 0.15 | m <sup>2</sup> | 1 | |
| 3 | 20상 | 방호벽 | 방호벽 파손(탈락우려) | | | | 1.00 | EA | 1 | |
| 4 | 21하 | 교면포장 | 접속부 파손 | | 0.3 | 1.0 | 0.30 | m <sup>2</sup> | 1 | |
| 5 | 23하 | 신축이음 | 후타재 파손 | | 0.3 | 0.3 | 0.09 | m <sup>2</sup> | 1 | |

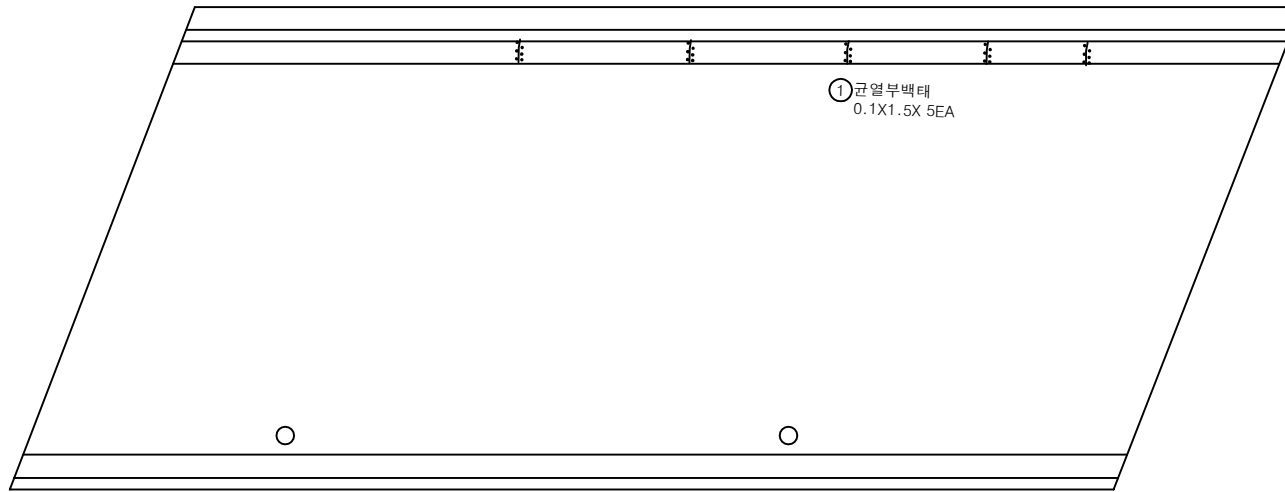
| 번호 | 구분 | 부재 | 손상내용 | 손상현황 | | | | | | 비 고 |
|---|---|---|---|---|---|---|---|---|---|---|
| 1 | 19하 | 방호벽 | 균열부백태 | | 0.1 | 1.5 | 0.75 | m <sup>2</sup> | 5 | |

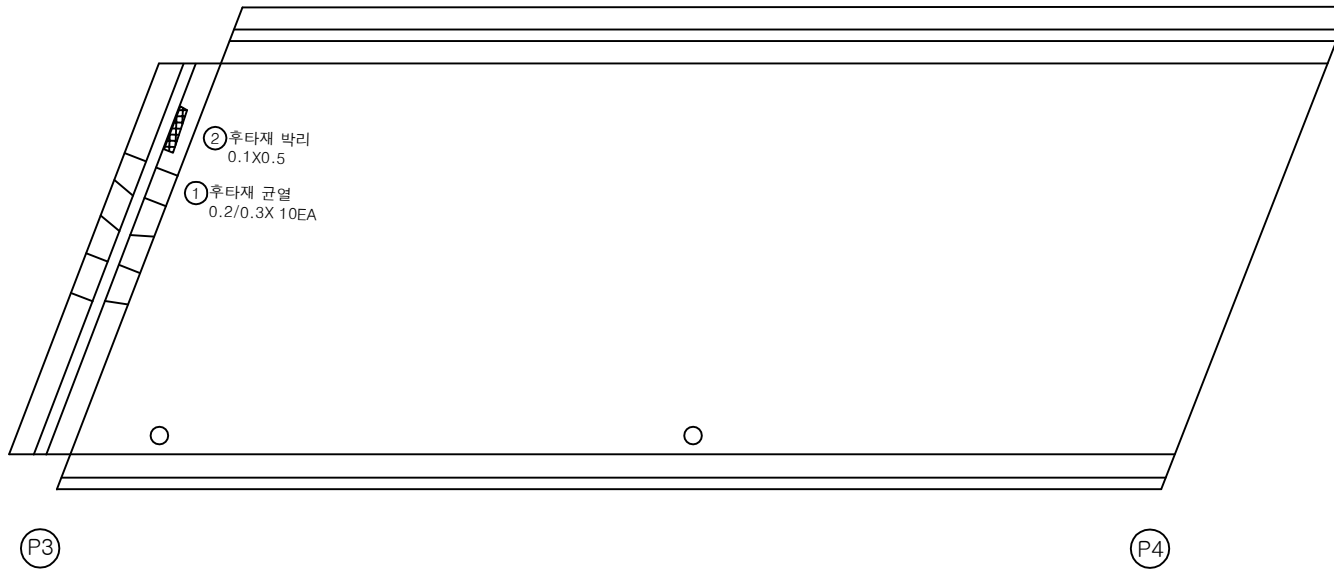
| 번호 | 구분 | 부재 | 손상내용 | 손상현황 | | | | | | 비 고 |
|---|---|---|---|---|---|---|---|---|---|---|
| 1 | 19하 | 신속이음 | 후타재 균열 | 0.2 | 0.3 | | 3.00 | m | 10 | |
| 2 | 19하 | 신속이음 | 후타재 박리 | | 0.1 | 0.5 | 0.05 | m <sup>2</sup> | 1 | |

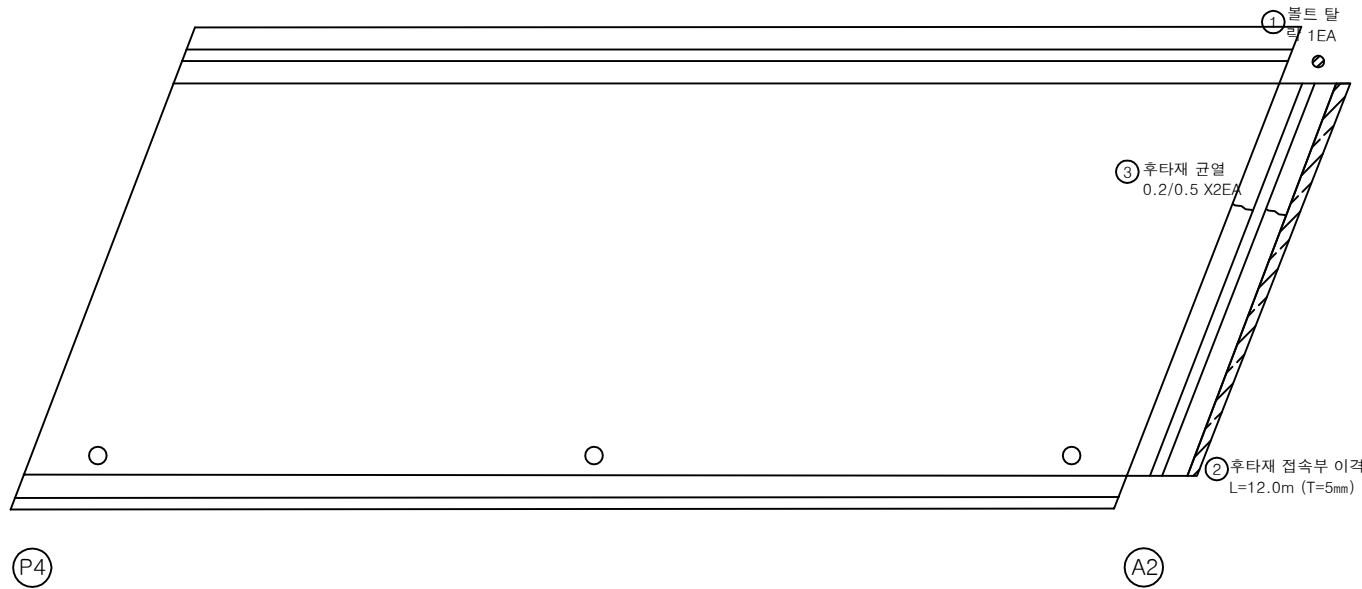
| 번호 | 구분 | 부재 | 손상내용 | 손상현황 | | | | | | 비 고 |
|---|---|---|---|---|---|---|---|---|---|---|
| 1 | 19하 | 교면포장 | 볼트 탈락 | | | | 1.00 | EA | 1 | |
| 2 | 23하 | 교면포장 | 후타재 접속부 이격 | | 12.0 | | 12.00 | m | 1 | (T=5.0mm) |
| 3 | 25상 | 신축이음 | 후타재 균열 | 0.2 | 0.5 | | 1.00 | m | 2 | |

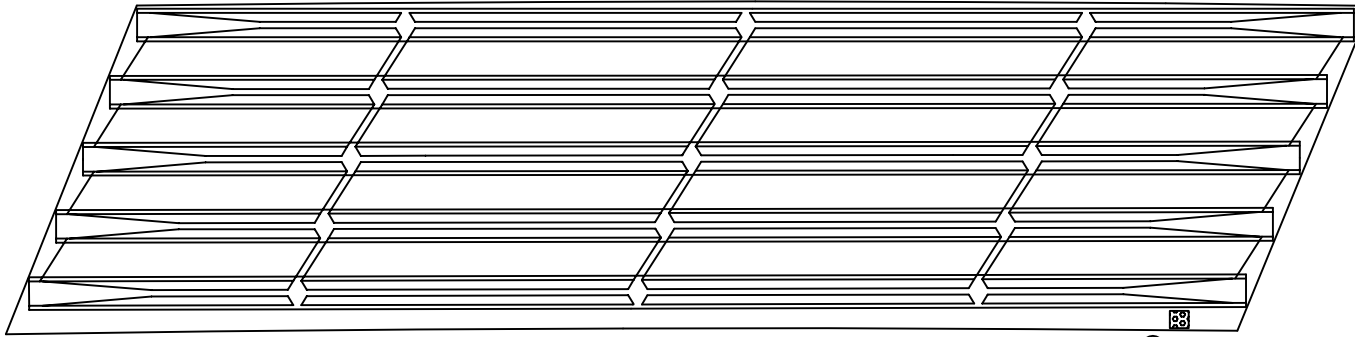
① 배수관 주위 백태  
0.5X0.5

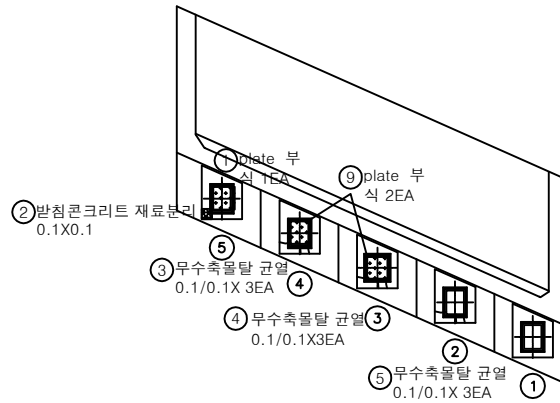
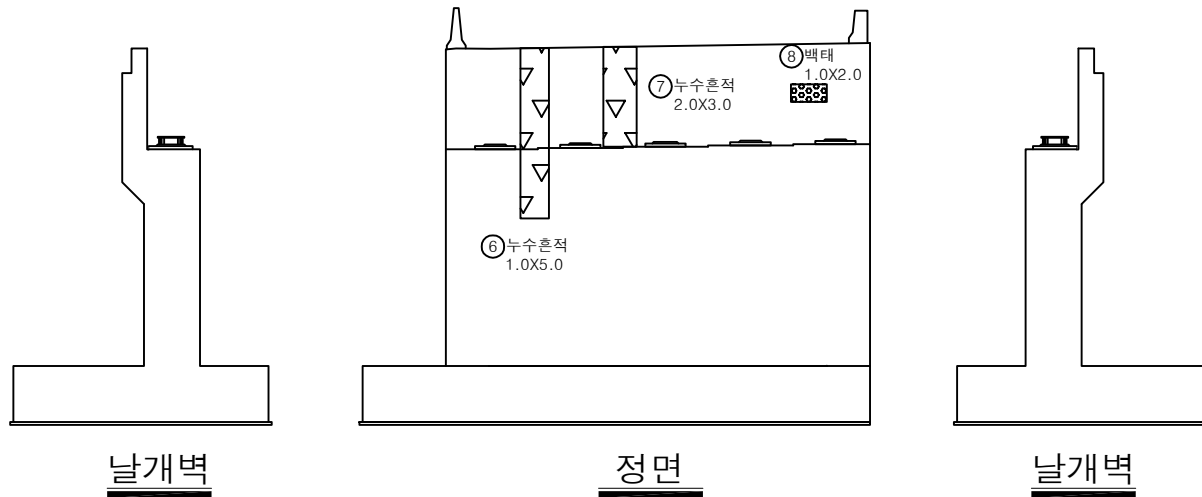
| 번호 | 구분 | 부재 | 손상내용 | 손상현황 | | | | | | 비고 |
|---|---|---|---|---|---|---|---|---|---|---|
| 1 | 19하 | 교량받침 | plate 부식 | | | | 1.00 | EA | 1 | |
| 3 | 19하 | 교량받침 | 무수축물탈 균열 | 0.1 | 0.1 | | 0.30 | m | 3 | 21'상 보수 |
| 4 | 19하 | 교량받침 | 무수축물탈 균열 | 0.1 | 0.1 | | 0.30 | m | 3 | 21'상 보수 |
| 5 | 19하 | 교량받침 | 무수축물탈 균열 | 0.1 | 0.1 | | 0.30 | m | 3 | 21'상 보수 |
| 6 | 19하 | 교대 | 누수흔적 | | 1.0 | 5.0 | 5.00 | m <sup>2</sup> | 1 | |
| 7 | 19하 | 교대 | 누수흔적 | | 2.0 | 3.0 | 6.00 | m <sup>2</sup> | 1 | |
| 8 | 19하 | 교대 | 백태 | | 1.0 | 2.0 | 2.00 | m <sup>2</sup> | 1 | 손상증가 |
| 9 | 23상 | 교량받침 | plate 부식 | | | | 2.00 | EA | 2 | |

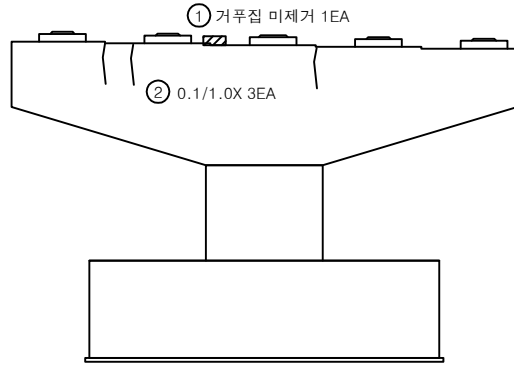
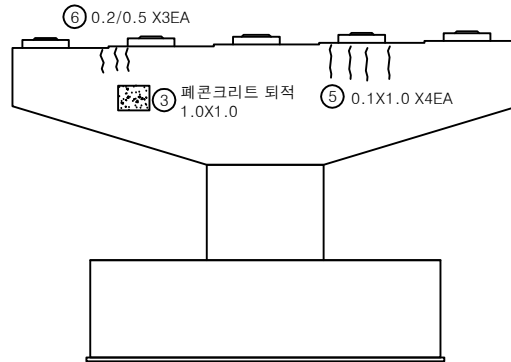
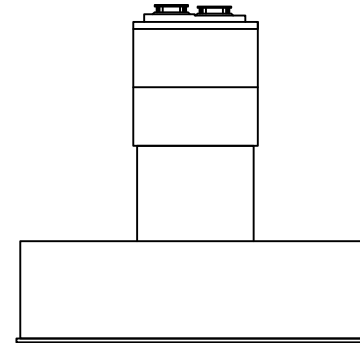
ID : 양지교(상주방향) 교각 P1

| 번호 | 구분 | 부재 | 손상내용 | 손상현황 | | | | | | 비 고 |
|---|---|---|---|---|---|---|---|---|---|---|
| 2 | 19하 | 교각 | 균열(0.3mm미만) | 0.1 | 1.0 | | 3.00 | m | 3 | |
| 4 | 19하 | 교량받침 | 발치콘크리트 균열 | 0.2 | 0.2 | | 0.40 | m | 2 | |
| 5 | 21하 | 교각 | 균열(0.3mm미만) | 0.1 | 1.0 | | 4.00 | m | 4 | 21하 보수 |
| 6 | 25상 | 교각 | 균열(0.3mm미만) | 0.2 | 0.5 | | 1.50 | m | 3 | |

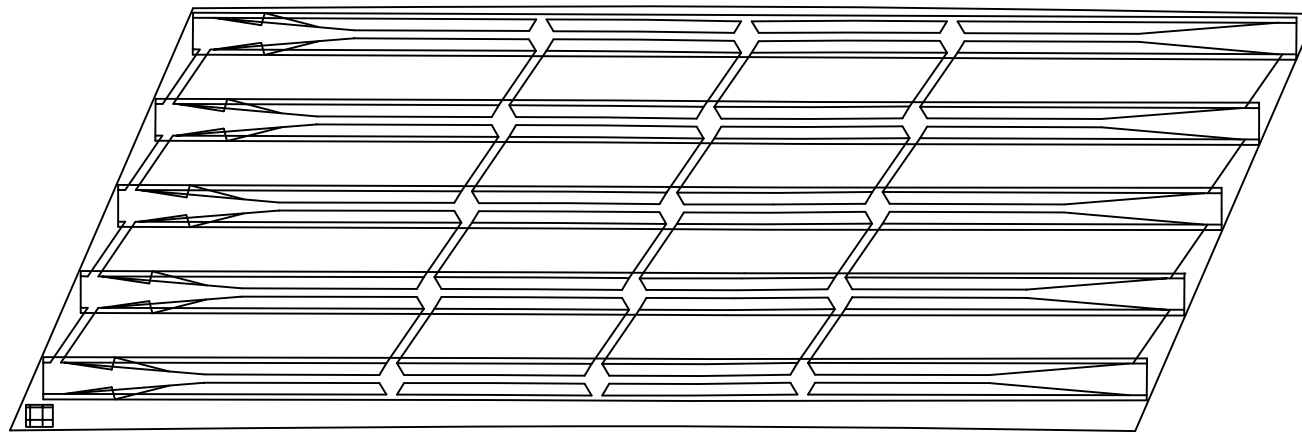
① 파손  
0.3X0.5

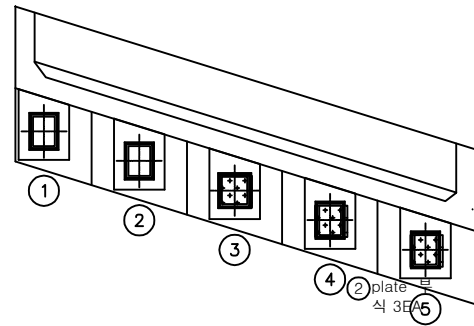
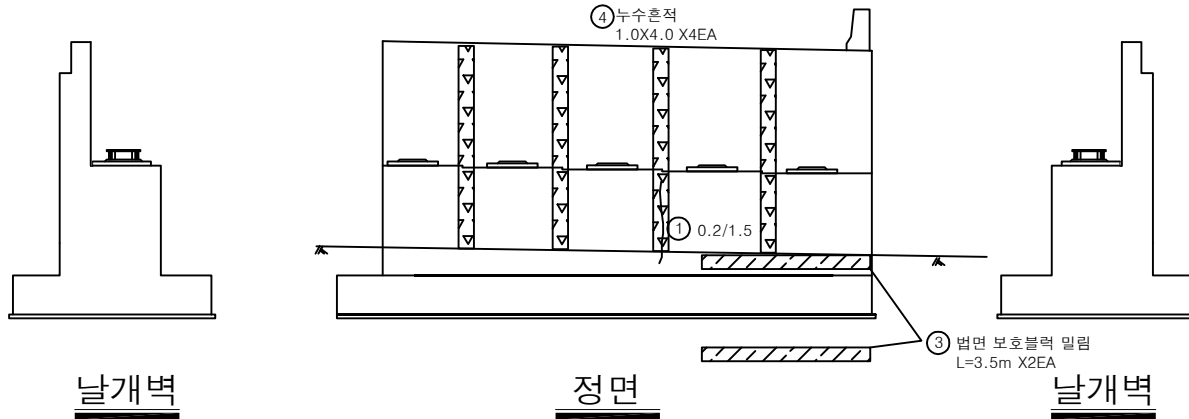
\*법면 보호블럭 밀림

| 번호 | 구분 | 부재 | 손상내용 | 손상현황 | | | | | | 비고 |
|---|---|---|---|---|---|---|---|---|---|---|
| 1 | 21하 | 교대 | 균열(0.3mm미만) | 0.2 | 1.5 | | 1.50 | m | 1 | |
| 2 | 21하 | 교량방청 | plate 부식 | | | | 3.00 | EA | 3 | |
| 4 | 24상 | 교대 | 누수흔적 | | 1.0 | 4.0 | 16.00 | m² | 4 | |
