상주영천고속도로 2024~2025년 시설물 안전점검 용역  
(2025년 상반기 정기안전점검)

# 외 관 조 사 망 도

오로교

ID : 오로교 바닥판하면 S11 (상주방향)

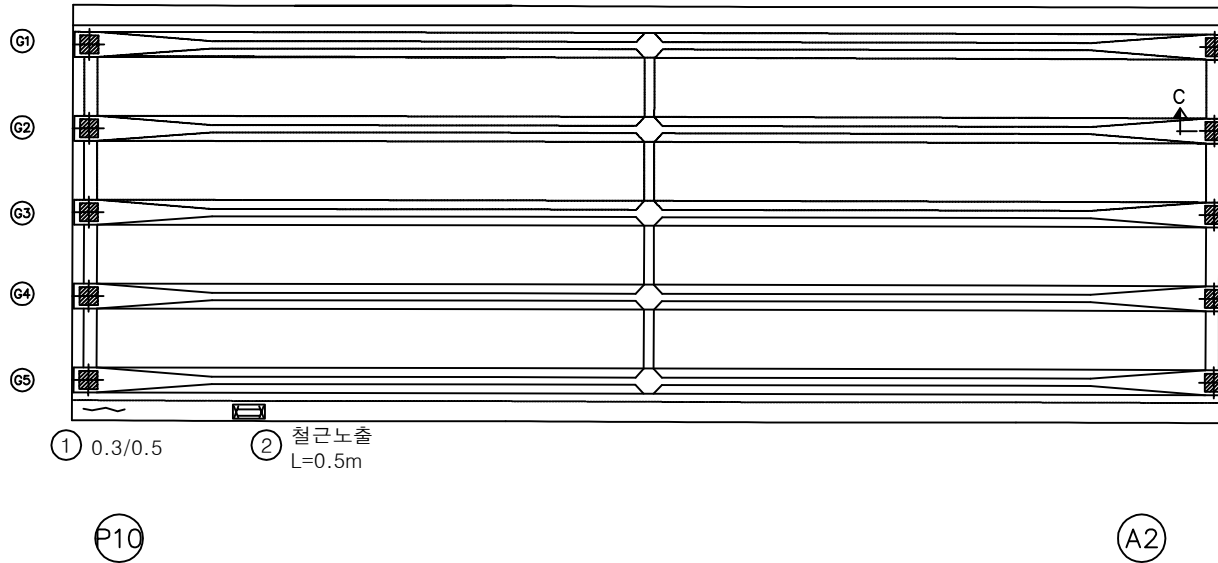
| 번호 | 구분 | 부재 | 손상내용 | 손상현황 | | | | | | 비고 |
|---|---|---|---|---|---|---|---|---|---|---|
| 1 | 23하 | 바닥판 | 균열(0.3mm이상) | 0.3 | 0.5 | | 0.50 | m | 1 | |
| 2 | 23하 | 바닥판 | 철근노출 | | 0.5 | | 0.50 | m | 1 | |
