# 14. 은산1터널 (평택방향)

| 용역명 | 서부내륙고속도로 2025년 시설물 정기안전점검 용역(하반기) |
| 시설물명 | 은산1터널(평택방향) |

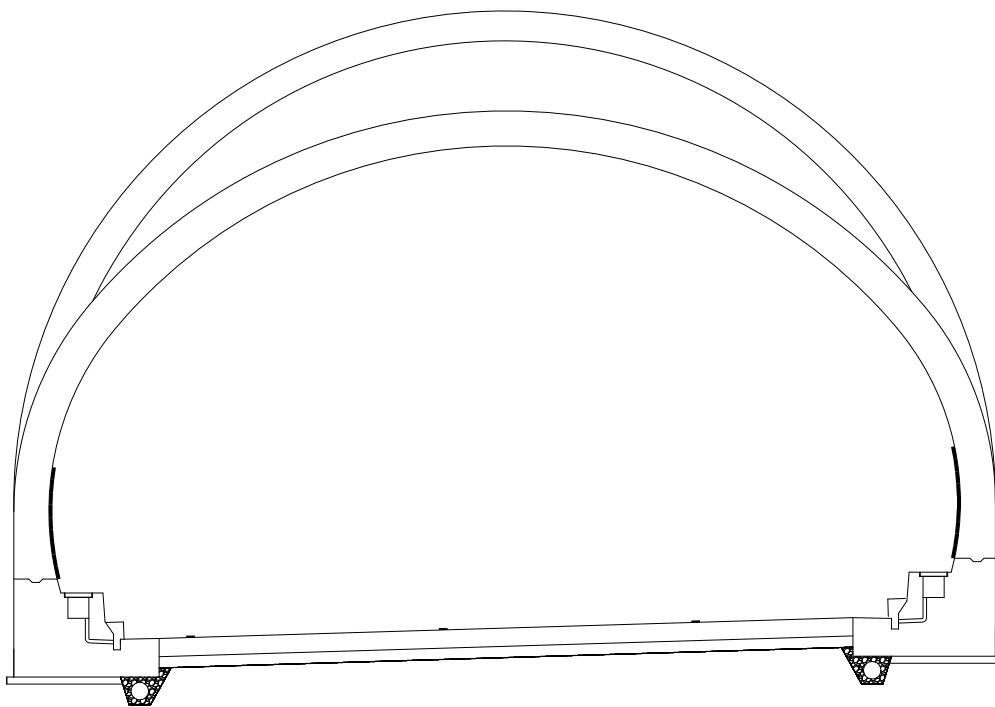
ID : 은산1터널 S1~5

| 번호 | 구분 | 결함 내용 | 손상규모 | | | | | | 비고 |
|---|---|---|---|---|---|---|---|---|---|
| 1 | 신규 | 균열/누수흔적 | 0.2 | - | 1.0 | 1 | 1.0 | m | - |
| 2 | 신규 | 충분리 | - | 0.1 | 0.5 | 1 | 0.05 | m² | - |
| 3 | 신규 | 백태 | - | 0.1 | 1.0 | 1 | 0.1 | m² | - |
| 4 | 신규 | 덮개 파손 | - | - | - | 1 | 1 | EA | - |
