## 15. 은산2터널 (익산방향)

| 용역명 | 서부내륙고속도로 2025년 시설물 정기안전점검 용역(하반기) |
| 시설물명 | 은산2터널(익산방향) |

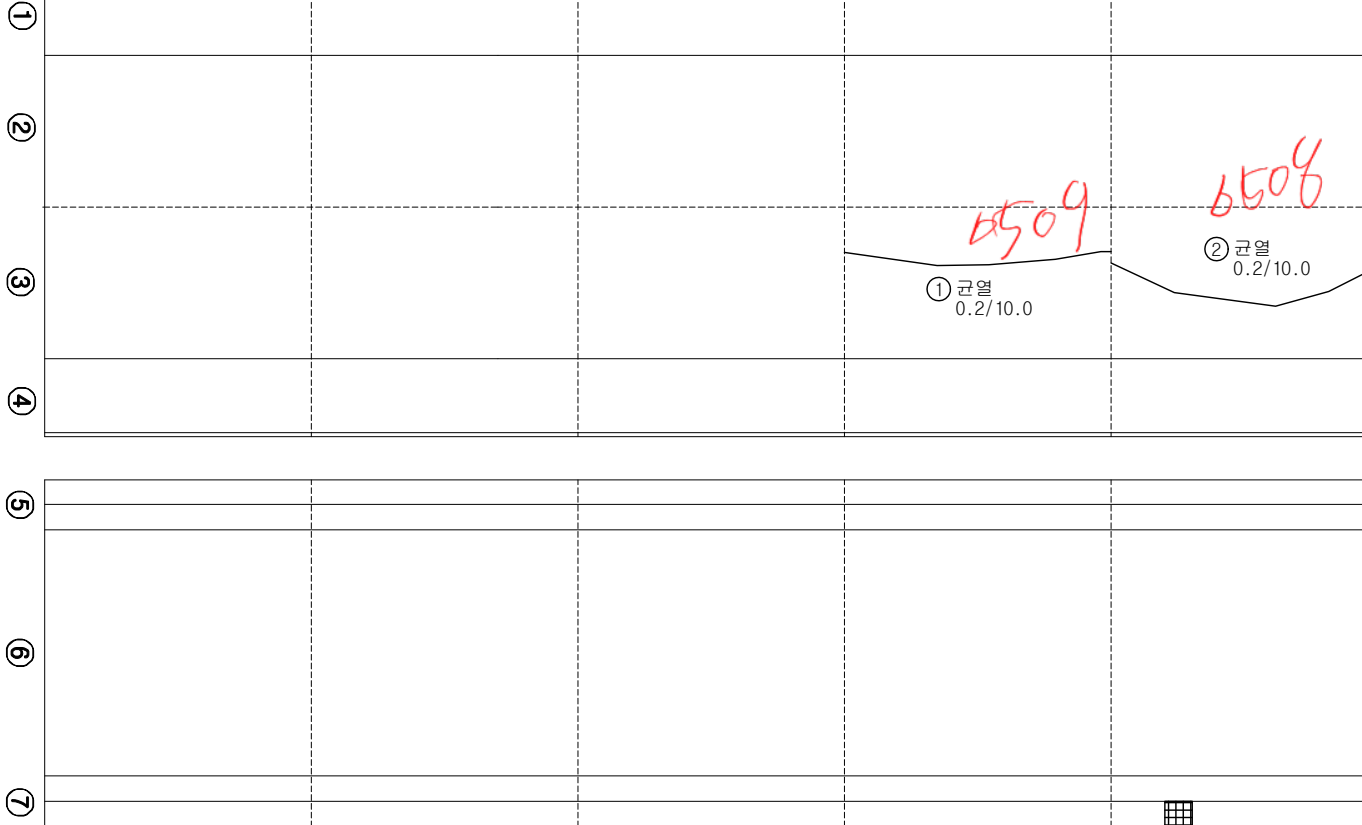
ID : 은산2터널 S6~10

| 번호 | 구분 | 결함 내용 | 손상규모 | | | | | | 비고 |
|---|---|---|---|---|---|---|---|---|---|
| 1 | 신규 | 균열 | 0.2 | - | 10.0 | 1 | 10.0 | m | - |
| 2 | 신규 | 균열 | 0.2 | - | 6.0 | 1 | 6.0 | m | - |
| 3 | 신규 | 덮개 파손 | - | - | - | 1 | 1 | EA | - |

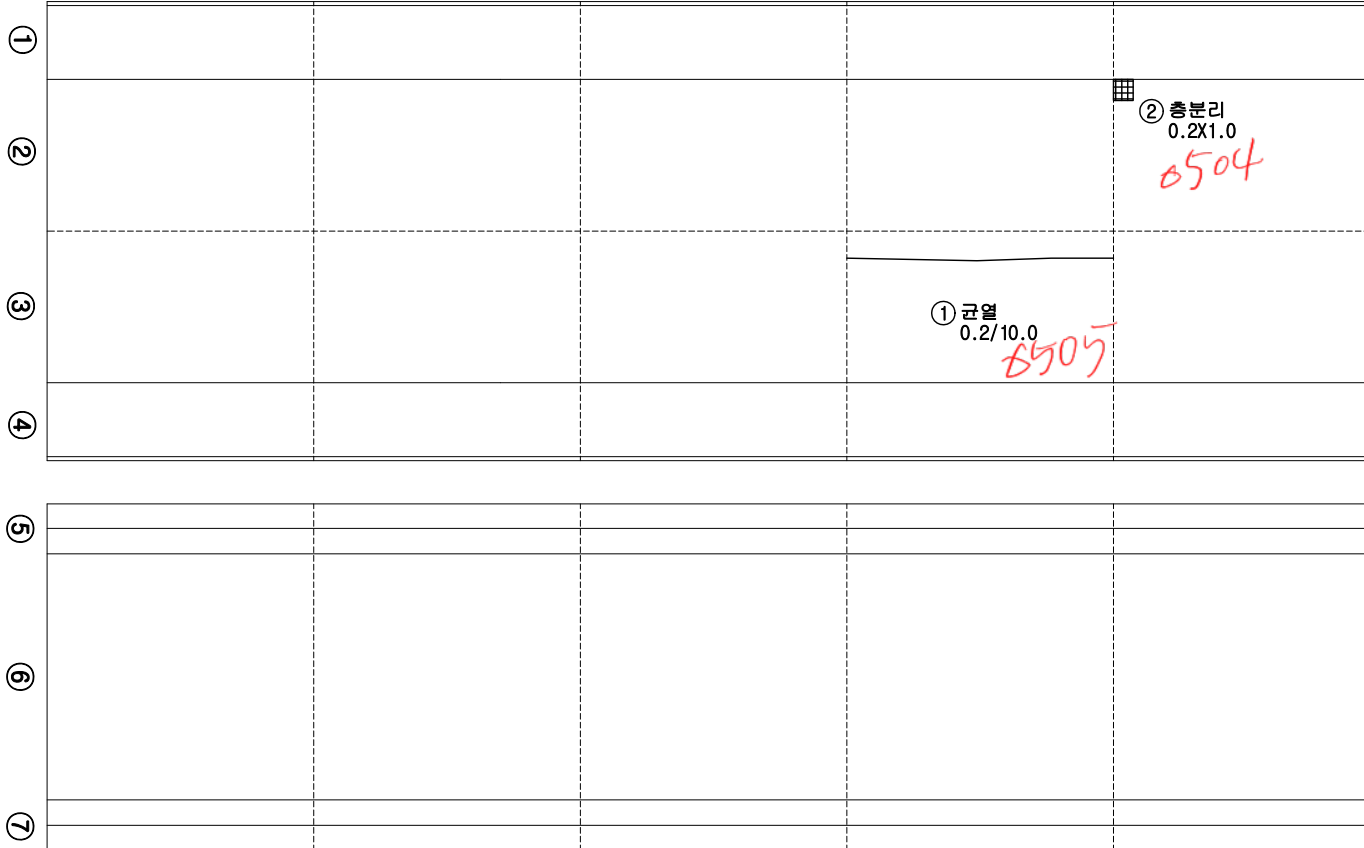
ID : 은산2터널 S16~20

| 번호 | 구분 | 결함 내용 | 손상규모 | | | | | | 비고 |
|---|---|---|---|---|---|---|---|---|---|
| 1 | 신규 | 균열 | 0.2 | - | 10.0 | 1 | 10.0 | m | - |
| 2 | 신규 | 충분리 | - | 0.2 | 1.0 | 1 | 0.2 | m² | - |
