# 17. 은산3터널 (익산방향)

| 용역명 | 서부내륙고속도로 2025년 시설물 정기안전점검 용역(하반기) |
| 시설물명 | 은산3터널(익산방향) |

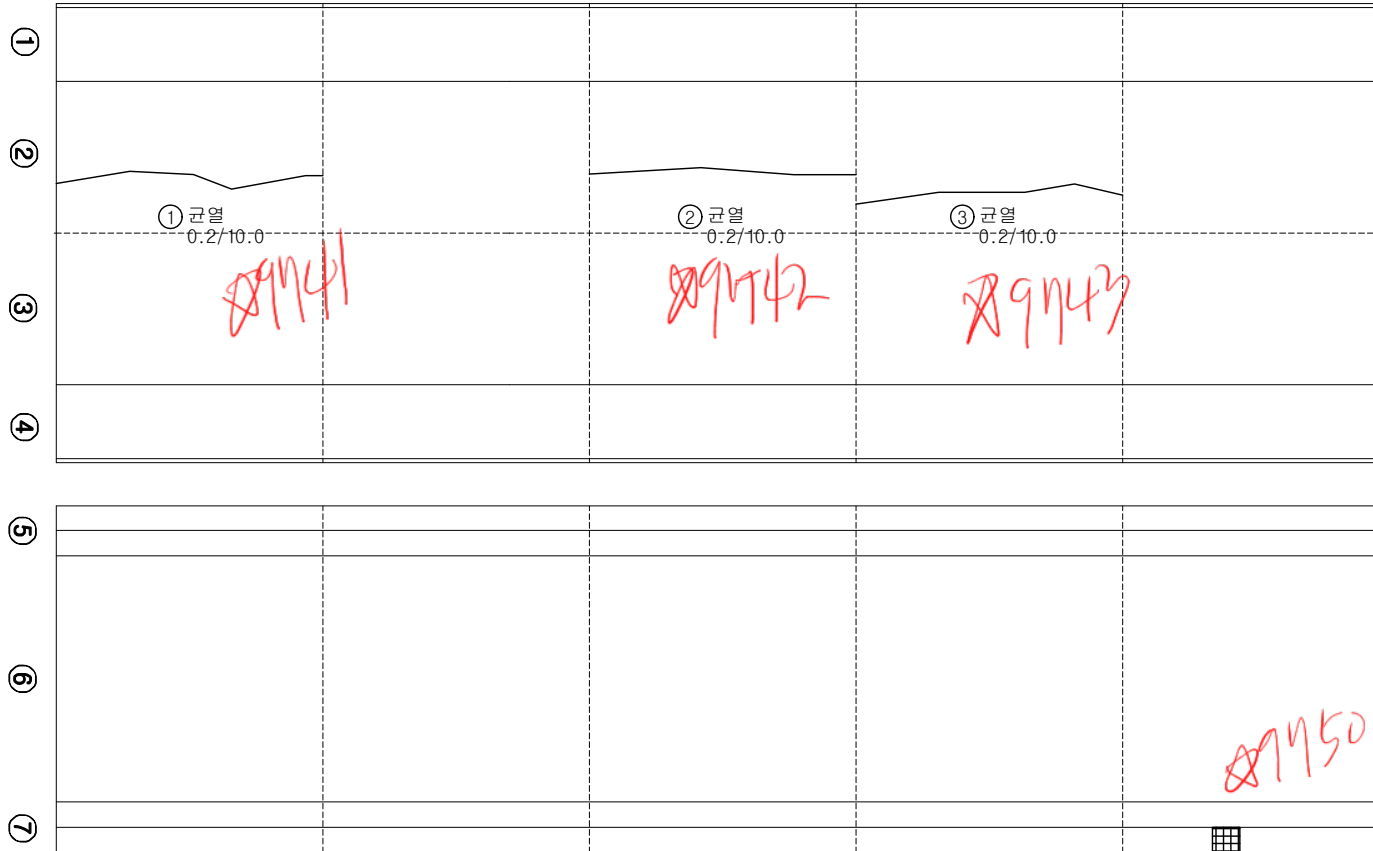
ID : 은산3터널 S11~15

④ 덮개 파손  
1EA

| 번호 | 구분 | 결함 내용 | 손상규모 | | | | | | 비고 |
|---|---|---|---|---|---|---|---|---|---|
| 1 | 신규 | 균열 | 0.2 | - | 10.0 | 1 | 10.0 | m | - |
| 2 | 신규 | 균열 | 0.2 | - | 10.0 | 1 | 10.0 | m | - |
| 3 | 신규 | 균열 | 0.2 | - | 10.0 | 1 | 10.0 | m | - |
| 4 | 신규 | 덮개 파손 | - | - | - | 1 | 1 | EA | - |

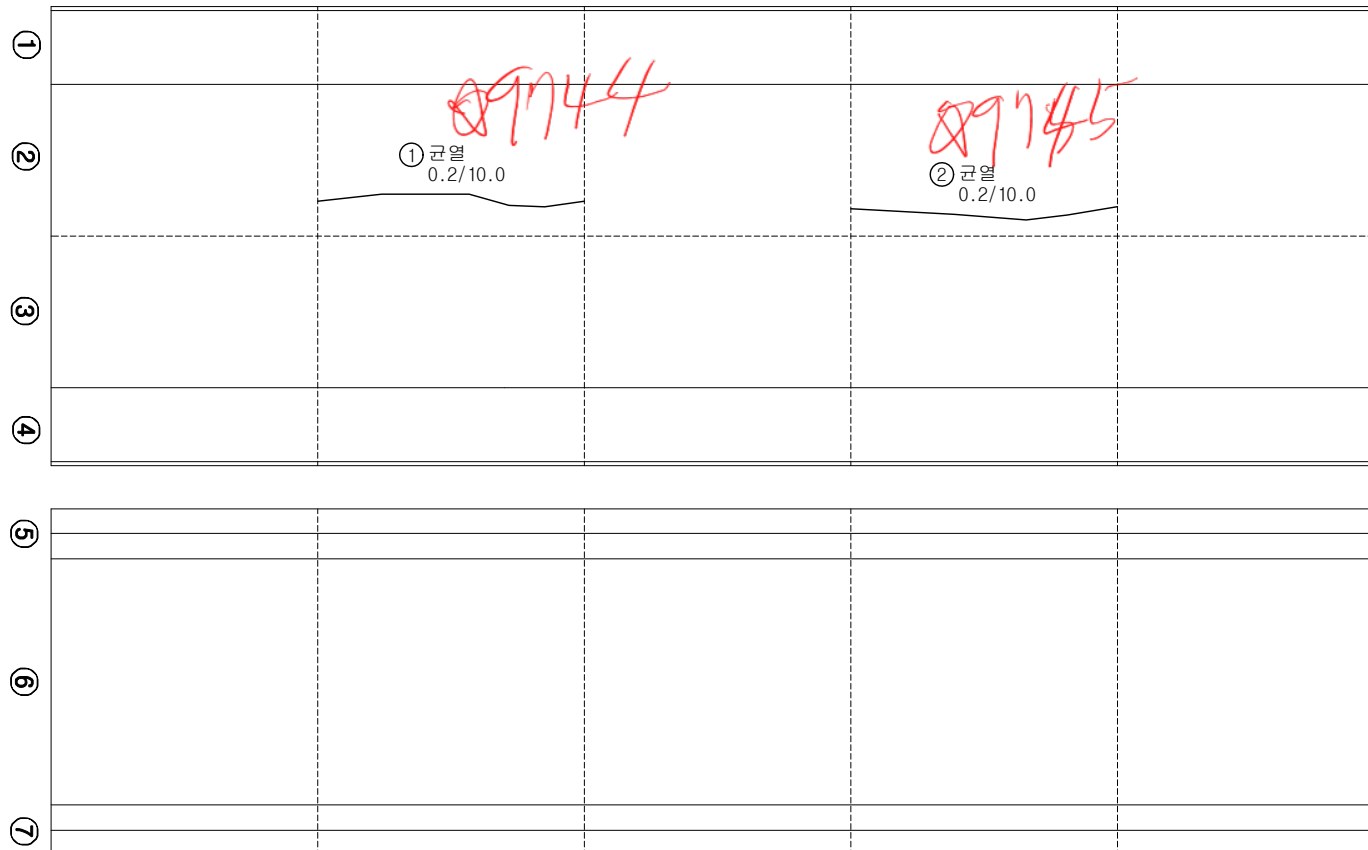
ID : 은산3터널 S16~20

| 번호 | 구분 | 결함 내용 | 손상규모 | | | | | | 비고 |
|---|---|---|---|---|---|---|---|---|---|
| 1 | 신규 | 균열 | 0.2 | - | 10.0 | 1 | 10.0 | m | - |
| 2 | 신규 | 균열 | 0.2 | - | 10.0 | 1 | 10.0 | m | - |

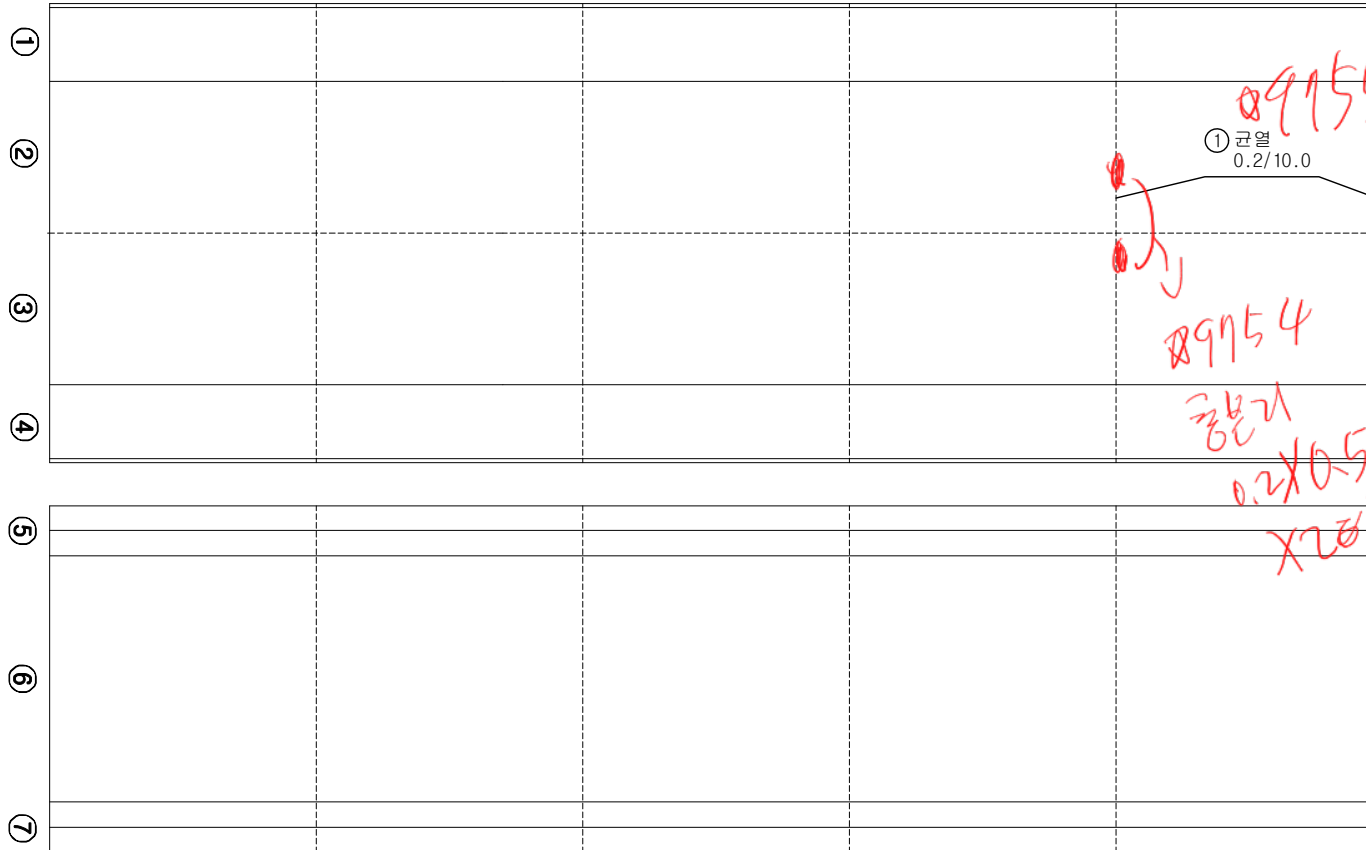
ID : 은산3터널 S36~40

| 번호 | 구분 | 결함 내용 | 손상규모 | | | | | | 비고 |
|---|---|---|---|---|---|---|---|---|---|
| 1 | 신규 | 균열 | 0.2 | - | 10.0 | 1 | 10.0 | m | - |

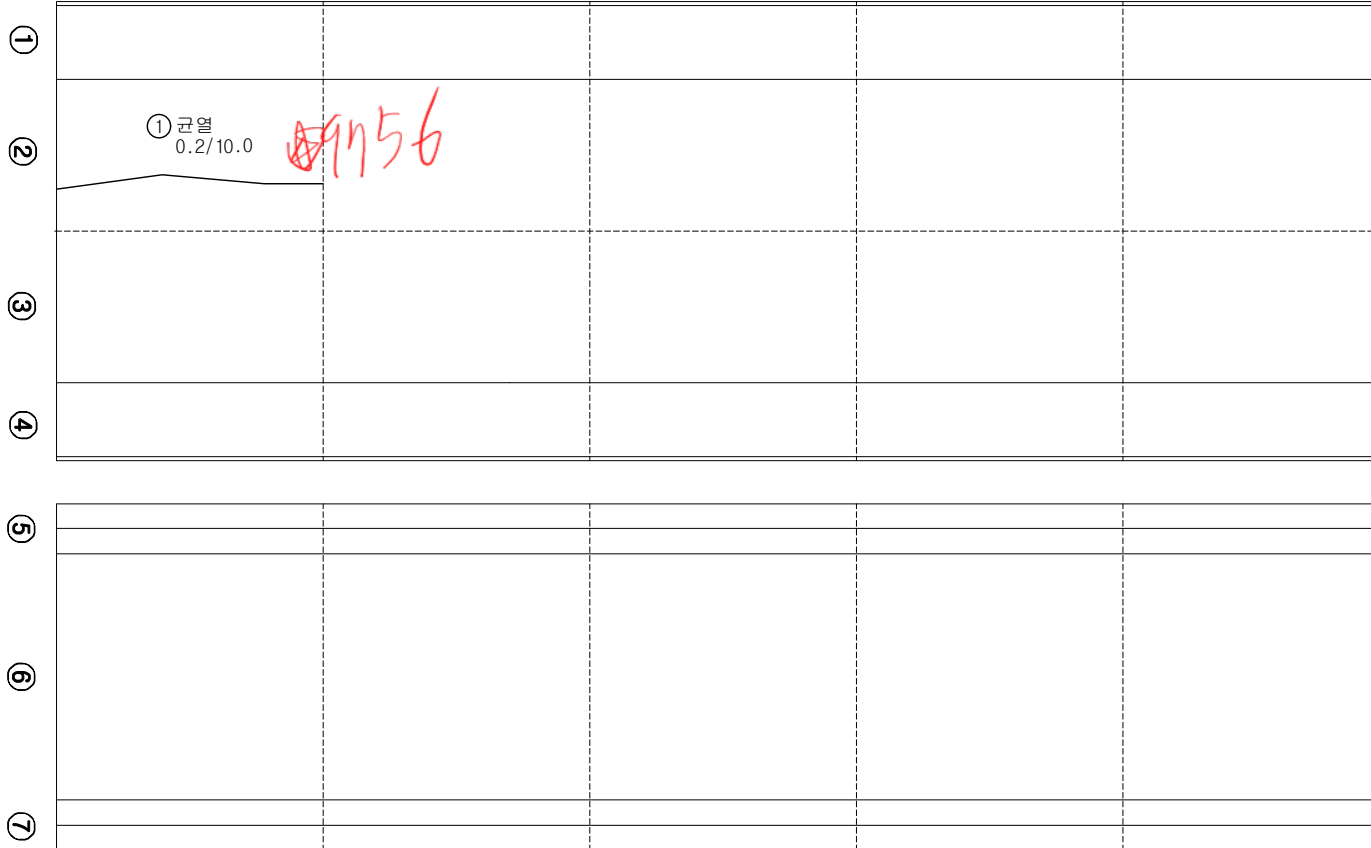
ID : 은산3터널 S41~45

| 번호 | 구분 | 결함 내용 | 손상규모 | | | | | | 비고 |
|---|---|---|---|---|---|---|---|---|---|
| 1 | 신규 | 균열 | 0.2 | - | 10.0 | 1 | 10.0 | m | - |
