## 20. 팔봉산터널 (평택방향)

| 범 | | 간선 | | 광상간선 | | 재료분리 | 용역명 | 서부내륙고속도로 2025년 시설물 정기안전점검 용역(하반기) |
| | | 편성/공동 | | 바리, 박막/파손 | | 시공이음/충분리 | 시설물명 | 팔봉산터널(평택방향) |

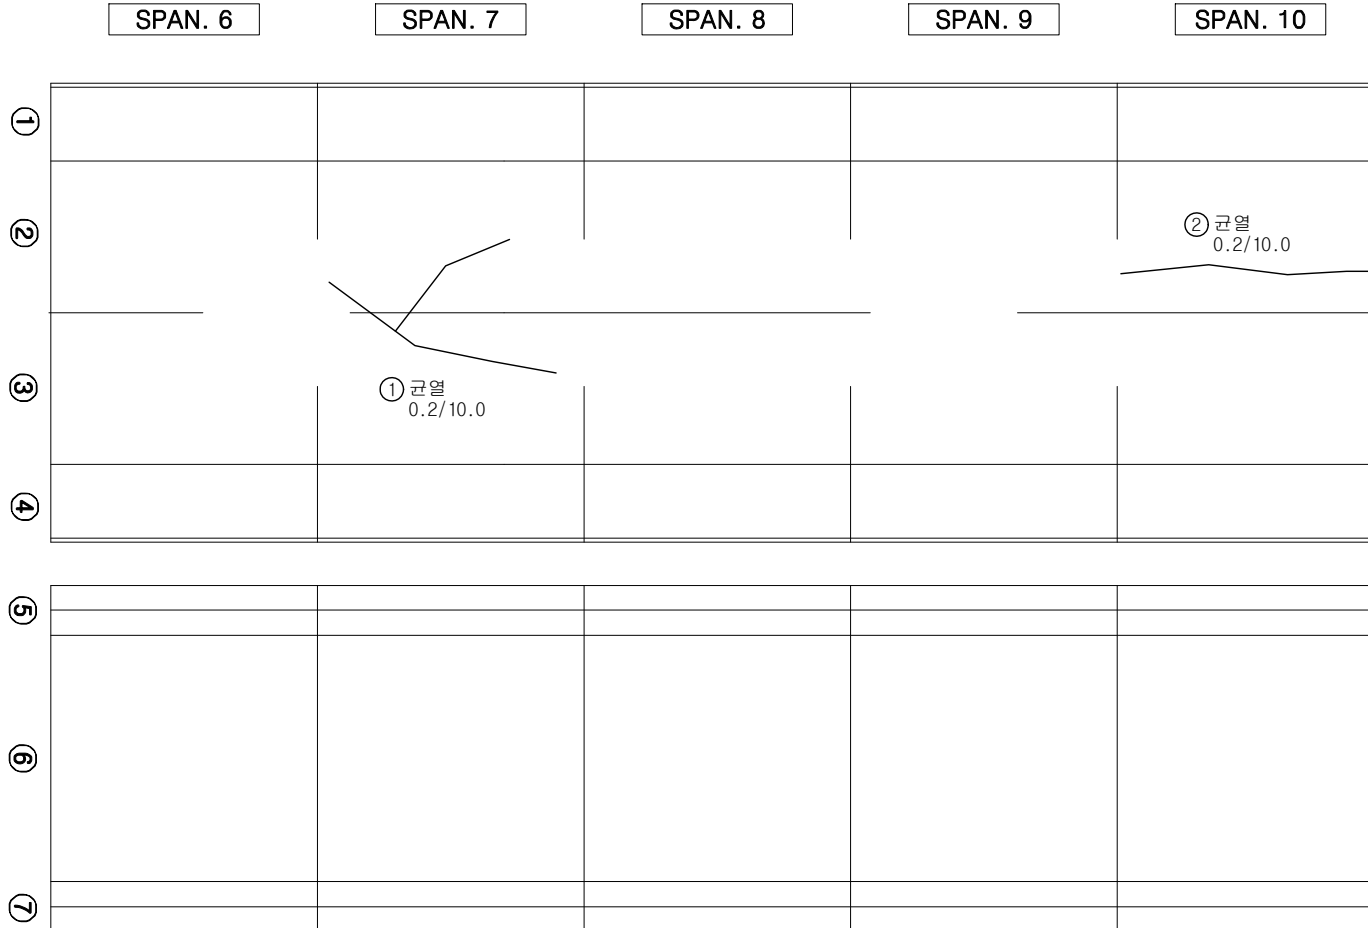
ID : 팔봉산터널 S6~10

| 번호 | 구분 | 결함 내용 | 손상규모 | | | | | | 비고 |
|---|---|---|---|---|---|---|---|---|---|
| 1 | 신규 | 균열 | 0.2 | - | 10.0 | 1 | 10.0 | m | - |
| 2 | 신규 | 균열 | 0.2 | - | 10.0 | 1 | 10.0 | m | - |

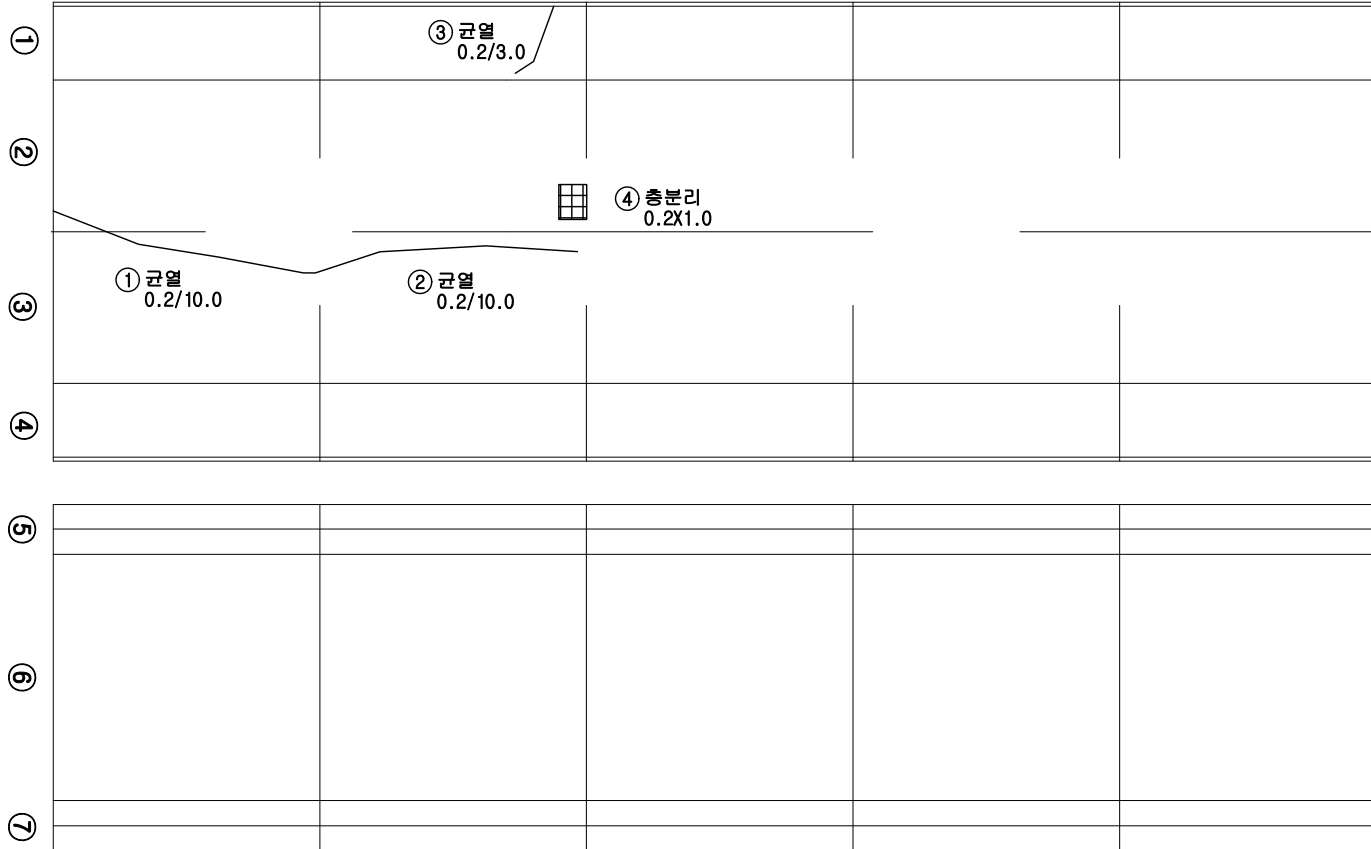
ID : 팔봉산터널 S11~15

| 번호 | 구분 | 결함 내용 | 손상규모 | | | | | | 비고 |
|---|---|---|---|---|---|---|---|---|---|
| 1 | 신규 | 균열 | 0.2 | - | 10.0 | 1 | 10.0 | m | - |
| 2 | 신규 | 균열 | 0.2 | - | 10.0 | 1 | 10.0 | m | - |
| 3 | 신규 | 균열 | 0.2 | - | 3.0 | 1 | 3.0 | m | - |
| 4 | 신규 | 층분리 | - | 0.2 | 1.0 | 1 | 0.2 | m² | - |

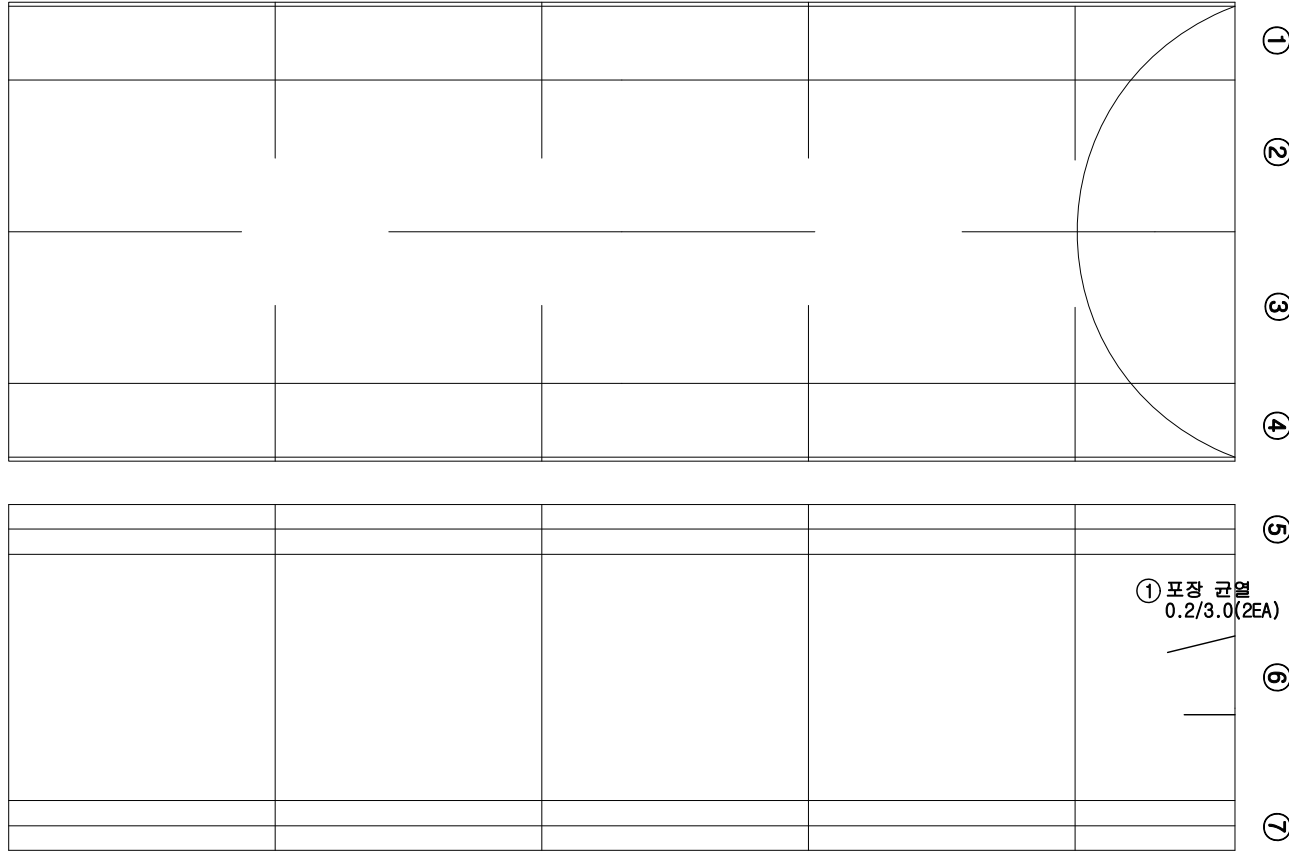
ID : 팔봉산터널 16~20

| 번호 | 구분 | 결함 내용 | 손상규모 | | | | | | 비고 |
|---|---|---|---|---|---|---|---|---|---|
| 1 | 신규 | 포장 균열 | 0.2 | - | 3.0 | 2 | 6.0 | m | - |
