### 손 상 물 량 표

불광천1복개 정밀안전진단 및 녹번천복개 정밀점검 용역

불 광 천 포 장 부  
J85(2K 245) ~ J90(2K 368)

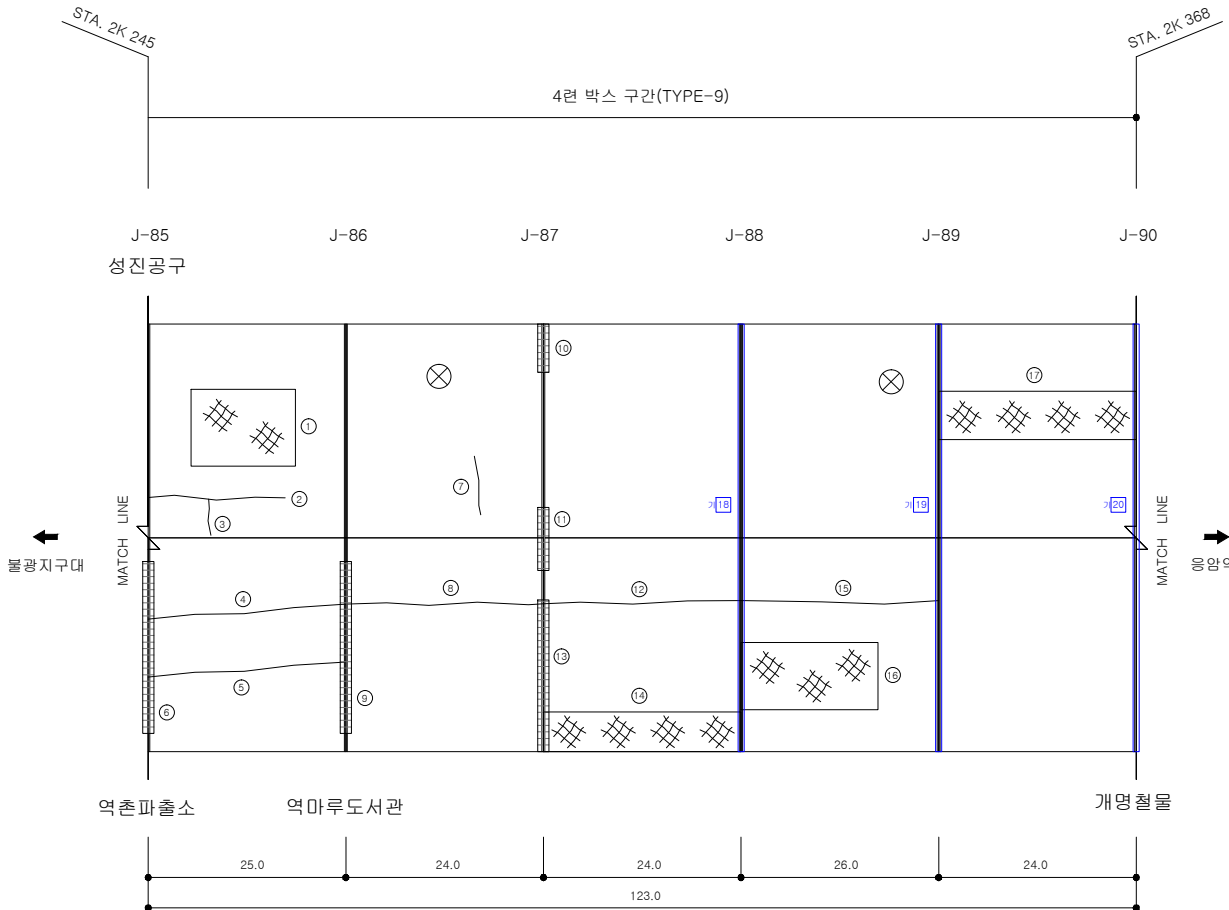
| 범 례 | | | ① ~ 2013 신규 | | 가① - 기존손상 | | | | ㉠ 보수완료 | | | |
|---|---|---|---|---|---|---|---|---|---|---|---|---|
| 1 | 85-86 | S | 2013 | 망상균열 | 4.7 | 10.0 | | | 47.0 | m | 1 | 신규 |
| 2 | 85-86 | S | 2013 | 균열 | | 17.0 | | | 17.0 | m | 1 | 신규 |
| 3 | 85-86 | S | 2013 | 균열 | | 3.0 | | | 3.00 | m | 1 | 신규 |
| 4 | 85-86 | S | 2013 | 균열 | 1.0 | 24.0 | | | 24.0 | m | 1 | 신규 |
| 5 | 85-86 | S | 2013 | 균열 | 1.0 | 24.0 | | | 24.0 | m | 1 | 신규 |
| 6 | 85 | S | 2013 | 후타재파손 | 0.8 | 7.3 | | | 5.84 | m | 1 | 신규 |
| 7 | 86-87 | S | 2013 | 균열 | | 3.0 | | | 3.00 | m | 1 | 신규 |
| 8 | 86-87 | S | 2013 | 균열 | 1.0 | 24.0 | | | 24.0 | m | 1 | 신규 |
| 9 | 86 | S | 2013 | 후타재파손 | 0.8 | 7.4 | | | 5.92 | m | 1 | 신규 |
| 10 | 87 | S | 2013 | 후타재파손 | 0.8 | 2.5 | | | 2.00 | m | 1 | 신규 |
| 11 | 87 | S | 2013 | 후타재파손 | 0.8 | 3.5 | | | 2.80 | m | 1 | 신규 |
| 12 | 87-88 | S | 2013 | 균열 | 1.0 | 24.0 | | | 24.0 | m | 1 | 신규 |
| 13 | 87 | S | 2013 | 후타재파손 | 0.8 | 6.0 | | | 4.80 | m | 1 | 신규 |
| 14 | 87-88 | S | 2013 | 망상균열 | 2.0 | 2.6 | | | 5.20 | m | 1 | 신규 |
| 15 | 88-89 | S | 2013 | 균열 | 1.0 | 26.0 | | | 26.0 | m | 1 | 신규 |
| 16 | 88-89 | S | 2013 | 망상균열 | 4.0 | 14.0 | | | 56.0 | m | 1 | 신규 |
| 17 | 89-90 | S | 2013 | 망상균열 | 3.0 | 24.0 | | | 72.0 | m | 1 | 신규 |
| 18 | 88 | S | 2013 | 보수완료 | 0.5 | 20.0 | | | 10.0 | m | 1 | 기존보수 |
| 19 | 89 | S | 2013 | 보수완료 | 0.5 | 20.0 | | | 10.0 | m | 1 | 기존보수 |
| 20 | 90 | S | 2013 | 보수완료 | 0.5 | 20.0 | | | 10.0 | m | 1 | 기존보수 |

-1순위 : Type-7~9 (예일여고~역말사거리)  
 -2순위 : Type-9~11 (역말사거리~신사오거리) 및 조인트 손상  
 -3순위 : Type-1~7 (시점~예일여고) 및 포장균열
