| REPORT OF ULTRASONIC EXAMINATION<br>초음파비파괴검사보고서 | | | | INDT | | 보고서번호<br>Report No. | ISU- 151102 - K08 -14 |
| Customer 주문주/Const. & MFR. 제작자<br>(주)신대구부산고속도로 /<br>(주)아워브레인 | | Project Name 공사명<br>신대구부산고속도로 1구간 정밀안전진단용역 | | Location 검사위치<br>원정교 | | | |
| Item Name 제품명<br>Steel Box Girder | | Material 재질 / Thickness 두께<br>SM490 / 8-32mm | | Dwg. No. 도면번호<br>N/A | | | |

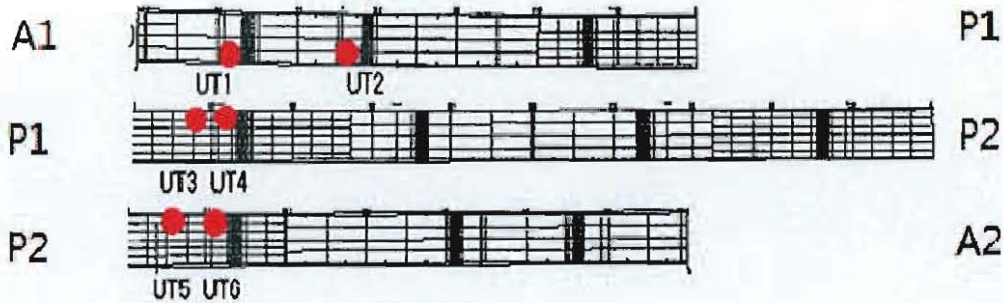
## 대구 G1

| REPORT OF ULTRASONIC EXAMINATION | | | | | | | | INDT | | 보고서번호<br>Report No. | ISU- 151102 - K08 -14 |
|---|---|---|---|---|---|---|---|---|---|---|---|
| 1 | 대구 G1-UT1 | ✓ | | NO RECORDABLE INDICATION | | | | 1 | | | |
| 2 | UT2 | ✓ | | NO RECORDABLE INDICATION | | | | 1 | | | |
| 3 | UT3 | ✓ | | NO RECORDABLE INDICATION | | | | 1 | | | |
| 4 | UT4 | ✓ | | NO RECORDABLE INDICATION | | | | 1 | | | |
| 5 | UT5 | ✓ | | NO RECORDABLE INDICATION | | | | 1 | | | |
| 6 | UT6 | ✓ | | NO RECORDABLE INDICATION | | | | 1 | | | |

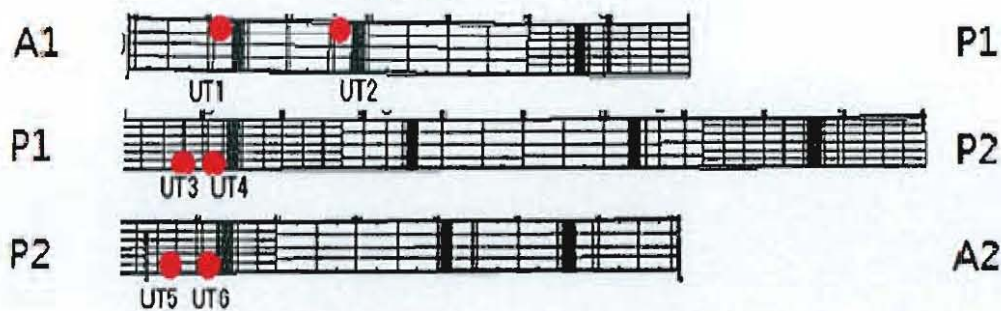
## 대구 G2

| REPORT OF ULTRASONIC EXAMINATION | | | | | | | | INDT | | 보고서번호<br>Report No. | ISU- 151102 - K08 -14 |
|---|---|---|---|---|---|---|---|---|---|---|---|
| 7 | 대구 G2-UT1 | ✓ | | NO RECORDABLE INDICATION | | | | 1 | | | |
| 8 | UT2 | ✓ | | NO RECORDABLE INDICATION | | | | 1 | | | |
| 9 | UT3 | ✓ | | NO RECORDABLE INDICATION | | | | 1 | | | |
| 10 | UT4 | ✓ | | NO RECORDABLE INDICATION | | | | 1 | | | |
| 11 | UT5 | ✓ | | NO RECORDABLE INDICATION | | | | 1 | | | |
| 12 | UT6 | ✓ | | NO RECORDABLE INDICATION | | | | 1 | | | |

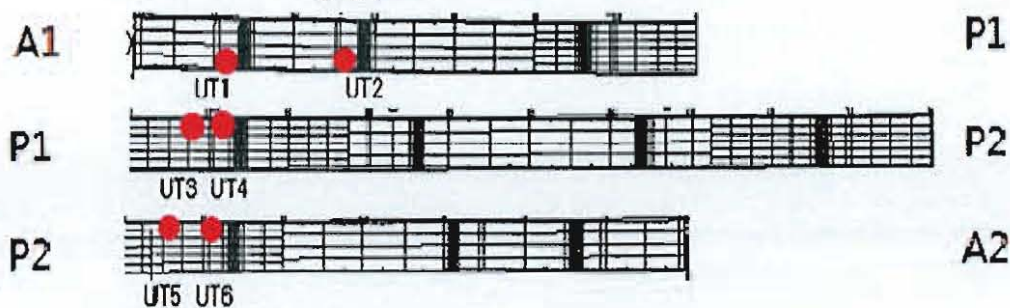
## 부산 G1

| REPORT OF ULTRASONIC EXAMINATION | | | | | | | | INDT | | 보고서번호<br>Report No. | ISU- 151102 - K08 -14 |
|---|---|---|---|---|---|---|---|---|---|---|---|
| 13 | 부산 G1-UT1 | ✓ | | NO RECORDABLE INDICATION | | | | 1 | | | |
| 14 | UT2 | ✓ | | NO RECORDABLE INDICATION | | | | 1 | | | |
| 15 | UT3 | ✓ | | NO RECORDABLE INDICATION | | | | 1 | | | |
| 16 | UT4 | ✓ | | NO RECORDABLE INDICATION | | | | 1 | | | |
| 17 | UT5 | ✓ | | NO RECORDABLE INDICATION | | | | 1 | | | |
| 18 | UT6 | ✓ | | NO RECORDABLE INDICATION | | | | 1 | | | |

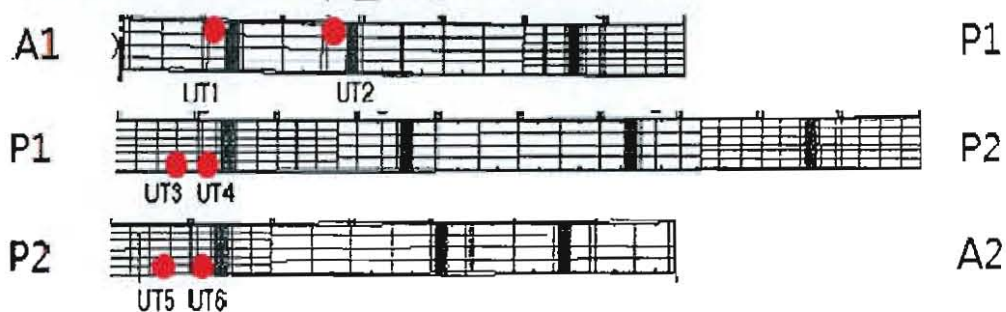
## 부산 G2

| REPORT OF ULTRASONIC EXAMINATION | | | | | | | | INDT | | 보고서번호<br>Report No. | ISU- 151102 - K08 -14 |
|---|---|---|---|---|---|---|---|---|---|---|---|
| 19 | 부산 G2-UT1 | ✓ | | NO RECORDABLE INDICATION | | | | 1 | | | |
| 20 | UT2 | ✓ | | NO RECORDABLE INDICATION | | | | 1 | | | |
| 21 | UT3 | ✓ | | NO RECORDABLE INDICATION | | | | 1 | | | |
| 22 | UT4 | ✓ | | NO RECORDABLE INDICATION | | | | 1 | | | |
| 23 | UT5 | ✓ | | NO RECORDABLE INDICATION | | | | 1 | | | |
| 24 | UT6 | ✓ | | NO RECORDABLE INDICATION | | | | 1 | | | |
