# 1. 위치도 및 터널전경

## 2. 본선

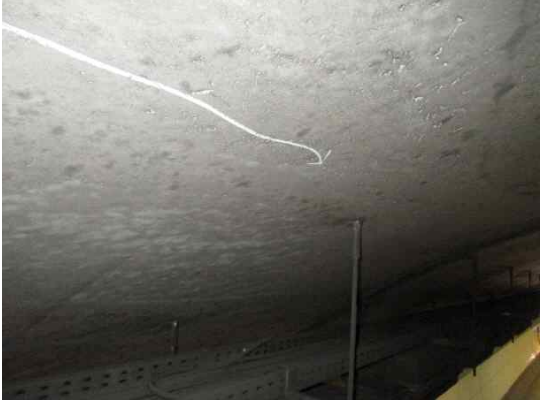
| 내 용 | 균열(0.3mm 이상, S21, 대구) | 내 용 | 들뜸(S29, 대구) |

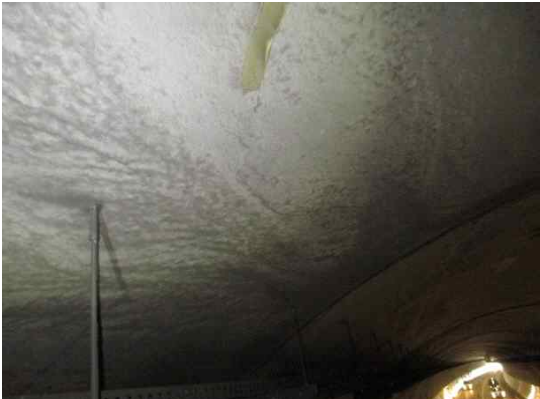
| 내 용 | 균열(0.3mm 미만, S33, 대구) | 내 용 | 균열(0.3mm 이상, S38, 대구) |

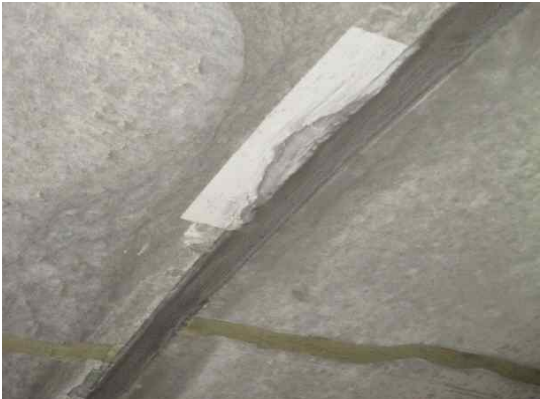
| 내 용 | 들뜸(S44, 대구) | 내 용 | 균열(0.3mm 미만, S51, 대구) |

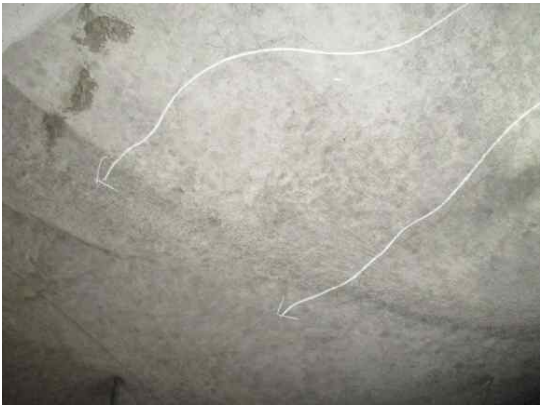
| 내 용 | 균열(0.3mm 미만, S59, 대구) | 내 용 | 균열(0.3mm 미만, S60, 대구) |

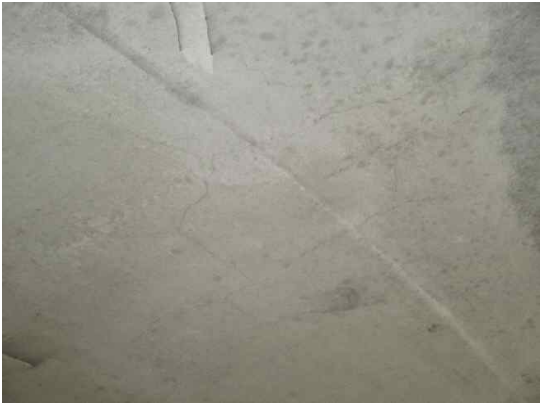
| 내 용 | 망상균열(S64, 대구) | 내 용 | 백태(S1, 부산) |

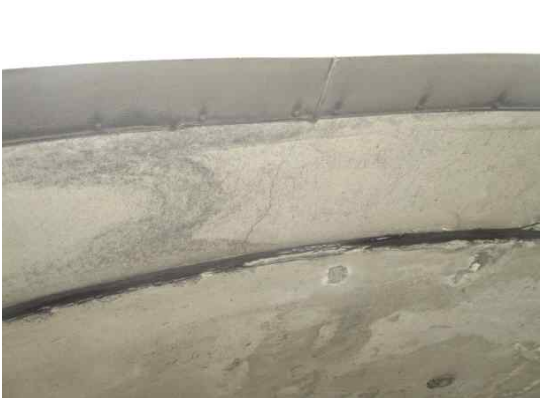
| 내 용 | 균열(0.3mm 이상, S1, 부산) | 내 용 | 들뜸(S1, 부산) |

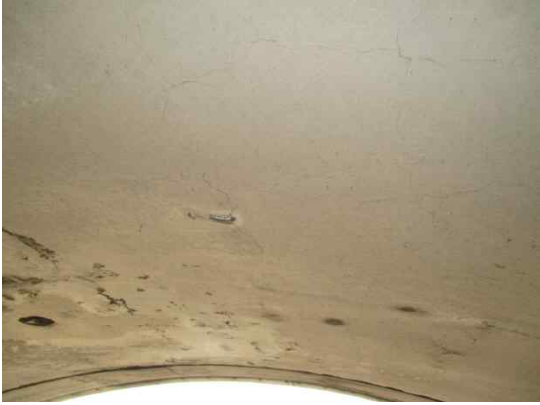
| 내 용 | 망상균열(S2, 부산) | 내 용 | 균열(0.3mm이상, S32, 부산) |

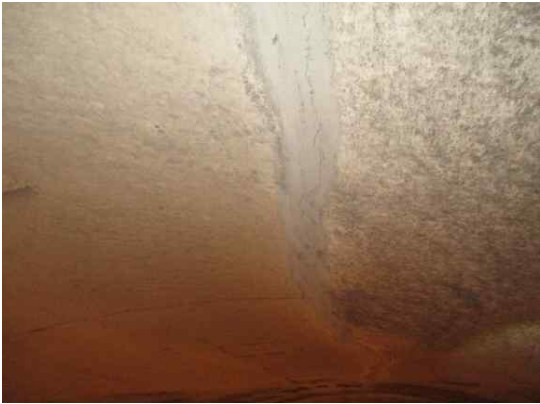
| 내 용 | 보수부 재균열(0.3mm 미만, S32, 부산) | 내 용 | 균열(0.3mm이상, S61, 부산) |

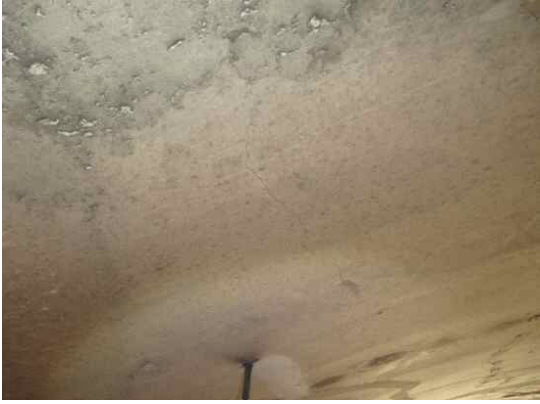
| 내 용 | 균열(0.3mm 미만, S62, 부산) | 내 용 | 균열(0.3mm 미만, S63, 부산) |

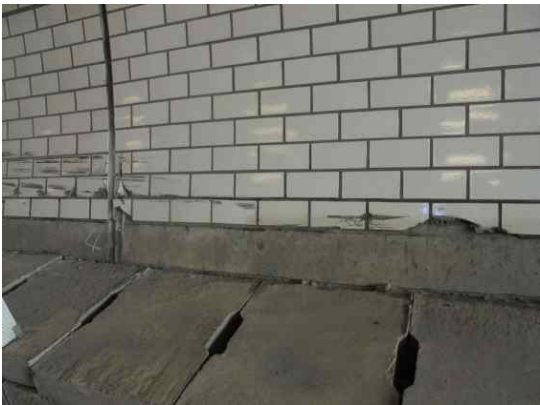
| 내 용 | 타일 파손(S4, 대구) | 내 용 | 타일파손(S30, 대구) |

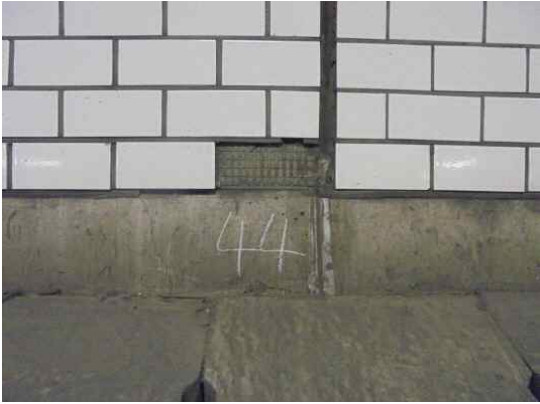
| 내 용 | 타일 파손(S45, 대구) | 내 용 | 백태(S2, 부산) |

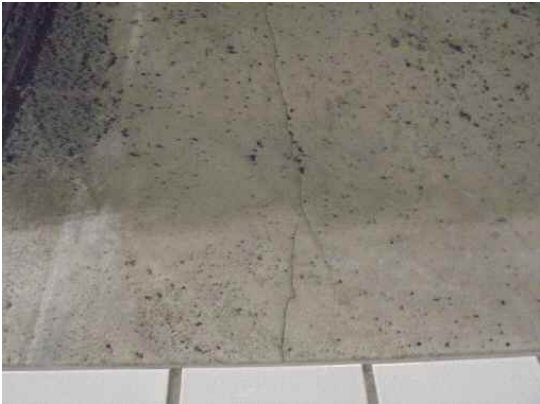
| 내 용 | 균열(0.3mm 이상, S12, 부산) | 내 용 | 타일 파손(S55, 부산) |

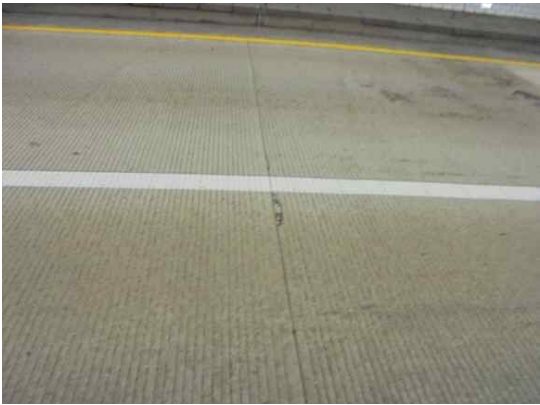
| 내 용 | 스폴링(S15, 대구) | 내 용 | 스폴링(S25, 대구) |

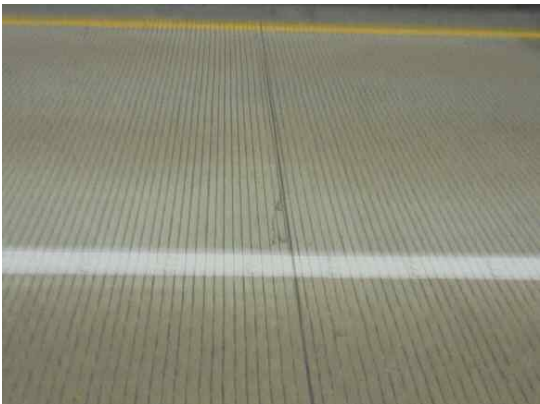
| 내 용 | 스폴링(S35, 대구) | 내 용 | 균열(S44, 대구) |

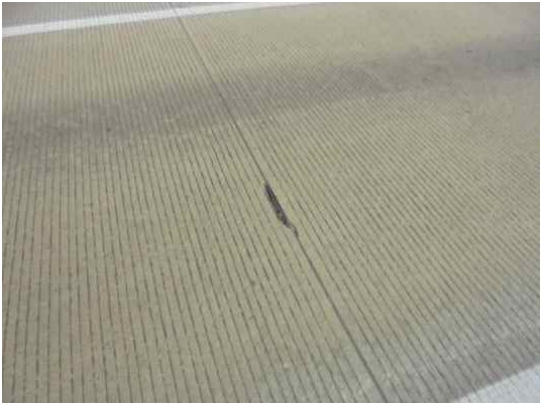
| 내 용 | 스폴링(S44, 대구) | 내 용 | 스폴링(S47, 대구) |

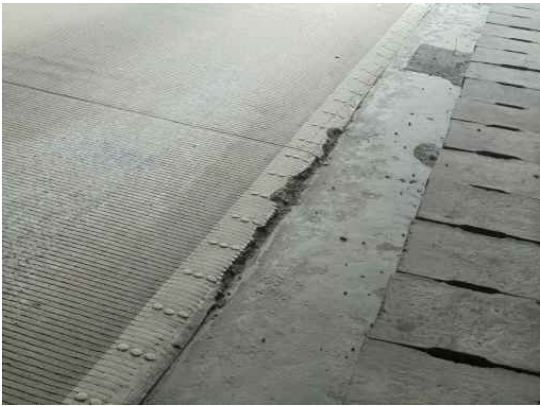
| 내 용 | 파손(S2, 부산) | 내 용 | 스폴링(S14, 부산) |

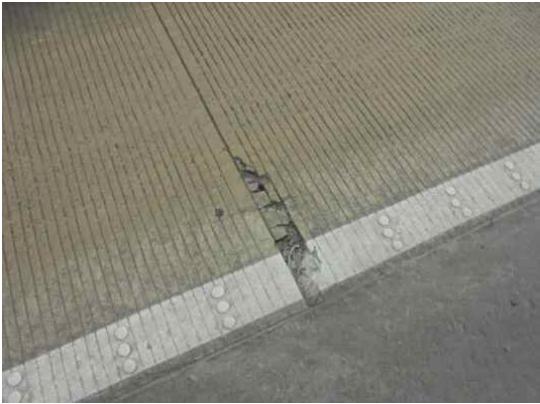
| 내 용 | 스폴링(S18, 부산) | 내 용 | 균열(S26, 부산) |

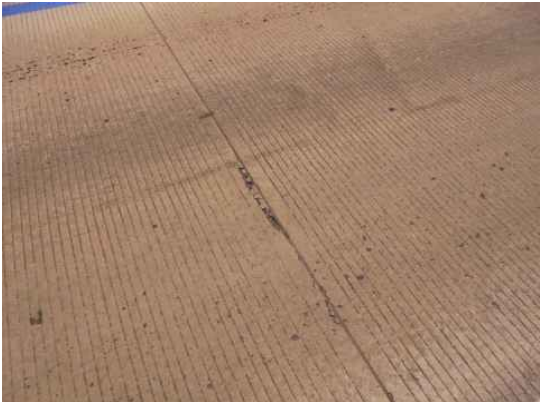
| 내 용 | 스폴링(S42, 부산) | 내 용 | 균열(S52, 부산) |

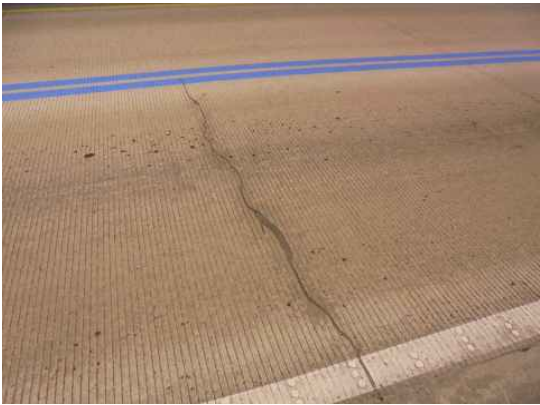
| 내 용 | 파손(S55, 부산) | 내 용 | 스폴링(S58, 부산) |

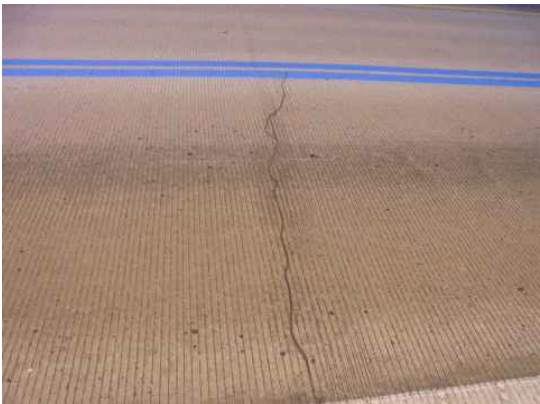
| 내 용 | 균열(S62, 부산) | 내 용 | 균열(S64, 부산) |

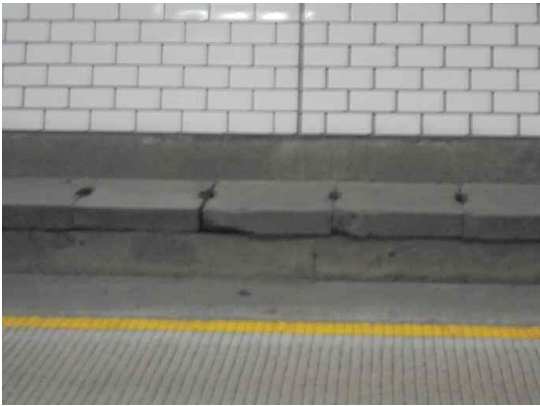
| 내 용 | 덮개 파손(S17, 대구) | 내 용 | 덮개 파손(S22, 부산) |

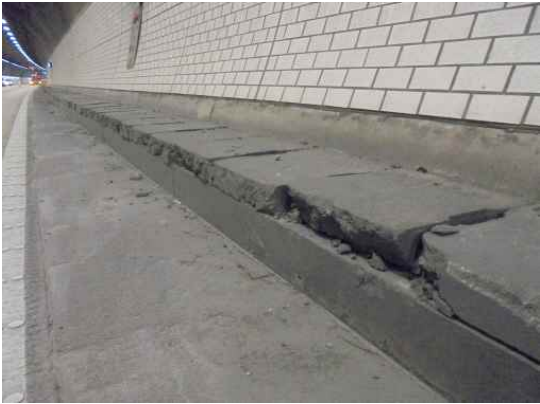
| 내 용 | 덮개 파손(S43, 부산) | 내 용 | 덮개 파손(S55, 부산) |

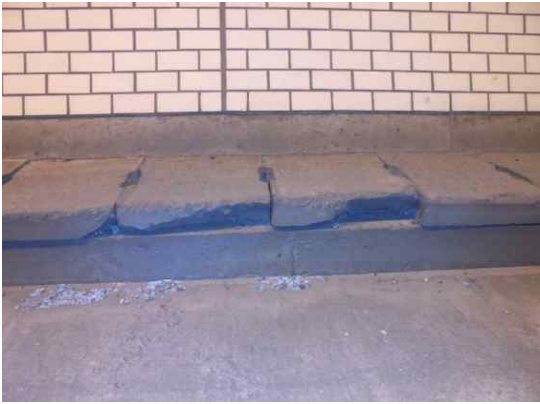
| 내 용 | 덮개 파손(S58, 부산) | 내 용 | 덮개 파손(S61, 부산) |

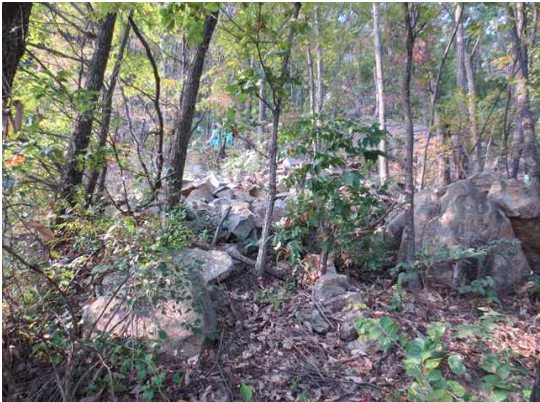
| 내 용 | 암괴(상부 자연사면 STA.0+0) | 내 용 | 암괴(상부 자연사면 STA.0+80) |

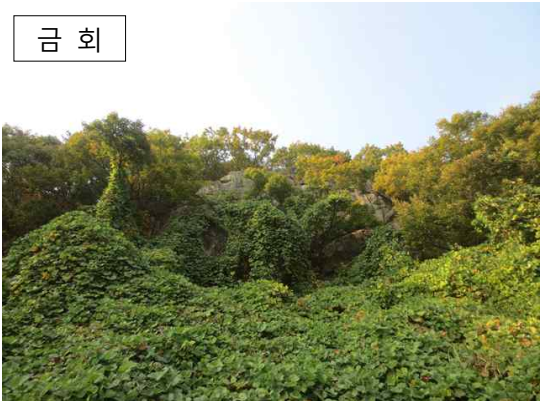
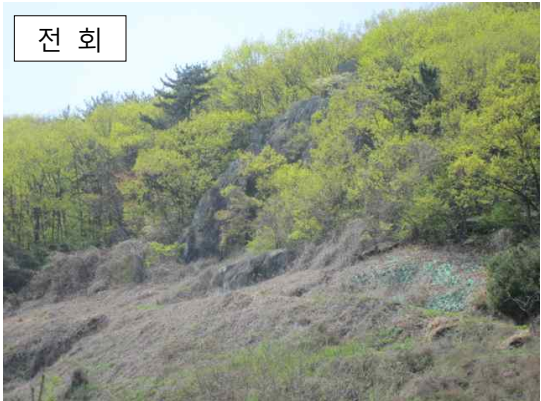
| 내 용 | 암괴(상부 자연사면 STA.0+100) | | |

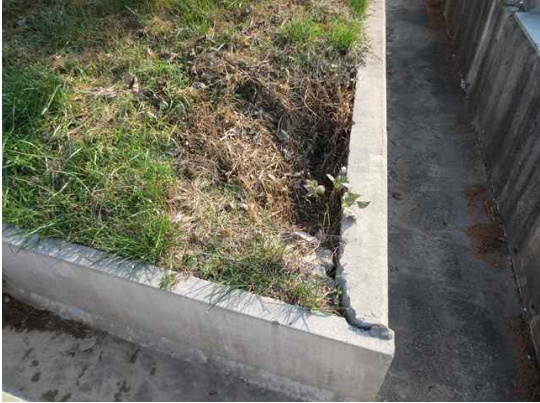
| 내 용 | 배수로 뒷채움 유실<br>(1단 사면부 STA.0+150) | 내 용 | 배수로 파손(갱문 STA.0+120) |
