결 은 교

바닥판 상면 손상현황도

P1 ~ A2(S2)

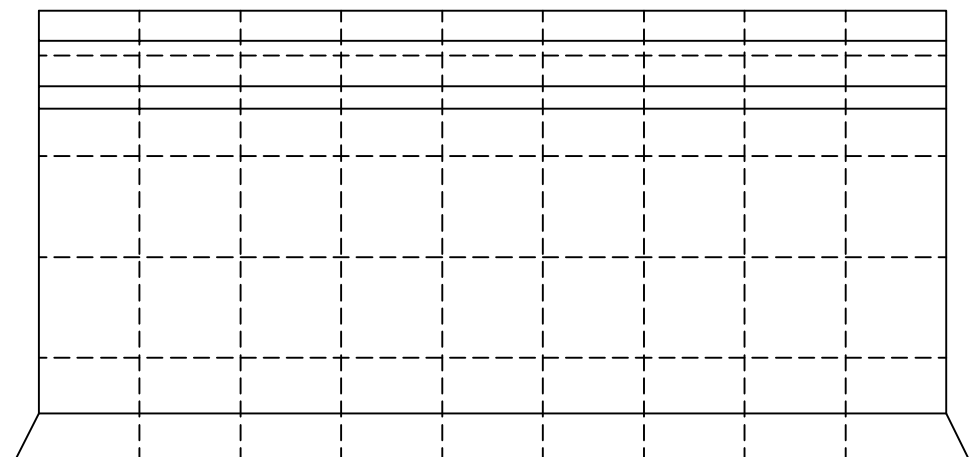
전면

① 받침부식 5ea
