거북교

바닥판 상면 손상현황도

A1 ~ P1(S1)

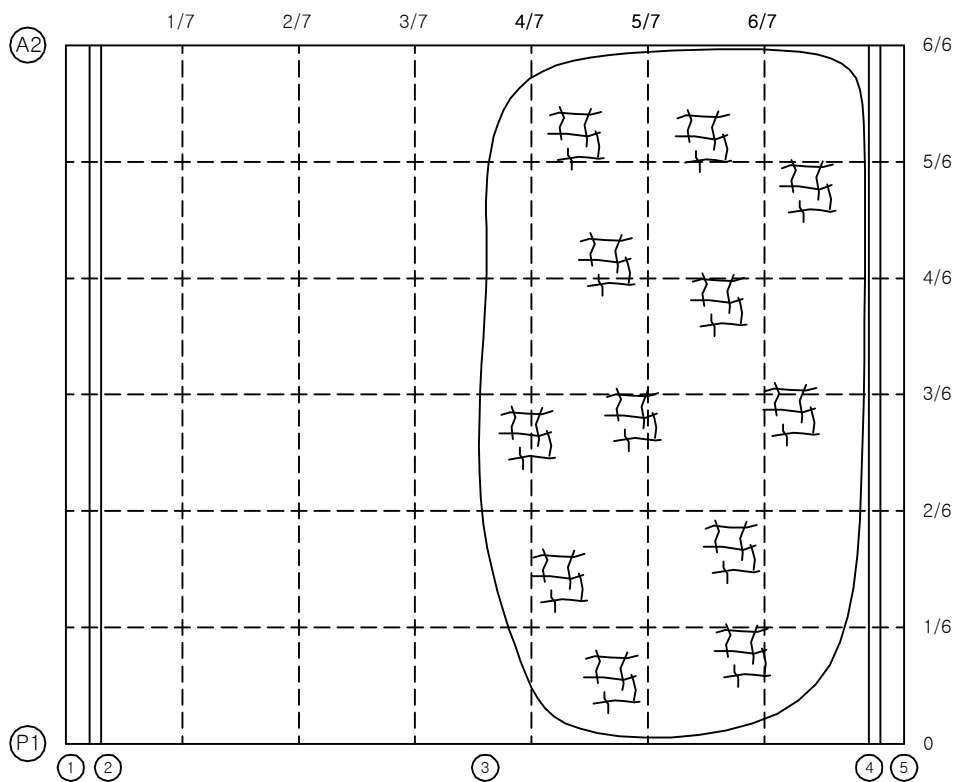
P1 ~ A2(S2)

① 망상균열  
4x4.5

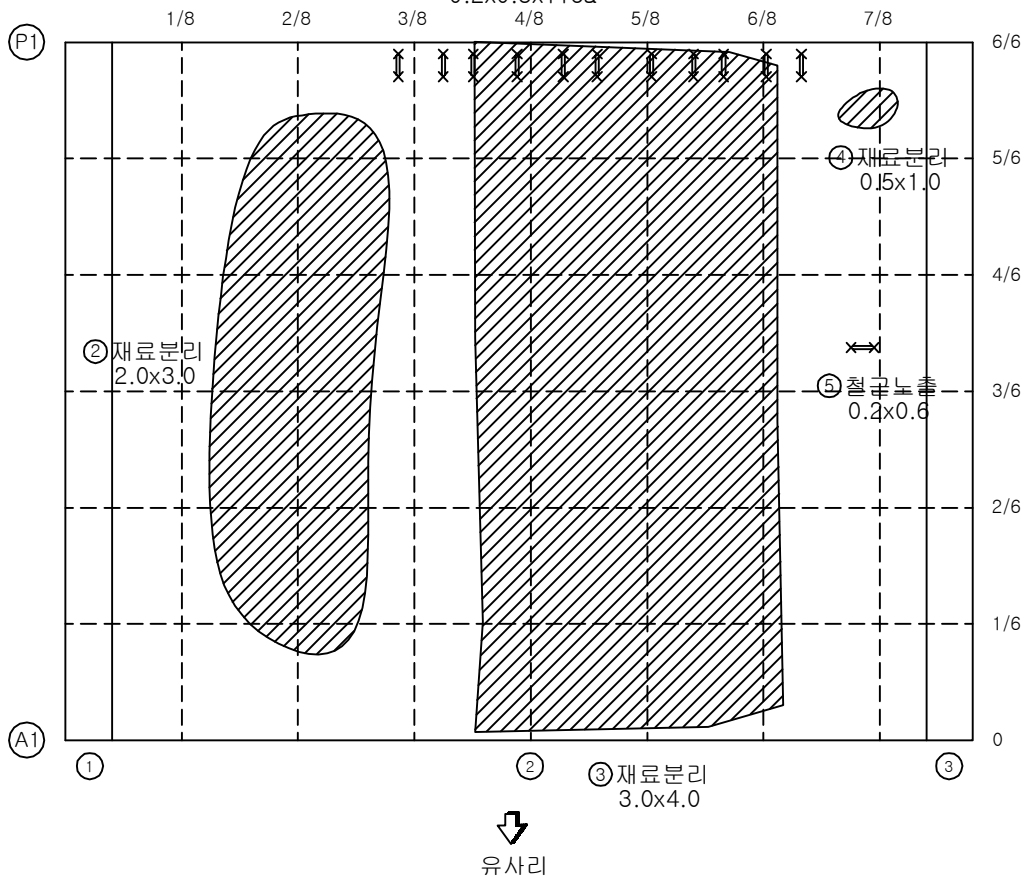
A1 ~ P1(S1)

① 철근노출  
0.2x0.3x11ea
