주 록 교

교각 손상현황도

PIER 1

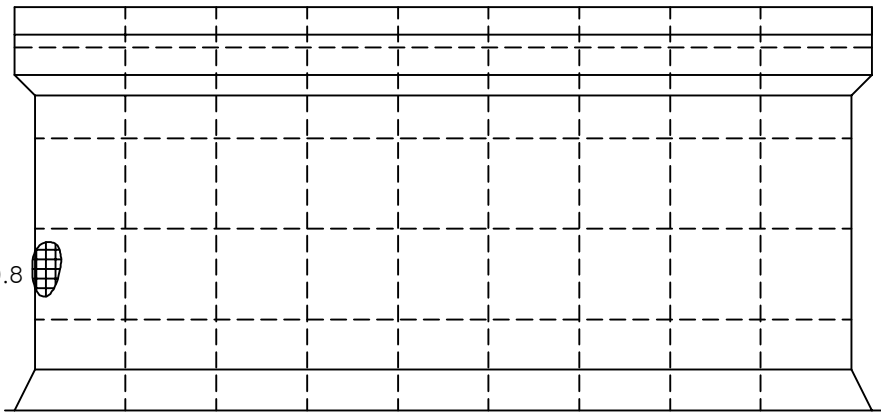
전면

① 파손  
0.3x0.8

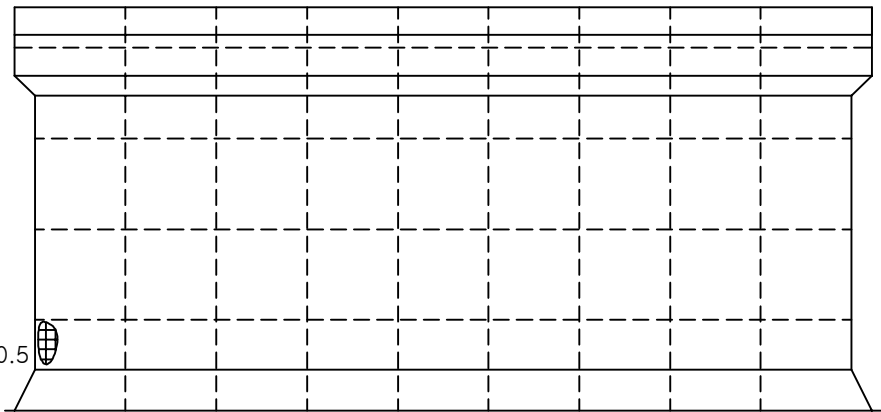
배면

② 파손  
0.2x0.5
