교 리 교

바닥판 상면 손상현황도

P2 ~ A2(S3)

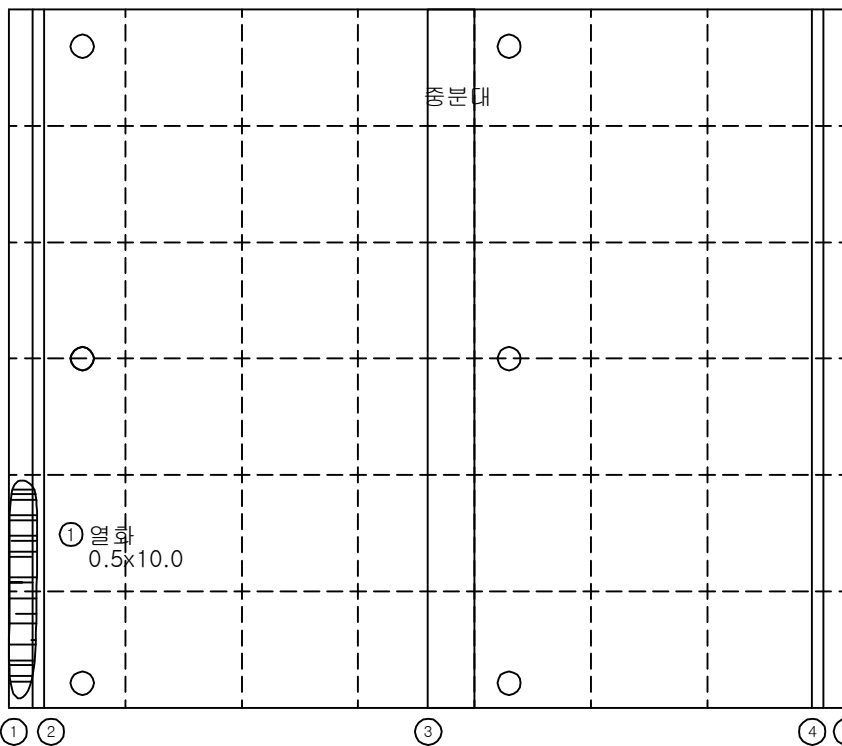
② 후타재 균열  
0.1/0.2x30ea

③ 차수판 탈락  
1ea
