용 강 2 교

교각 손상현황도

PIER 1

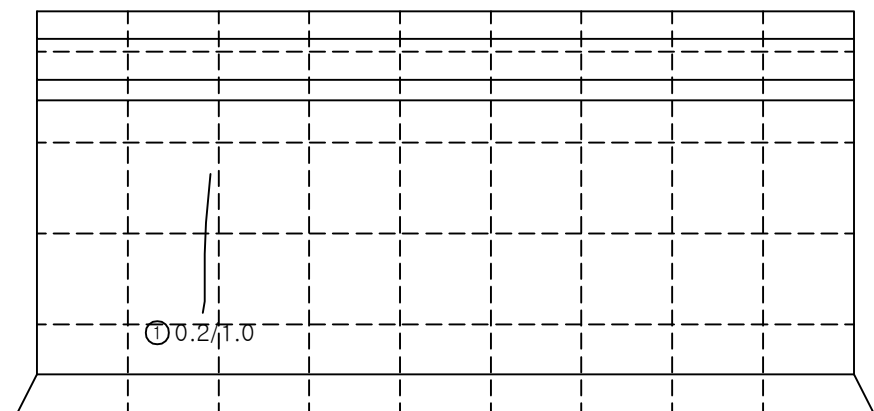
배면

① 0.2/1.0
