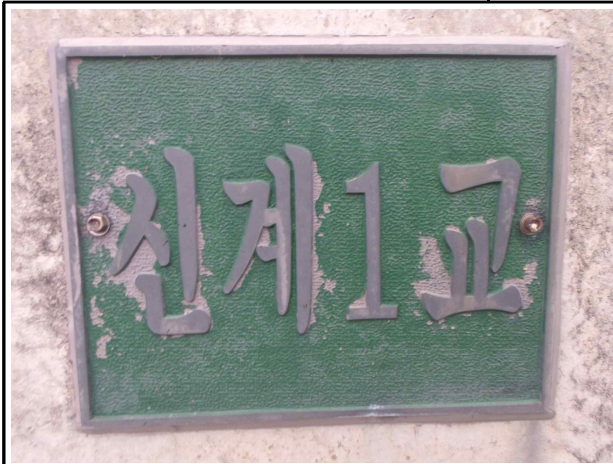
No. 1

| 내 용 | 교 명 판 |

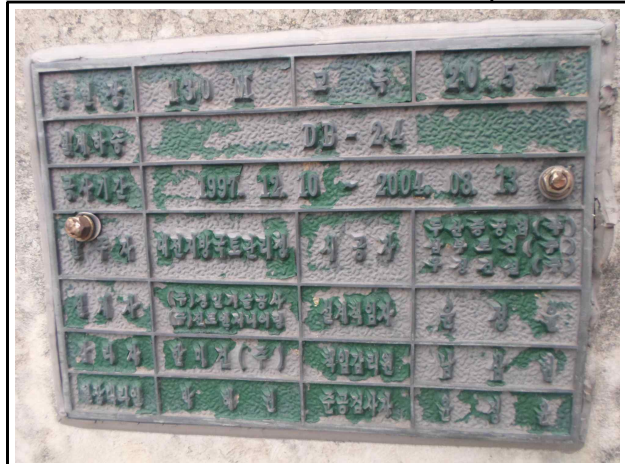
No. 2

| 내 용 | 교 명 판 |

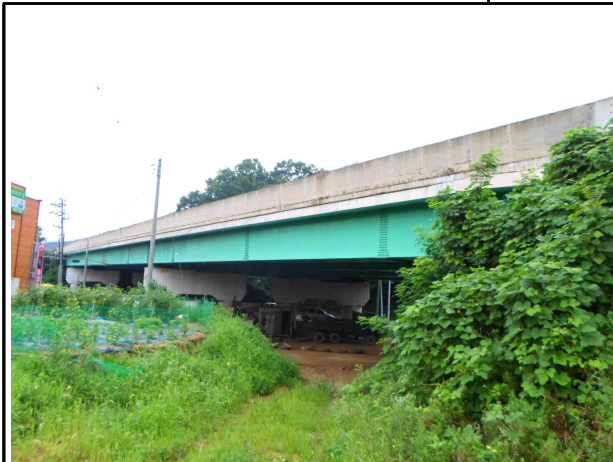
No. 3

| 내 용 | 전경 |

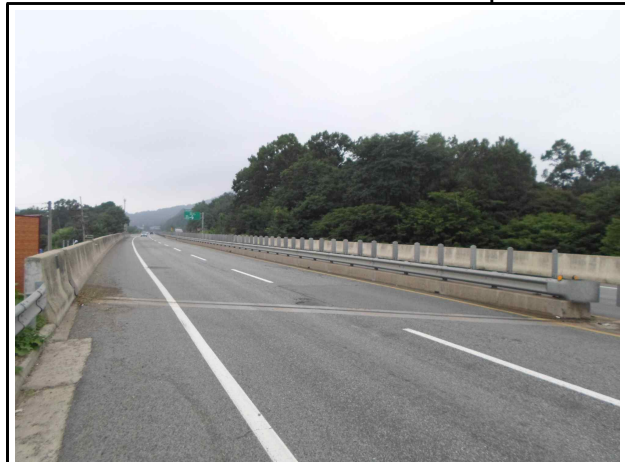
No. 4

| 내 용 | A1 → A2 전경 |

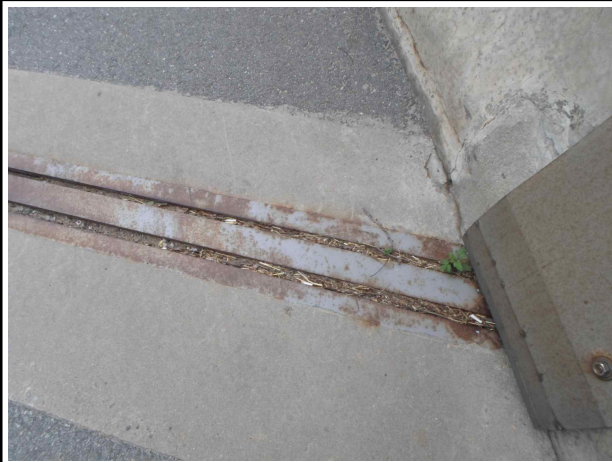
No. 5

| 내 용 | 유간토사퇴적 (L=1.5m) |

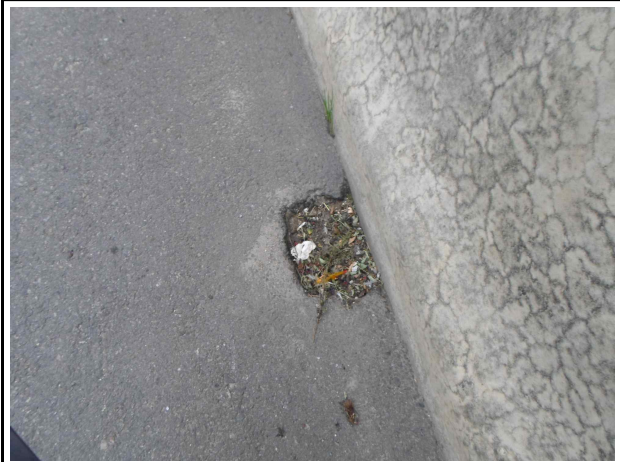
No. 6

| 내 용 | 배수구막힘 |

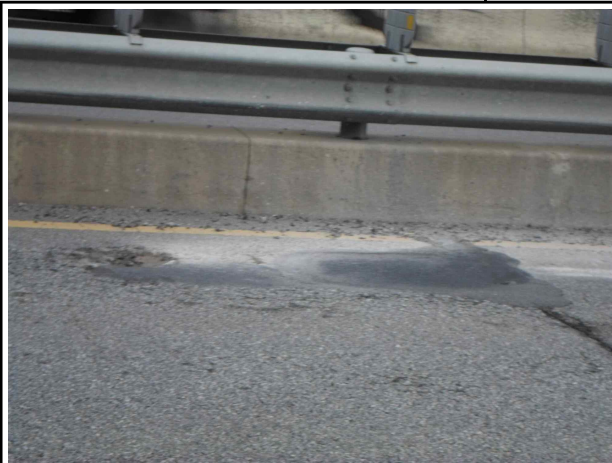
No. 7

| 내 용 | 아스콘패임 (1.0m × 1.5m) |

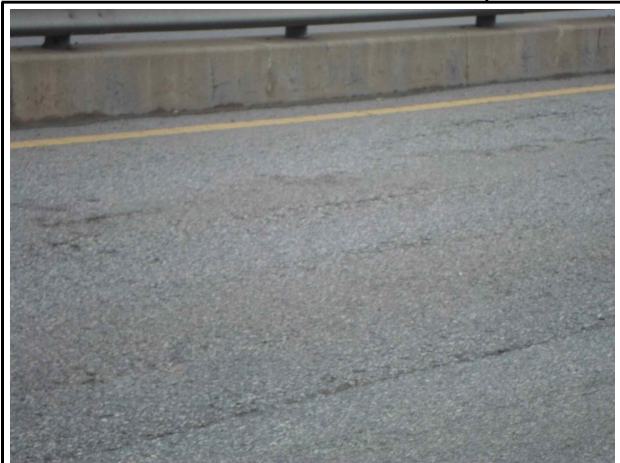
No. 8

| 내 용 | 아스콘마모 (3.0m × 20.0m) |

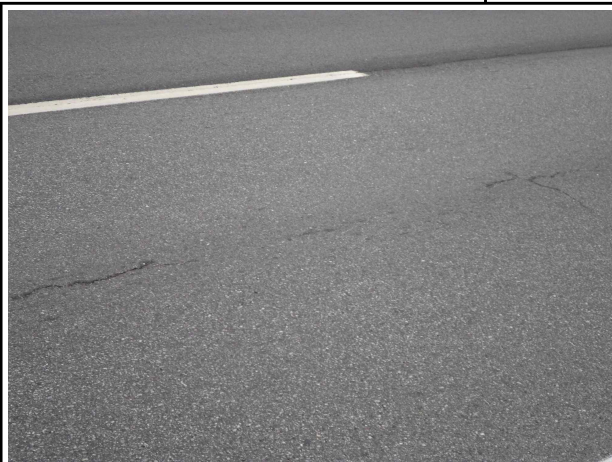
No. 9

| 내 용 | 아스콘균열 (L=4.0m) |

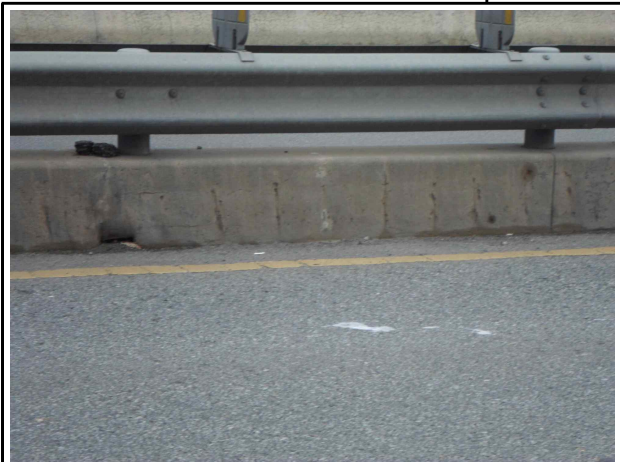
No. 10

| 내 용 | 철근노출 (L=0.3m, 24EA) |

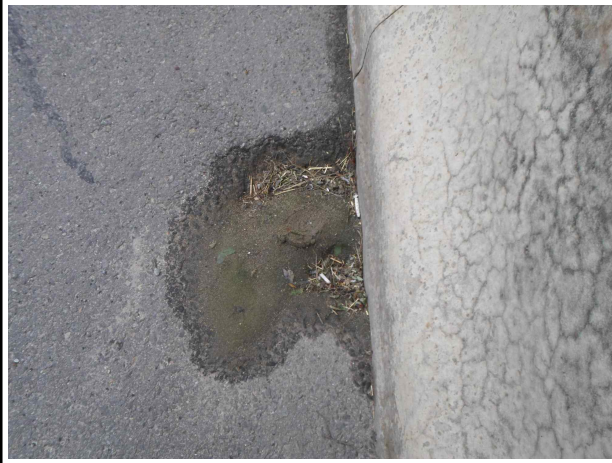
No. 11

| 내 용 | 배수구막힘 |

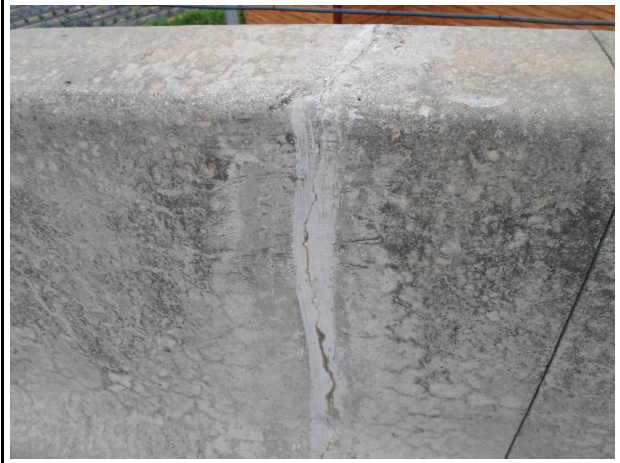
No. 12

| 내 용 | 보수부재균열 (cw:0.1mm, L=1.2m) |

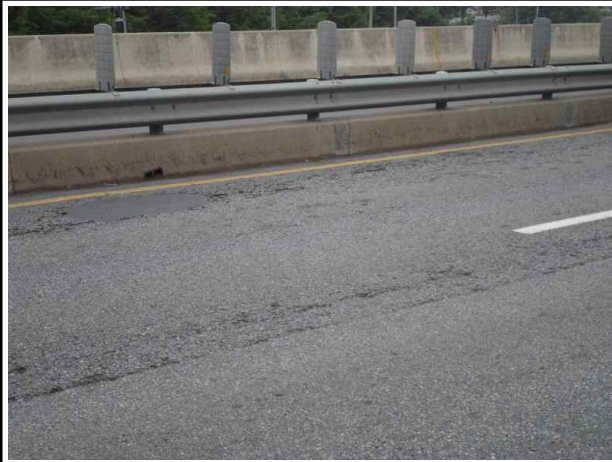
No. 13

| 내 용 | 아스콘마모 (3.0m × 20.0m) |

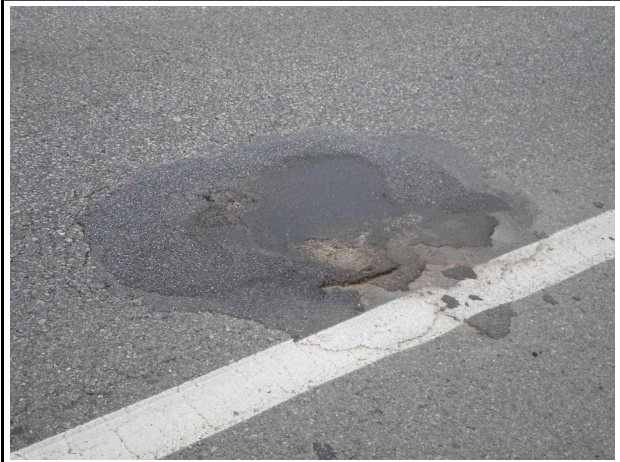
No. 14

| 내 용 | 아스콘패임 (1.5m × 1.5m) |

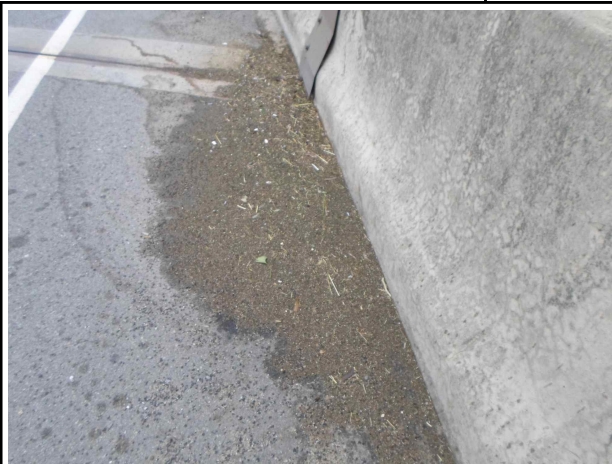
No. 15

| 내 용 | 토사퇴적 (1.0m × 0.6m) |

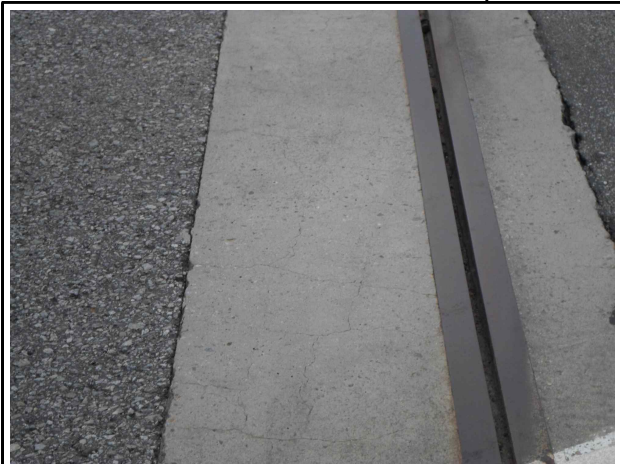
No. 16

| 내 용 | 후타재 망상균열 (0.1m × 7.0m) |

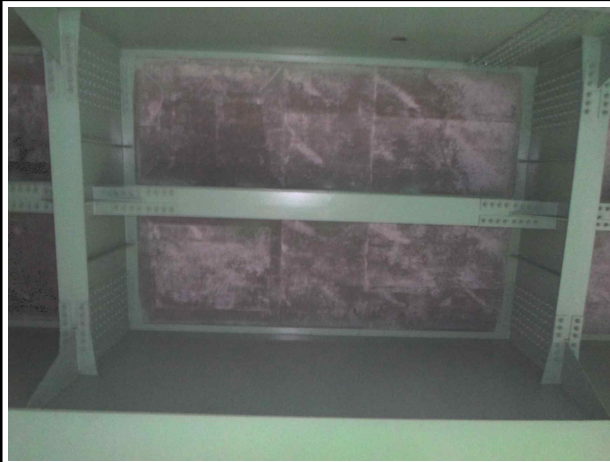
No. 17

| 내 용 | 상태양호 |

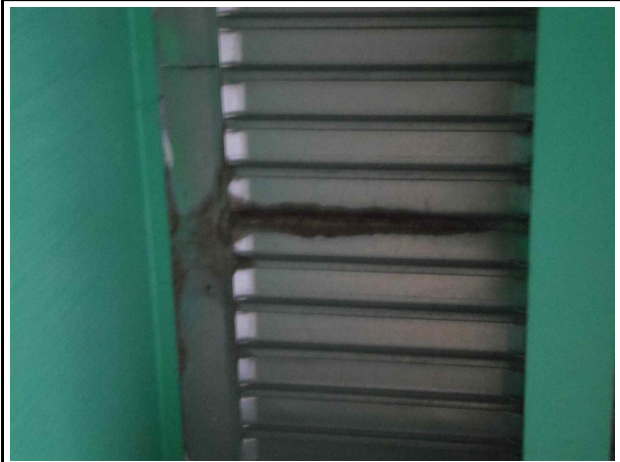
No. 18

| 내 용 | 데크플레이트 부식 (0.3m × 1.0m) |

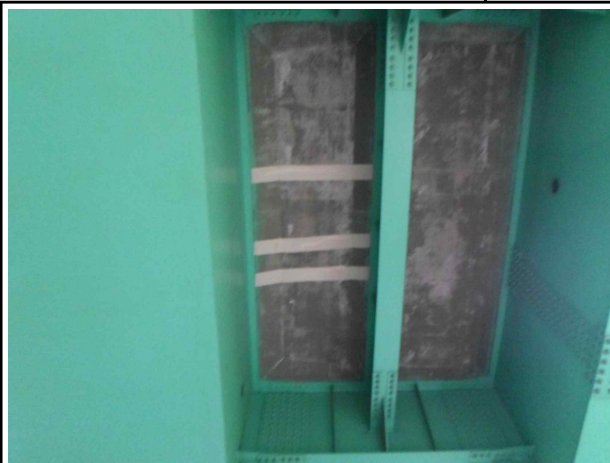
No. 19

| 내 용 | 균열보수부 |

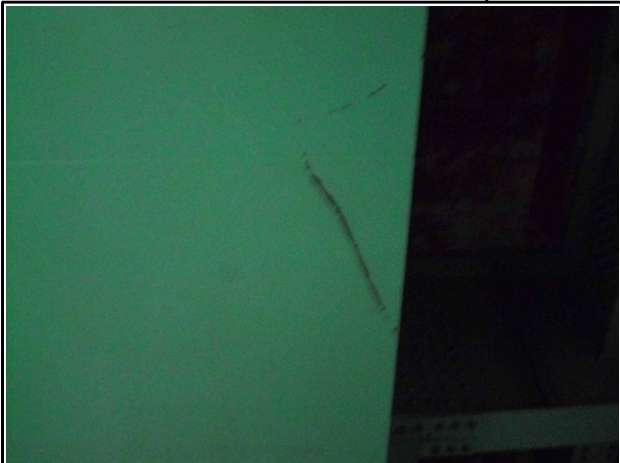
No. 20

| 내 용 | 굽힘 (0.1m × 0.5m) |

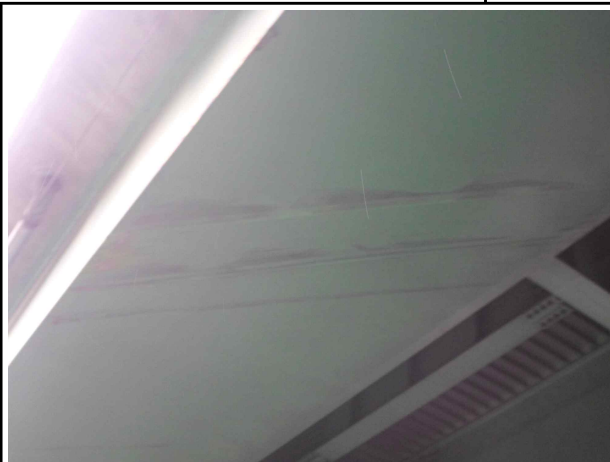
No. 21

| 내 용 | 굽힘 (1.0m × 3.0m) |

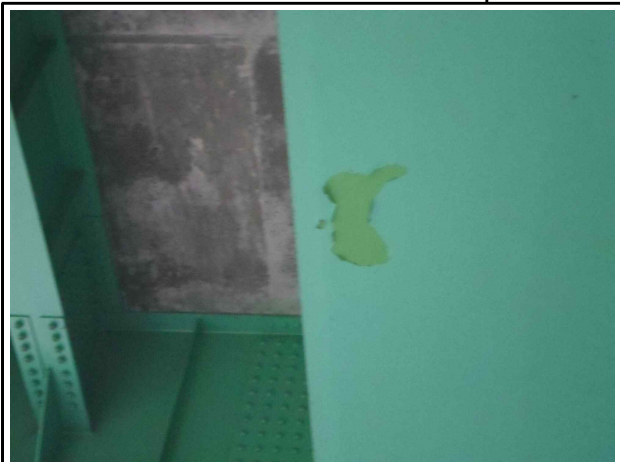
No. 22

| 내 용 | 도장탈락 (0.2m × 0.3m) |

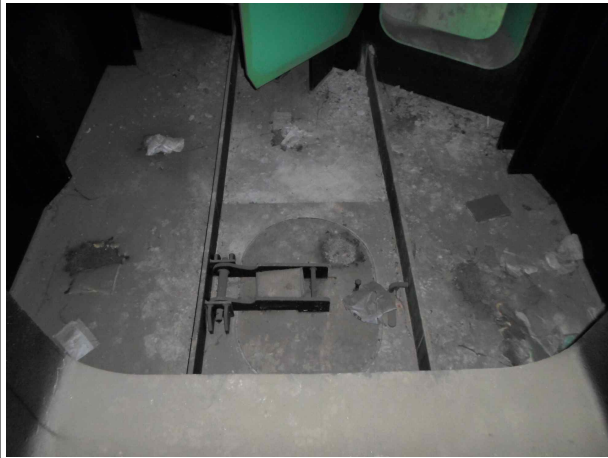
No. 23

| 내 용 | 이물질퇴적 (2.5m × 2.0m) |

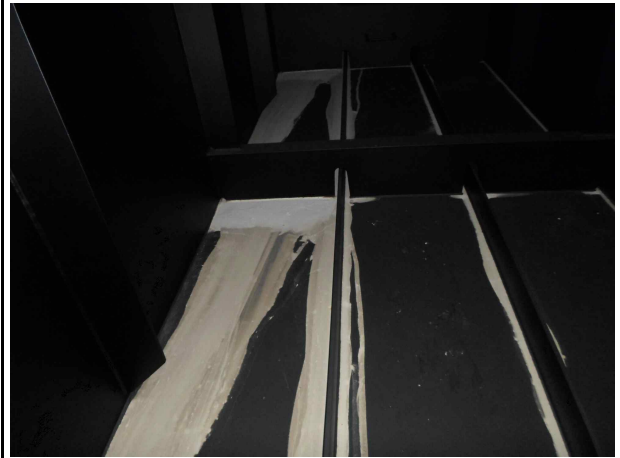
No. 24

| 내 용 | 우수유입흔적 (40.0m × 0.2m) |

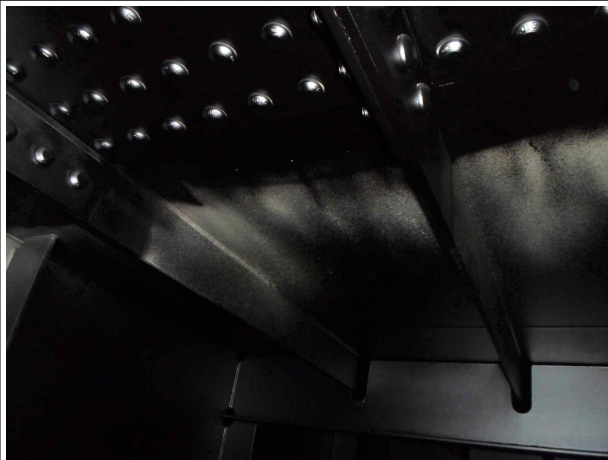
No. 25

| 내 용 | 도장불량 (0.5m × 2.5m) |

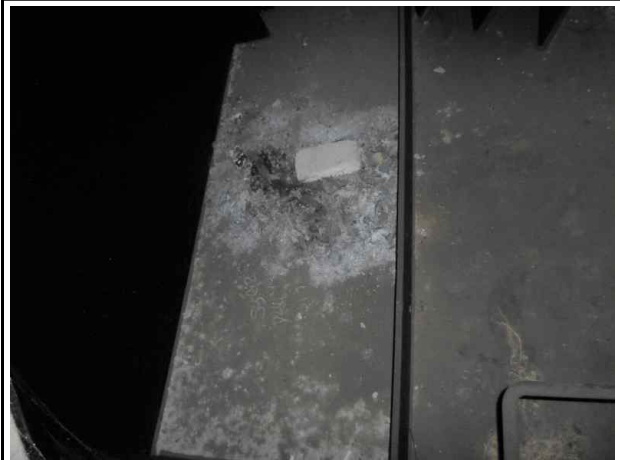
No. 26

| 내 용 | 이물질퇴적 (0.5m × 0.5m) |

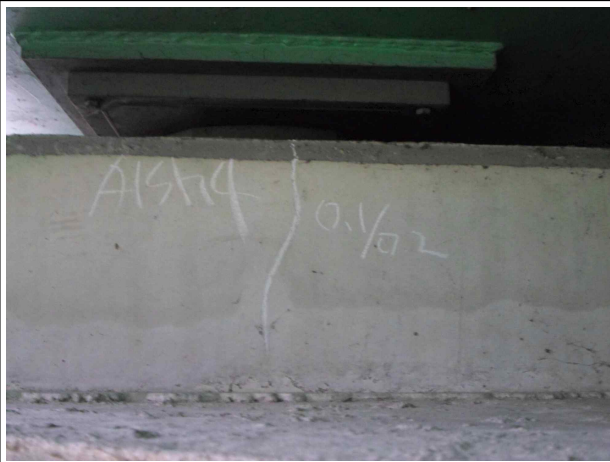
No. 27

| 내 용 | 받침콘크리트균열 (cw:0.1mm, L=0.2m) |

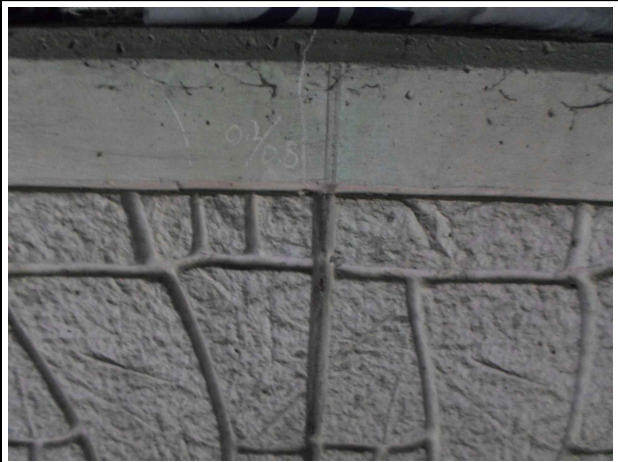
No. 28

| 내 용 | 균열 (cw:0.2mm, L=0.8m) |

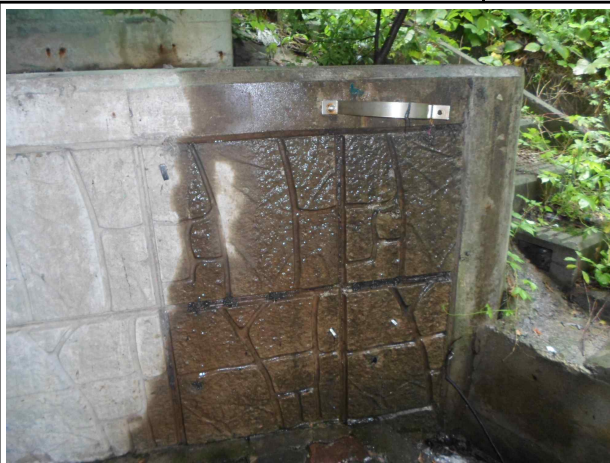
No. 29

| 내 용 | 누수흔적 (1.0m × 1.5m) |

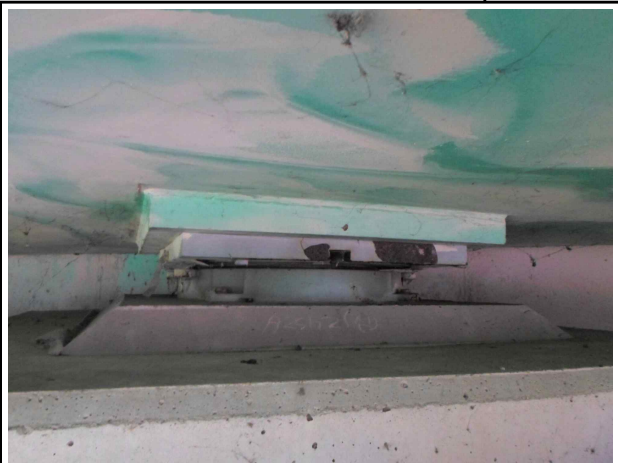
No. 30

| 내 용 | Plate 부식 |

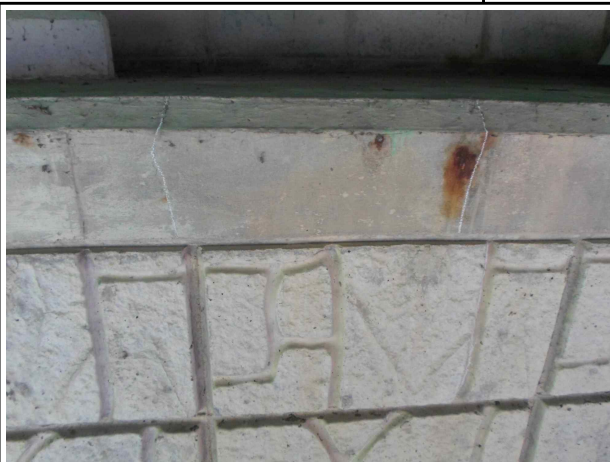
No. 31

| 내 용 | 균열 (cw:0.2mm, 1.0m) 2EA |

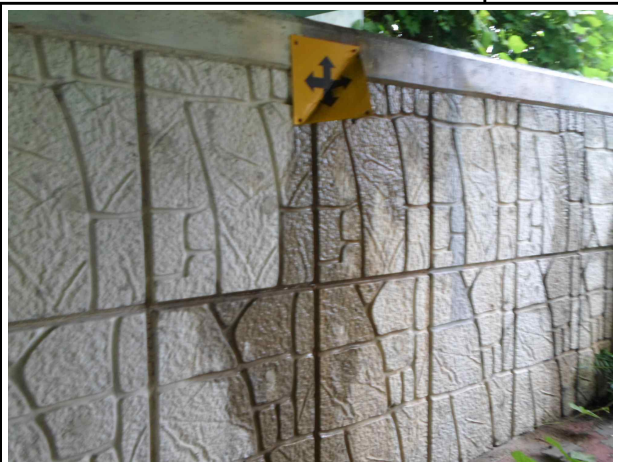
No. 32

| 내 용 | 누수흔적 (1.0m × 1.5m) |

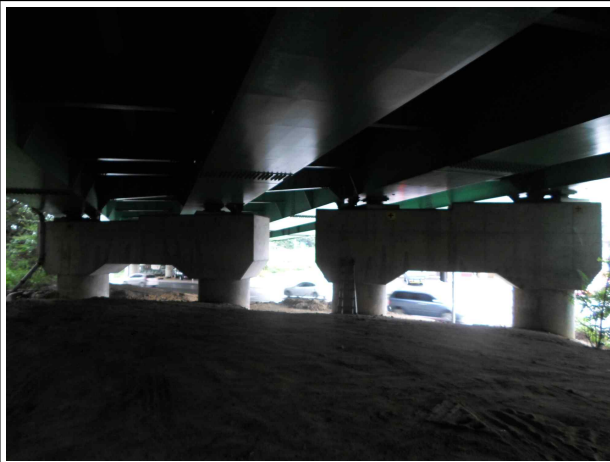
No. 33

| 내 용 | 전 경 |

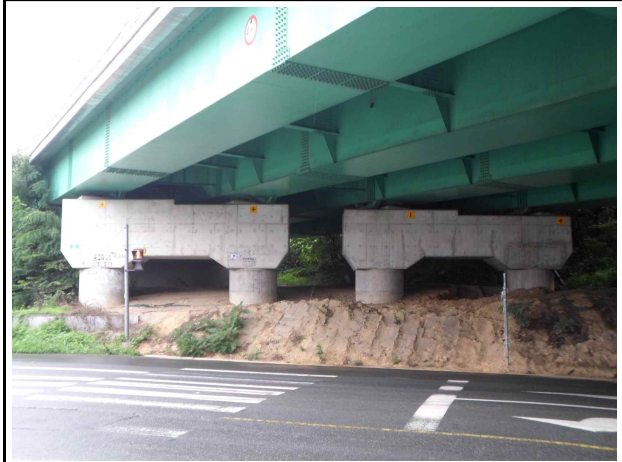
No. 34

| 내 용 | 전 경 |

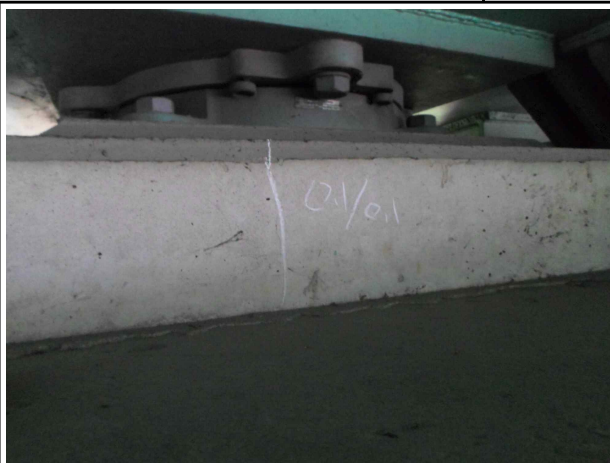
No. 35

| 내 용 | 반침콘크리트균열 (cw:0.1mm, L=1.0m) |

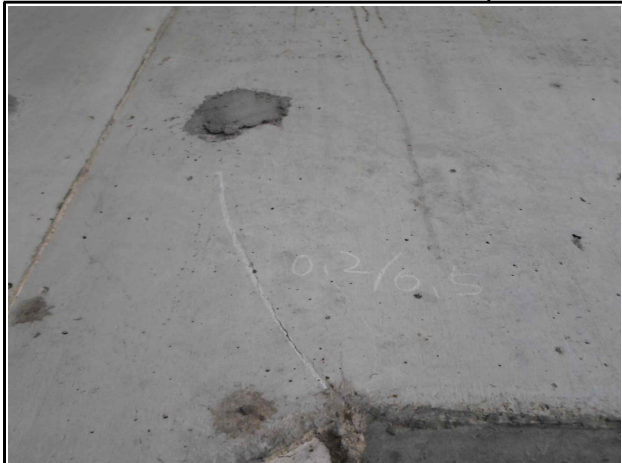
No. 36

| 내 용 | 균열 (cw:0.2mm, L=0.5m) |

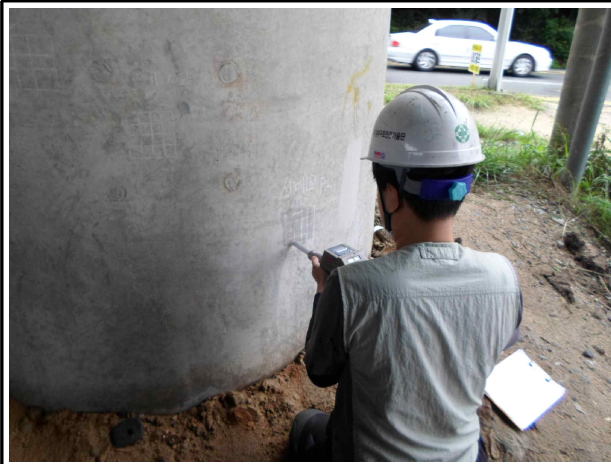
No. 37

| 내 용 | 반발경도시험 |

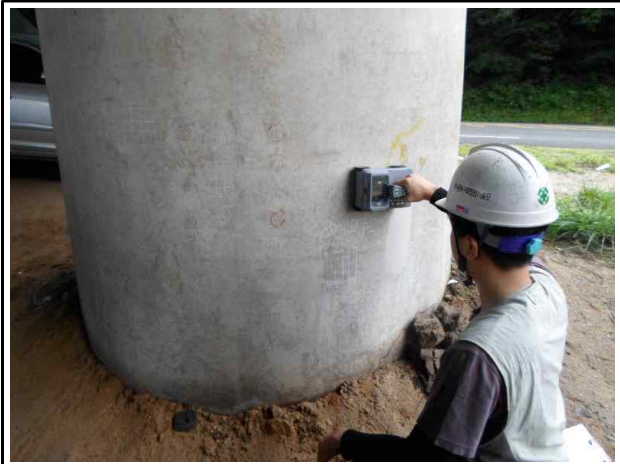
No. 38

| 내 용 | 피복두께측정 |

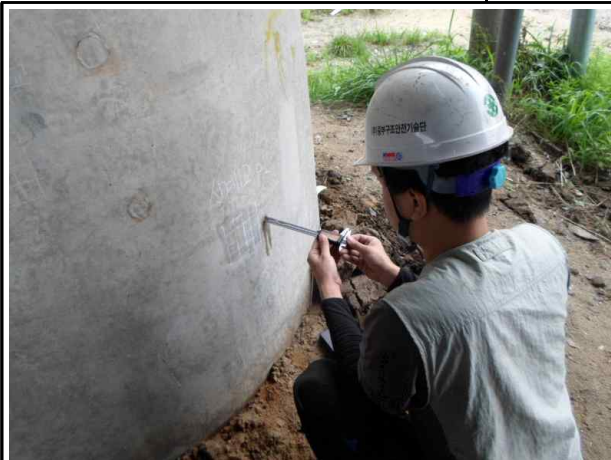
No. 39

| 내 용 | 탄산화시험 |

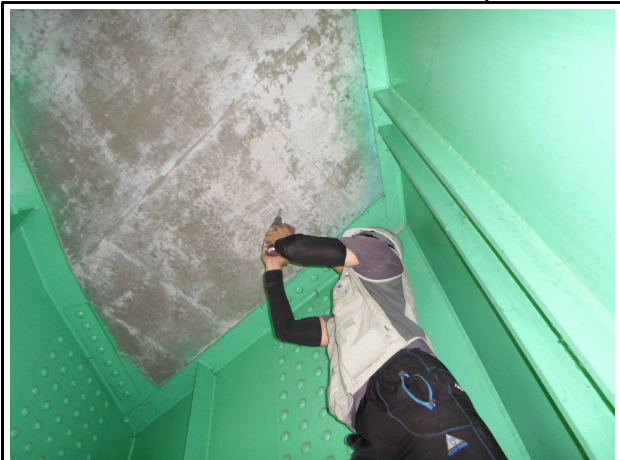
No. 40

| 내 용 | 반발경도시험 |

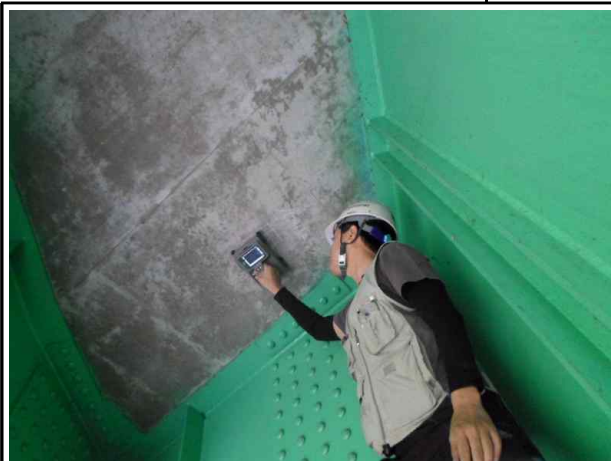
No. 41

| 내 용 | 피복두께 측정 |

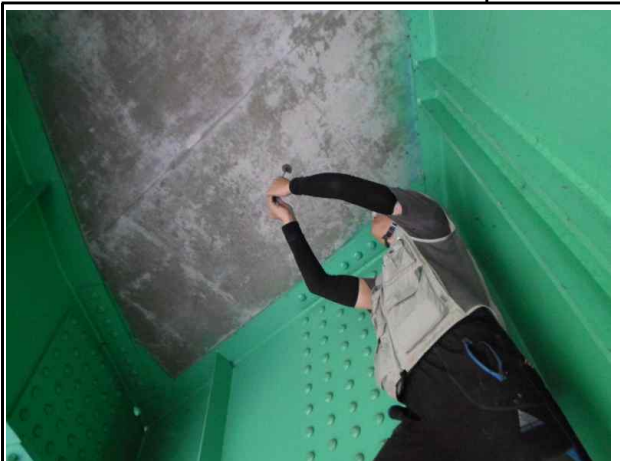
No. 42

| 내 용 | 탄산화시험 |
