## 전경사진

## □ 교면

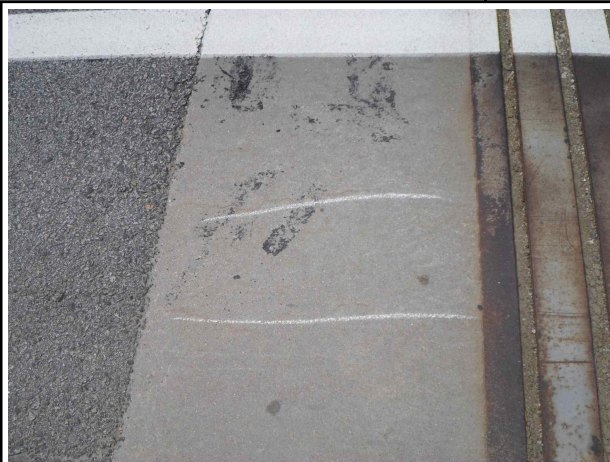
No. 7

| 위 치 | 신축이음 A1 |
| 내 용 | 후타재 균열 (cw:0.1mm, L=0.4m) |

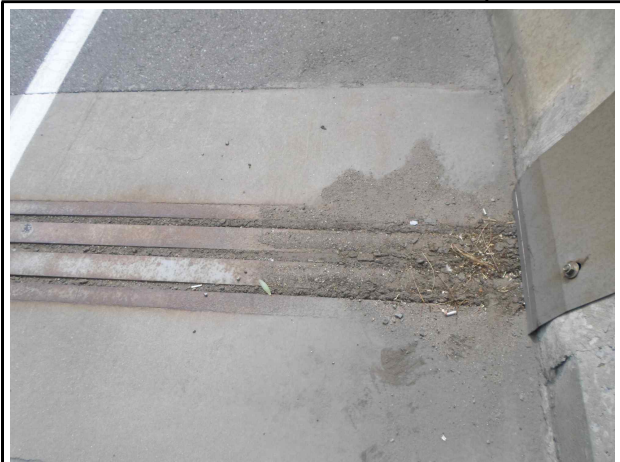
No. 8

| 위 치 | 신축이음 A1 |
| 내 용 | 유간 이물질퇴적 (L=3.0m) |

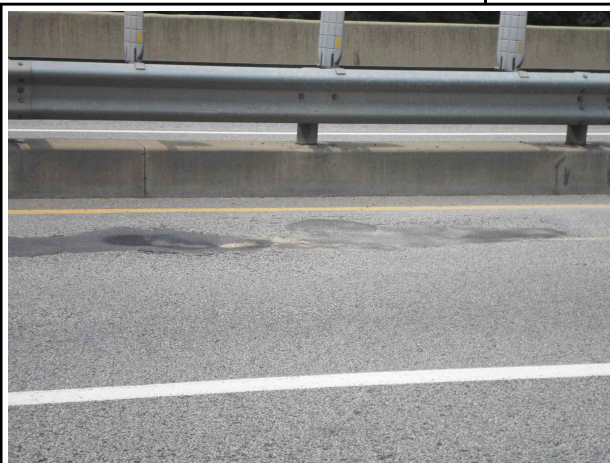
No. 9

| 위 치 | 교면 S1 |
| 내 용 | 아스콘 소성변형 및 밀림 (0.3m×3.0m) |

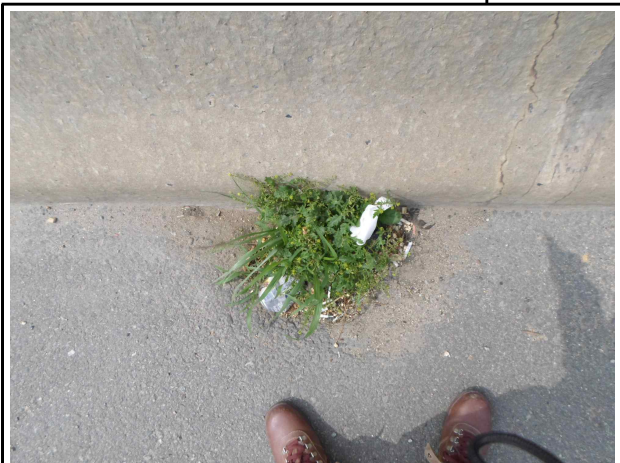
No. 10

| 위 치 | 교면 S1 |
| 내 용 | 배수구막힘 |

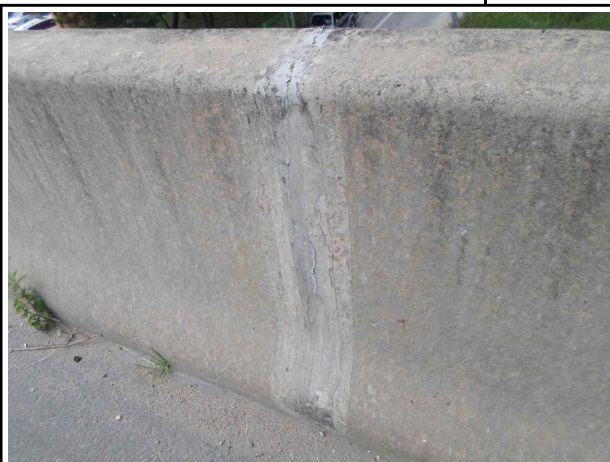
No. 11

| 위 치 | 방호벽 S2 |
| 내 용 | 보수부재 균열 (cw:0.1mm, L=1.0m) |

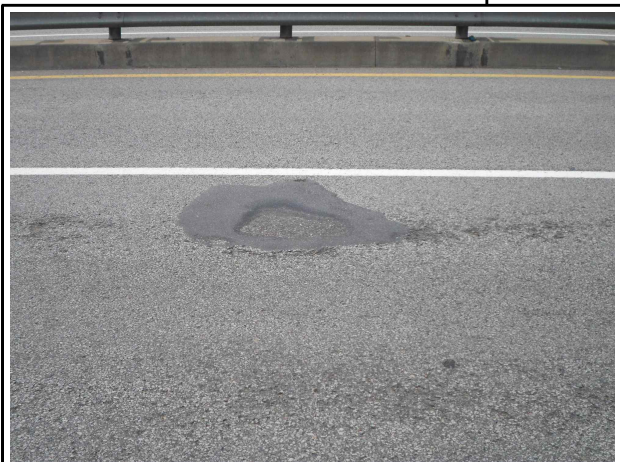
No. 12

| 위 치 | 교면 S2 |
| 내 용 | 보수부 아스콘 변형 (1.0m×1.0m) |

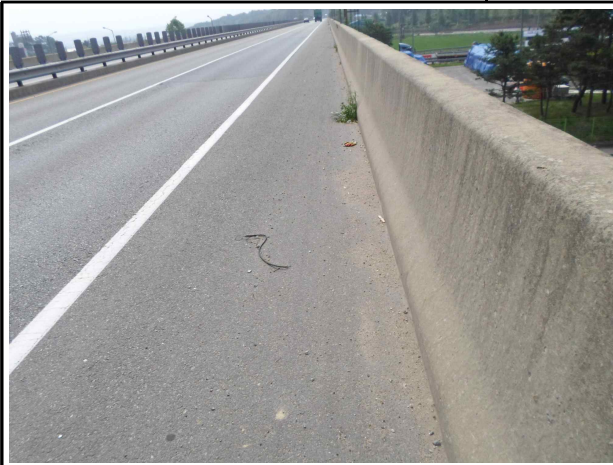
No. 13

| 위 치 | 교면 S2 |
| 내 용 | 토사퇴적 (0.5m × 43.0) |

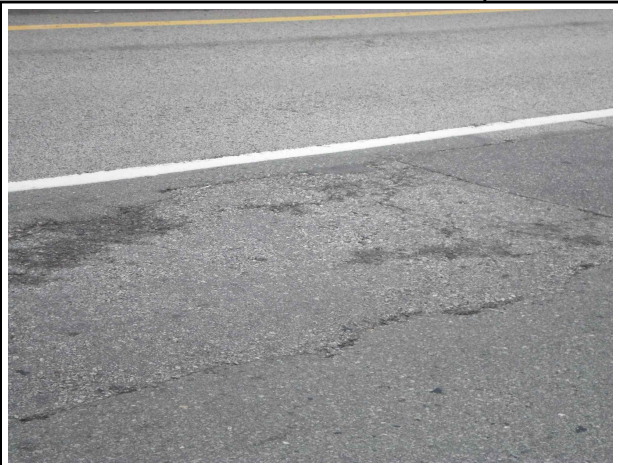
No. 14

| 위 치 | 교면 S3 |
| 내 용 | 아스콘요철 및 변형 (2.0m × 3.0m) |

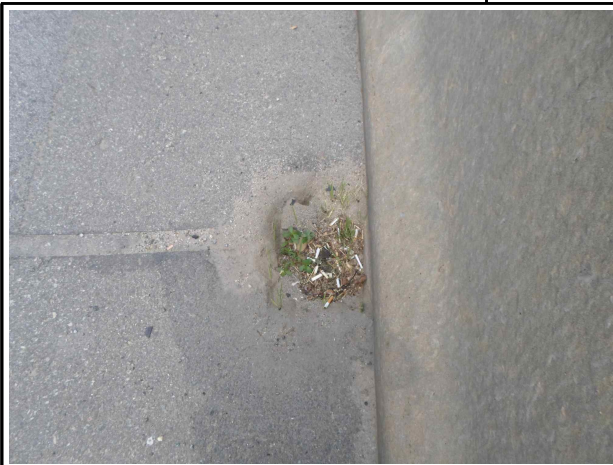
No. 15

| 위 치 | 교면 S4 |
| 내 용 | 배수구막힘 |

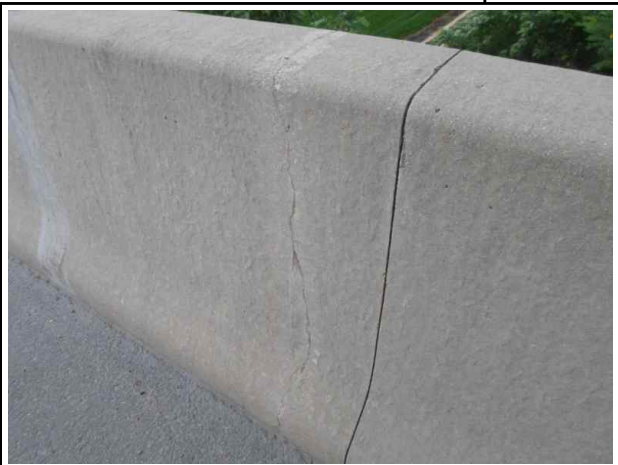
No. 16

| 위 치 | 방호벽 S5 |
| 내 용 | 균열 (cw:0.3mm, L=1.0m) |

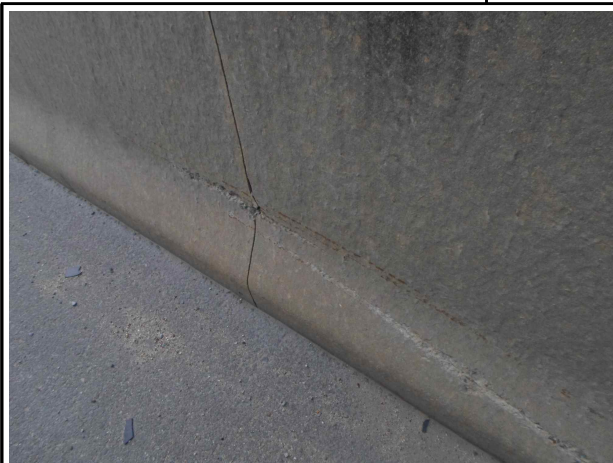
No. 17

| 위 치 | 방호벽 S5 |
| 내 용 | 차량사고흔적 (0.3m × 1.0m) |

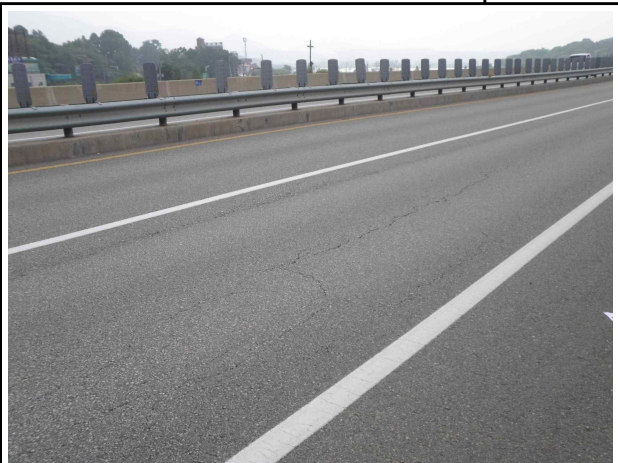
No. 18

| 위 치 | 교면 S5 |
| 내 용 | 아스콘균열 (L=20.0m, 2EA) |

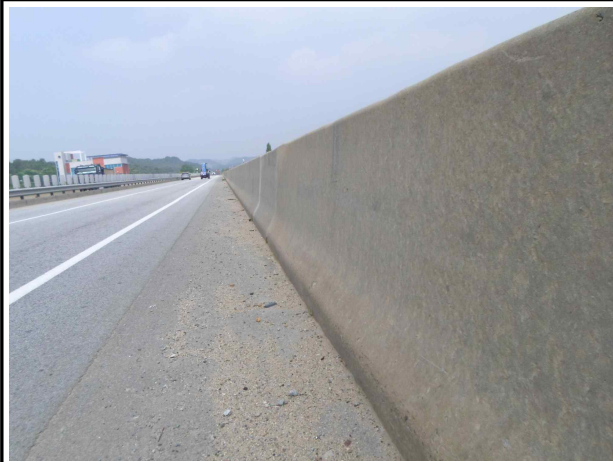
No. 19

| 위 치 | 교면 S7 |
| 내 용 | 토사퇴적 (1.0m × 43.0m) |

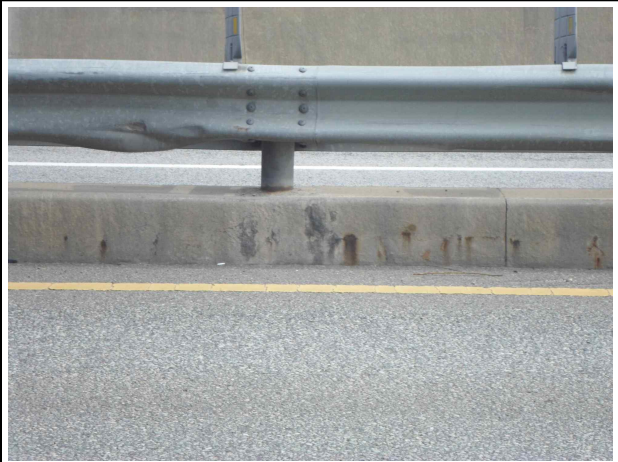
No. 20

| 위 치 | 중앙분리대 S7 |
| 내 용 | 철근노출 (0.2m × 2.0m) |

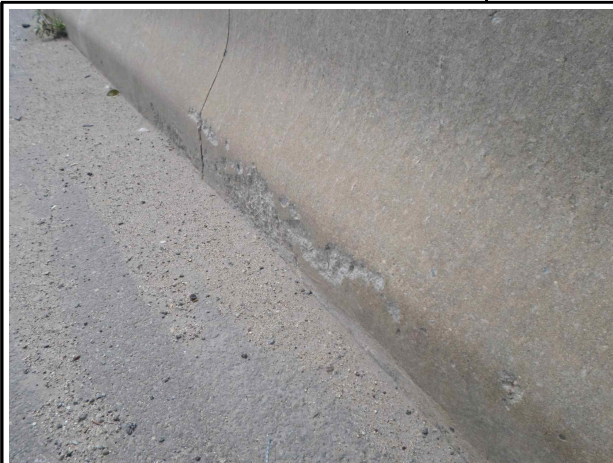
No. 21

| 위 치 | 방호벽 S8 |
| 내 용 | 표면부스러짐 (0.3m × 2.0m) |

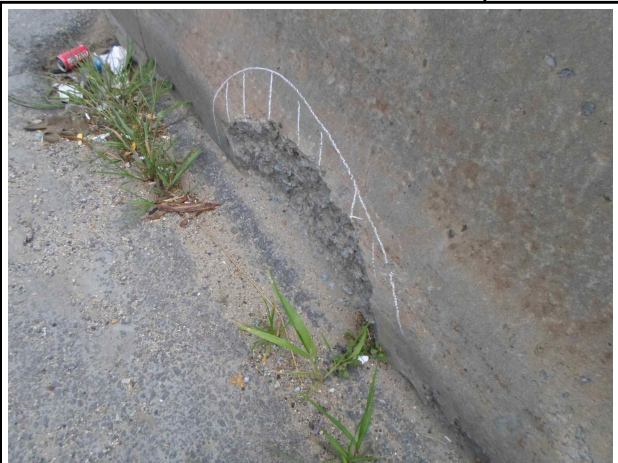
No. 22

| 위 치 | 방호벽 S8 |
| 내 용 | 파손 (0.3m × 0.6m) |

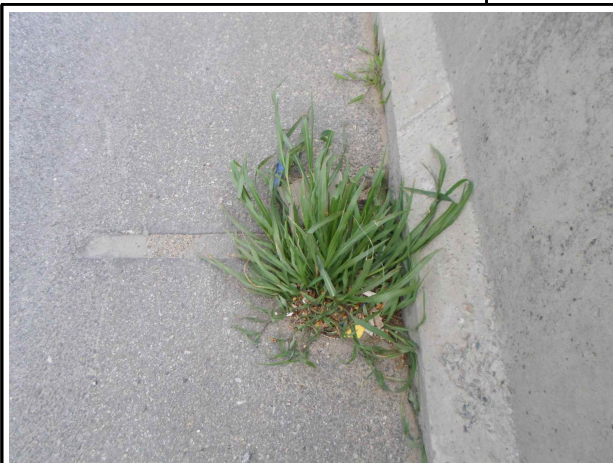
No. 23

| 위 치 | 교면 S9 |
| 내 용 | 배수구막힘 |

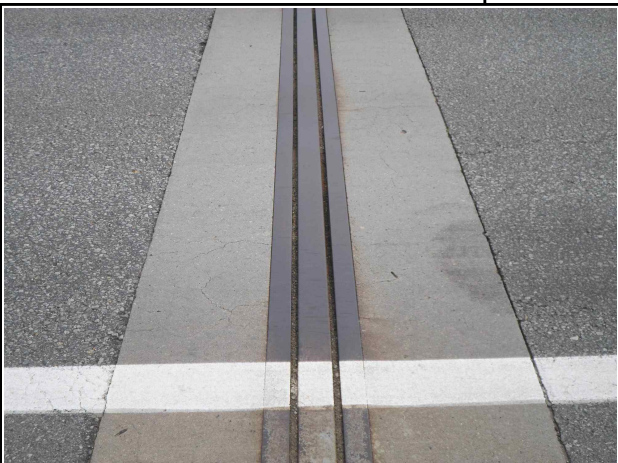
No. 24

| 위 치 | 신축이음 A2 |
| 내 용 | 후타재 망상균열 (0.4m × 0.6m) |

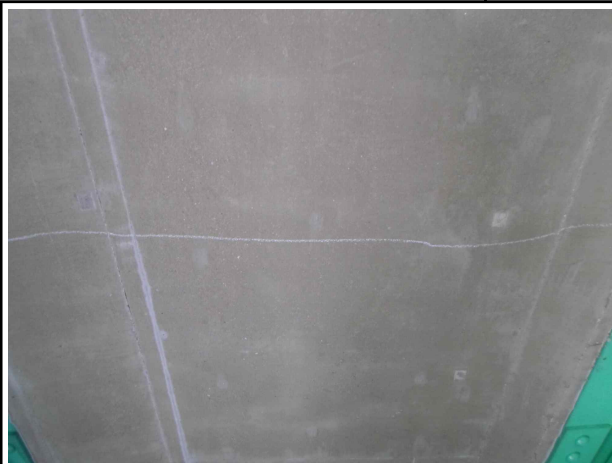
No. 25

| 위 치 | 바닥판 S1 |
| 내 용 | 균열 (cw:0.1mm, L=1.2m) |

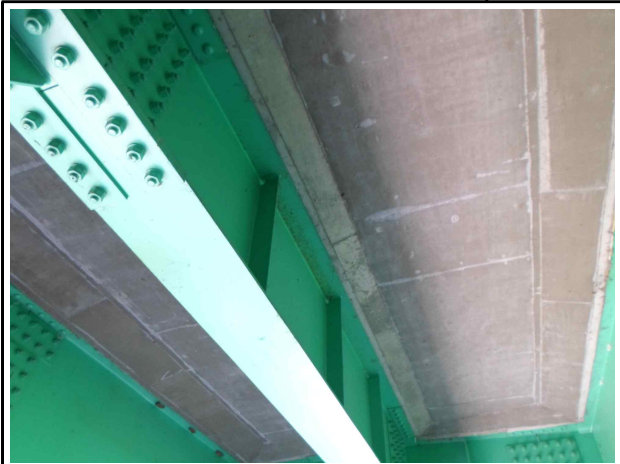
No. 26

| 위 치 | 바닥판 S4 |
| 내 용 | 상태양호 |

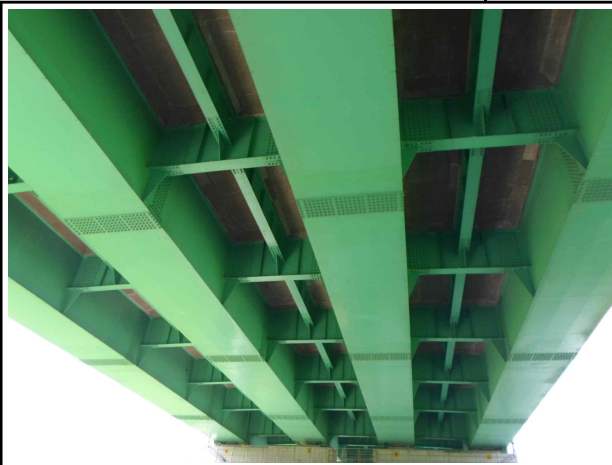
No. 27

| 위 치 | 거더외부 S7 |
| 내 용 | 상태양호 |

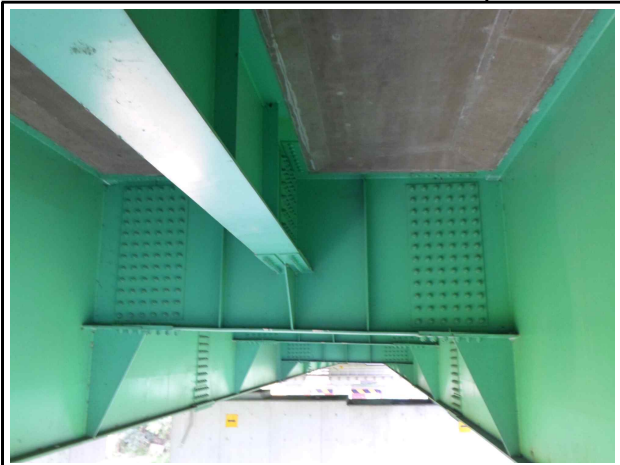
No. 28

| 위 치 | 가로보 S6 |
| 내 용 | 상태양호 |

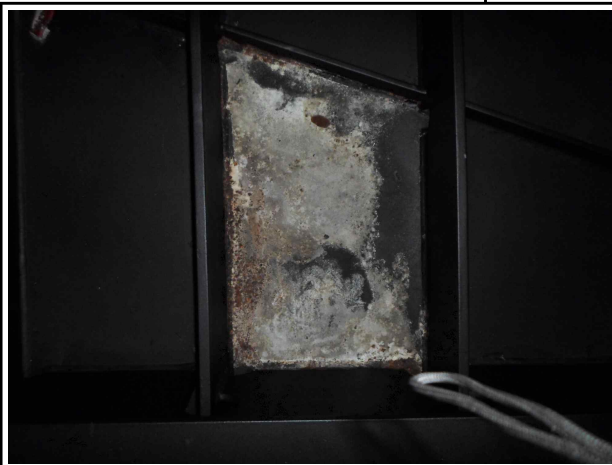
No. 29

| 위 치 | 거더내부 S1/G2 |
| 내 용 | 부식 (0.4m × 0.3m) |

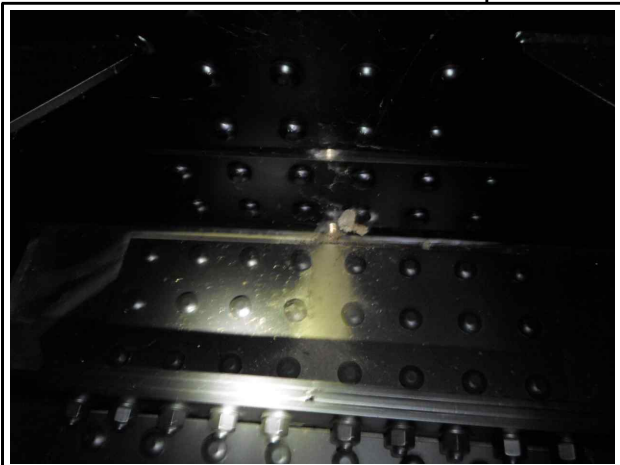
No. 30

| 위 치 | 거더내부 S1/G4 |
| 내 용 | 우수유입흔적 |

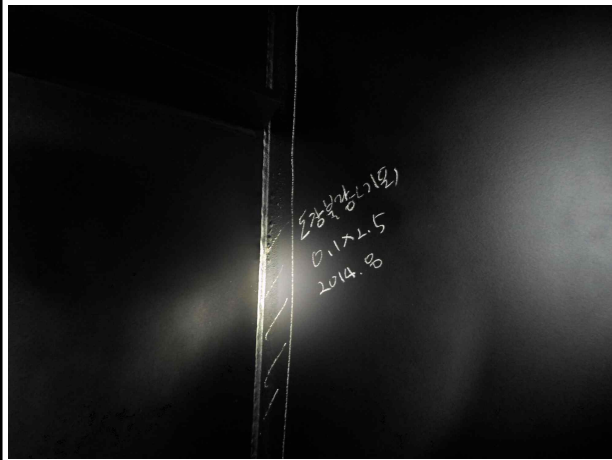
No. 31

| 위 치 | 거더내부 S2/G3 |
| 내 용 | 도장불량(0.1m × 2.5m) |

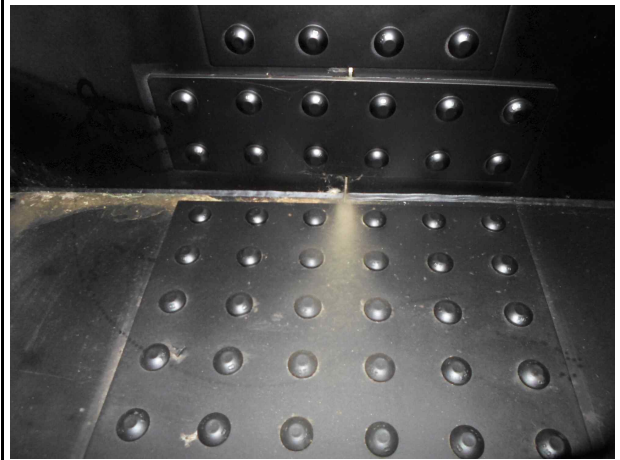
No. 32

| 위 치 | 거더내부 S3/G4 |
| 내 용 | 우수유입흔적 |

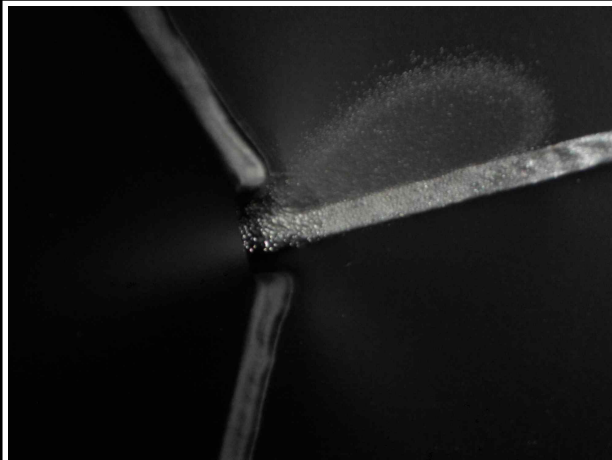
No. 33

| 위 치 | 거더내부 S4/G3 |
| 내 용 | 도장불량(0.2m × 0.2m) |

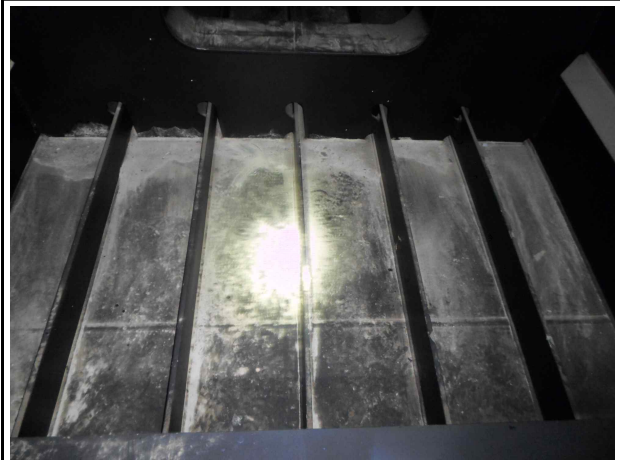
No. 34

| 위 치 | 거더내부 S5/G4 |
| 내 용 | 이물질퇴적(2.5m × 1.5m) |

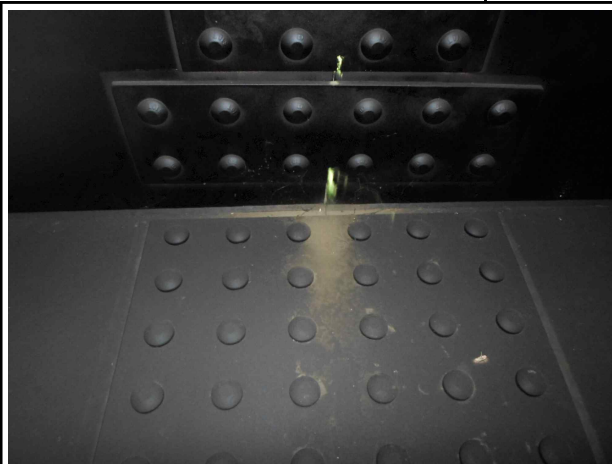
No. 35

| 위 치 | 거더내부 S9/G2 |
| 내 용 | 우수유입흔적 |

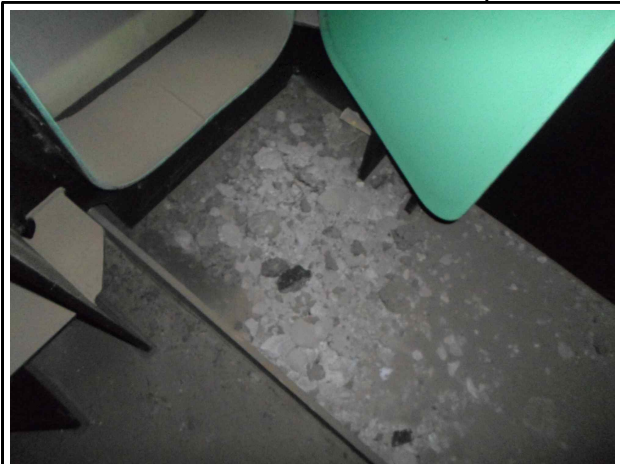
No. 36

| 위 치 | 거더내부 S9/G3 |
| 내 용 | 버력 콘크리트 퇴적(1.0m × 1.0m) |

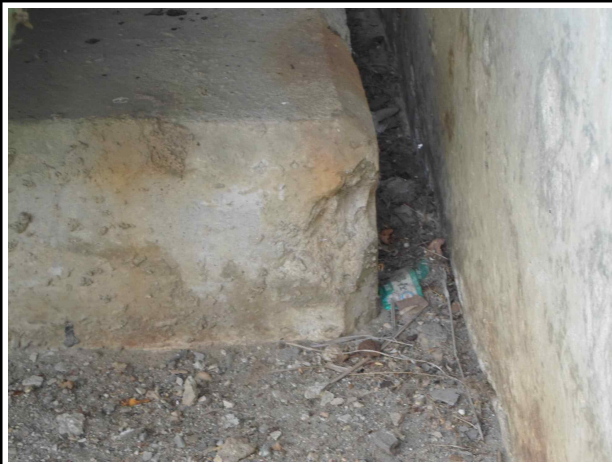
No. 37

| 위 치 | A1/SH1 |
| 내 용 | 반침콘크리트파손 (0.1m×0.1m) |

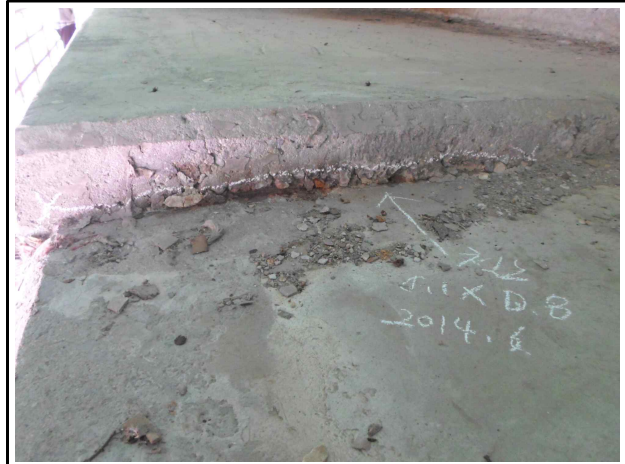
No. 38

| 위 치 | A2 교좌면 |
| 내 용 | 철근노출 (0.1m×0.8m) |

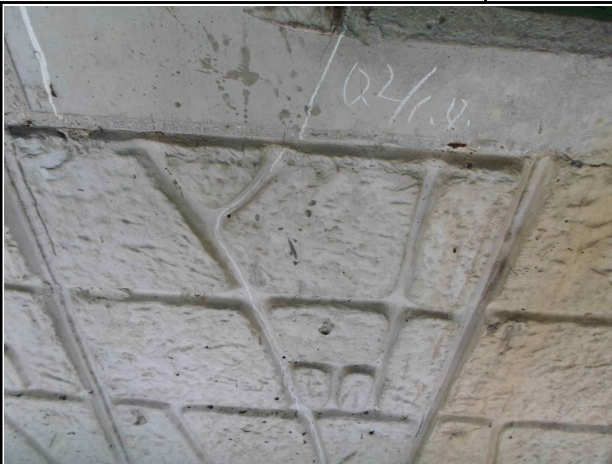
No. 39

| 위 치 | A2 전면 |
| 내 용 | 균열 (cw:0.2mm, L=1.0m) |

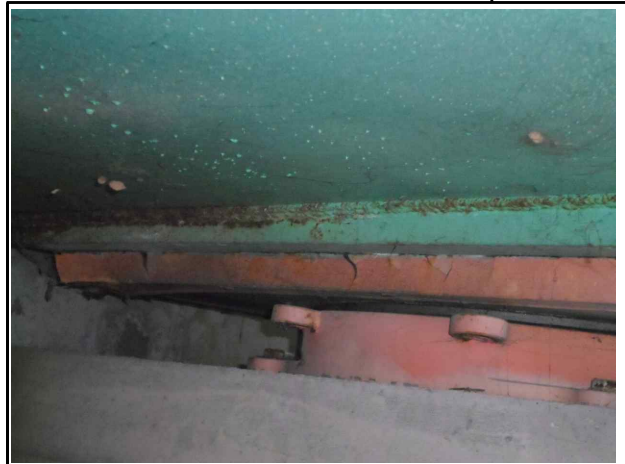
No. 40

| 위 치 | A2/SH2 |
| 내 용 | 용접부부식 (0.1m×0.6m) |

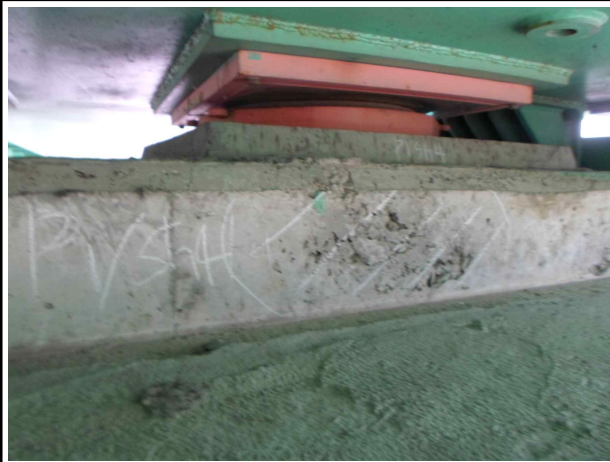
No. 41

| 위 치 | P1/SH4 |
| 내 용 | 받침콘크리트재료분리 (0.2m×0.1m) |

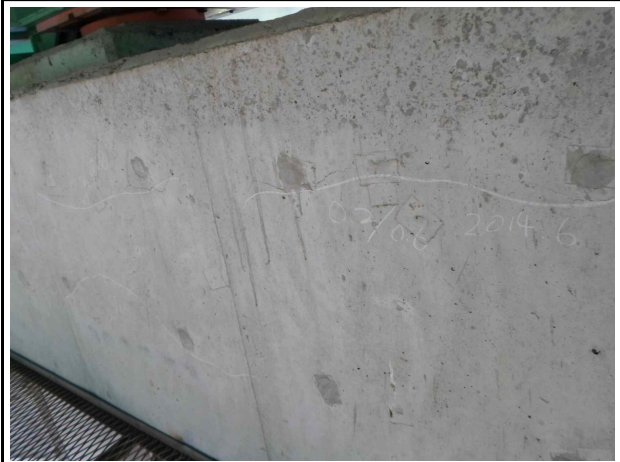
No. 42

| 위 치 | P1 코핑 |
| 내 용 | 균열 (cw:0.2mm, L=0.8m) |

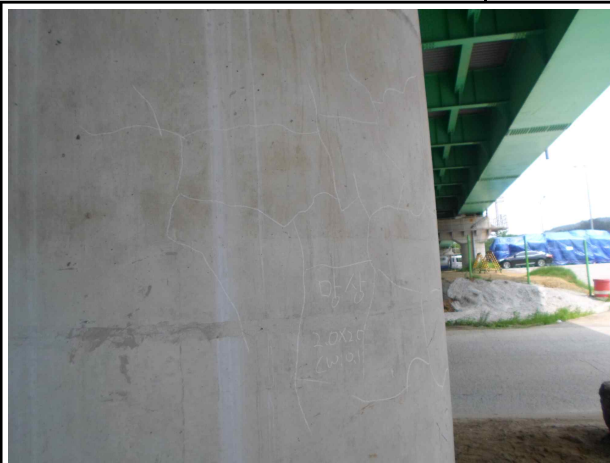
No. 43

| 위 치 | P2 기둥 |
| 내 용 | 망상균열 (2.0m×3.0m) |

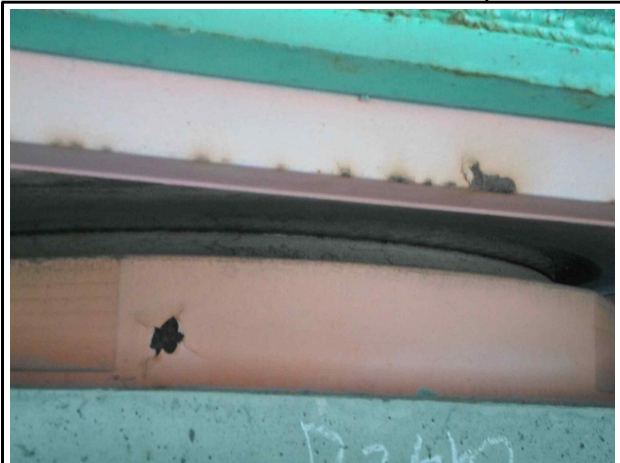
No. 44

| 위 치 | P2/SH2 |
| 내 용 | Plate 부식 |

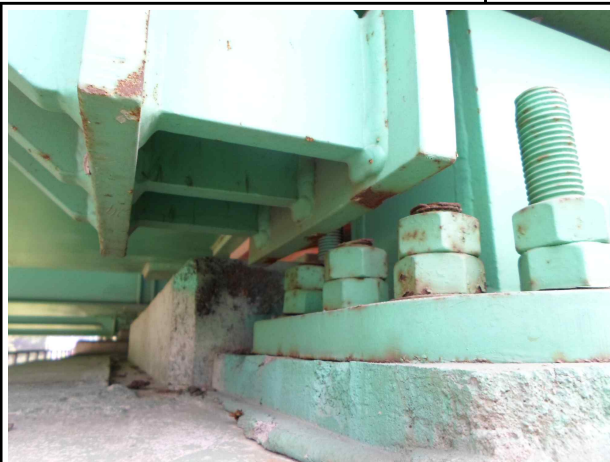
No. 45

| 위 치 | P3 이동제한장치 |
| 내 용 | 고정볼트와 상부판 접촉흔적 |

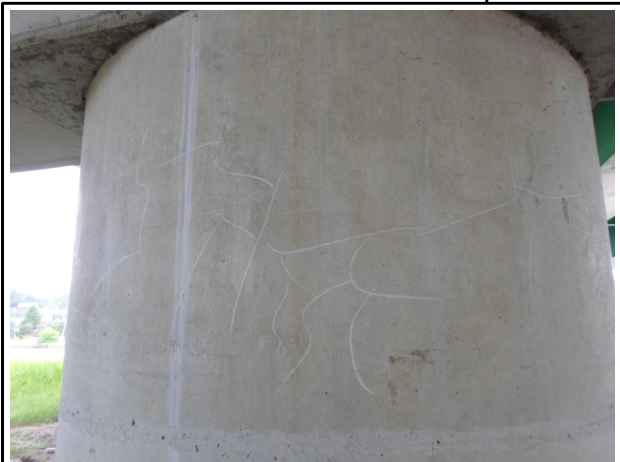
No. 46

| 위 치 | P3 기둥 |
| 내 용 | 망상균열 (1.0m×3.0m) |

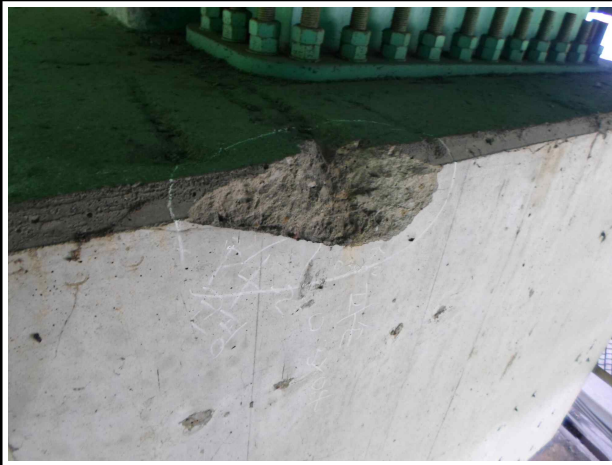
No. 47

| 위 치 | P4 코핑 |
| 내 용 | 파손 (0.3m × 0.4m) |

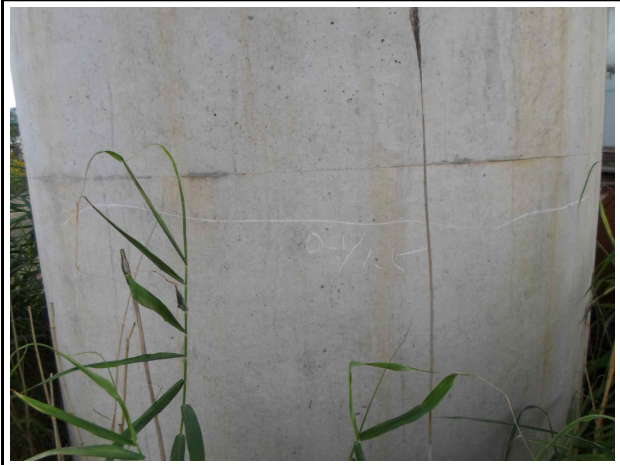
No. 48

| 위 치 | P5 기둥 |
| 내 용 | 균열 (cw:0.1mm, L=1.5m) |

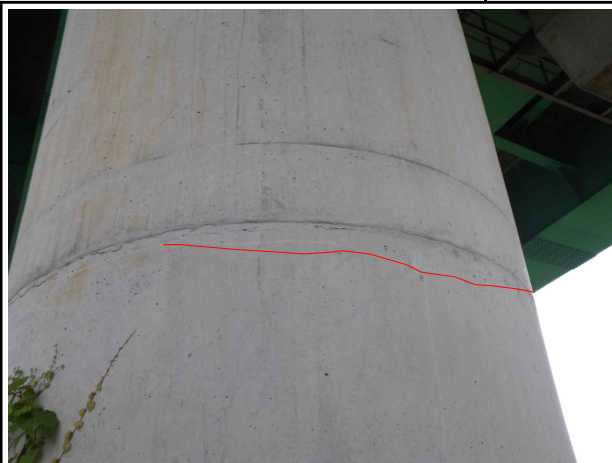
No. 49

| 위 치 | P6 기둥 |
| 내 용 | 균열 (cw:0.3mm, L=3.0m) |

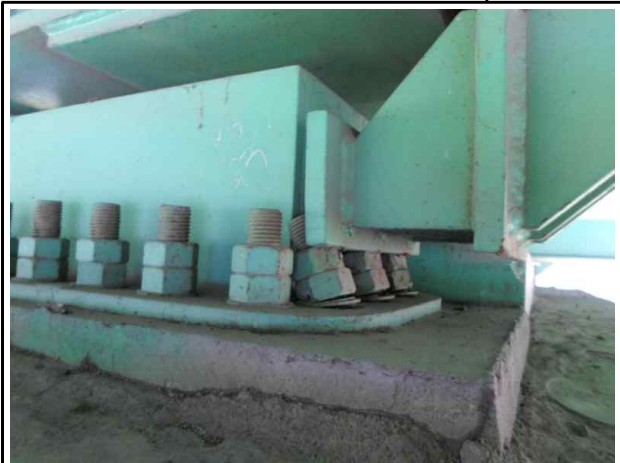
No. 50

| 위 치 | P6 이동제한장치 |
| 내 용 | 고정볼트손상 |

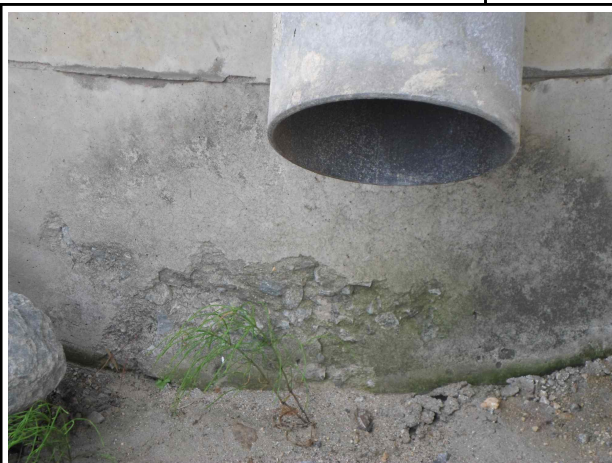
No. 51

| 위 치 | P7 기둥 |
| 내 용 | 파손 (0.2m × 0.2m) |

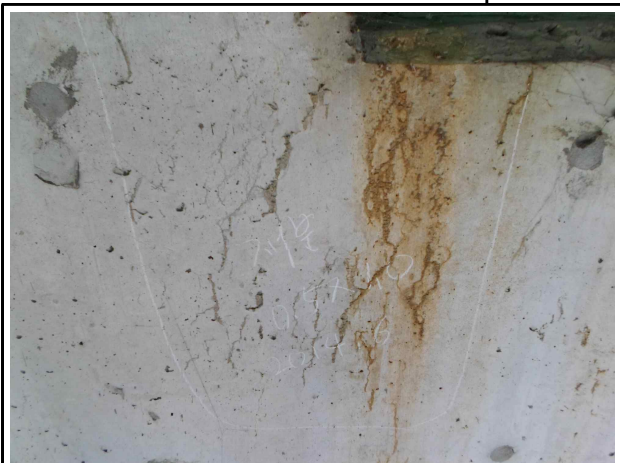
No. 52

| 위 치 | P8 코핑 |
| 내 용 | 재료분리 (0.5m × 1.0m) |
