## 7. 청도IC 1교

Project Title  
2017년 상반기 시설물 정기점검 용역

Drawing Title  
청도IC-1교 (상,하행선) 평면도, 종·횡단면도

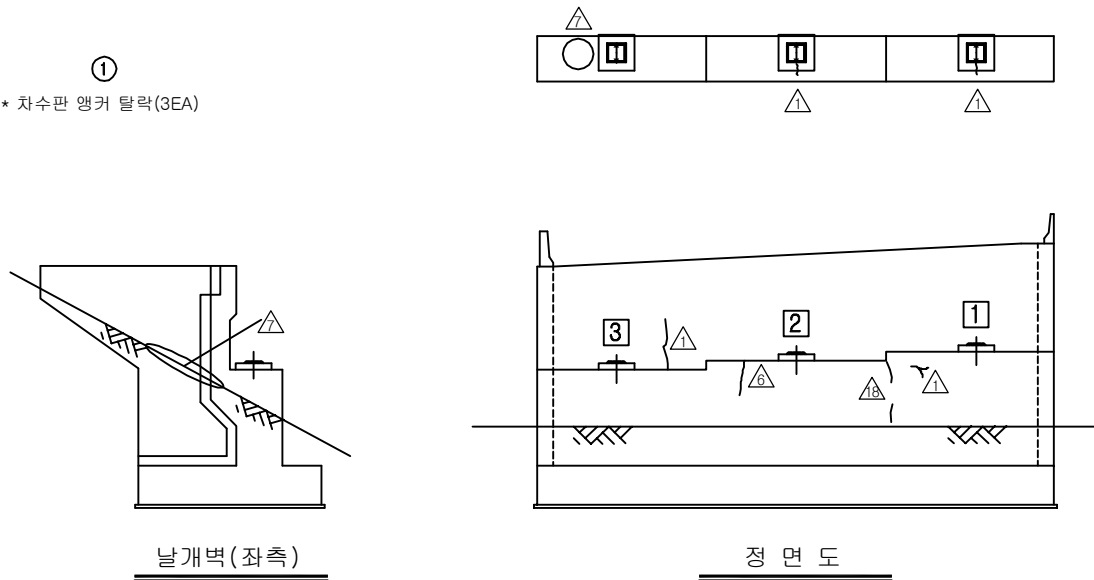
①  
\* 차수판 앵커 탈락(3EA)

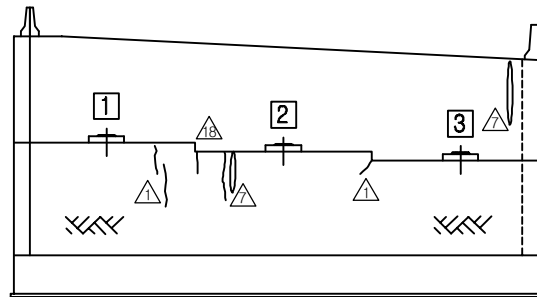
\* 차수판 앵커 탈락(3EA)
