**2017년 상반기 시설물 정기점검 용역**  
**정 기 점 검 사 진 첵**  
**[2종 절토사면 손상현황 사진첩]**

**2017. 06.**

**新 대구부산고속도로주식회사**  
**New DAEGU BUSAN Expressway Co., Ltd.**

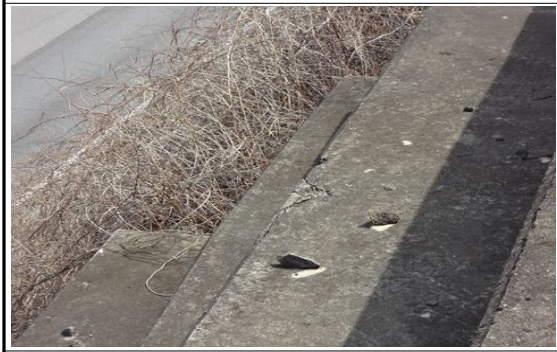
| 부산절토 5 (부산기점 21.92~22.28Km / 9공구 10+620~10+980) | |
|---|---|
| 22.04K 1단 계단식옹벽 손상 | 22.10K 2단 백태 |

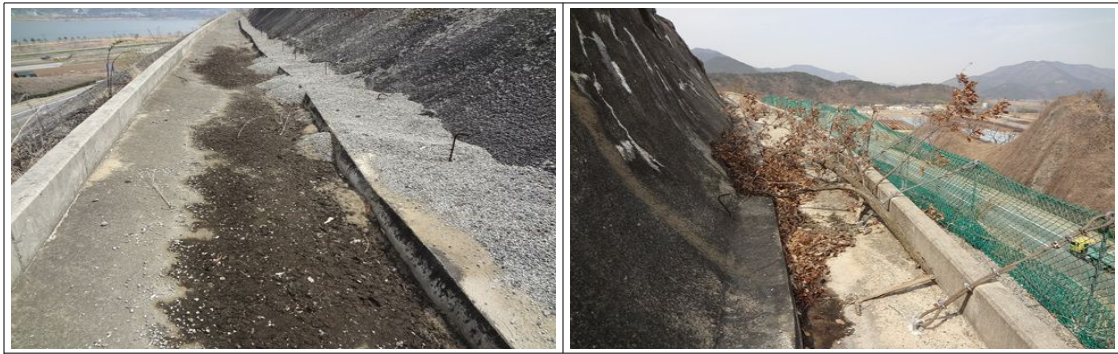
22.13K 1단 토사퇴적, 폐목적치

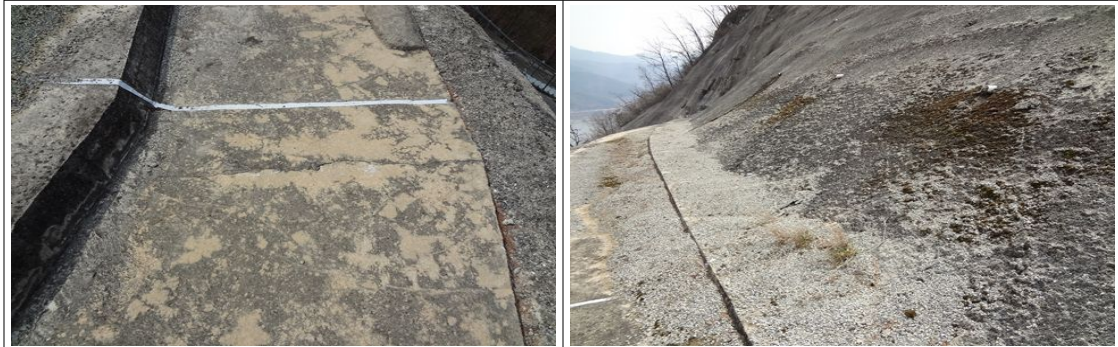
22.16K 3소단배수로 균열 0.5

22.16K 4단 콘크리트 들뜸

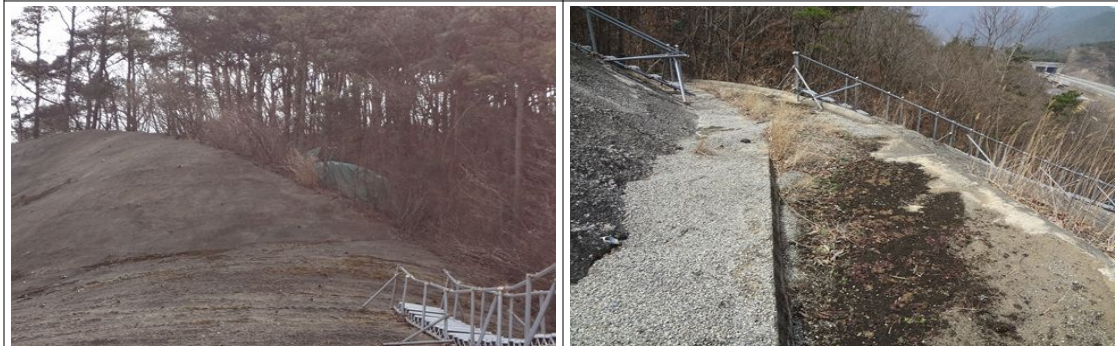
22.17K 4단 점검계단 연장요망

22.18K 2소단배수로 토사퇴적

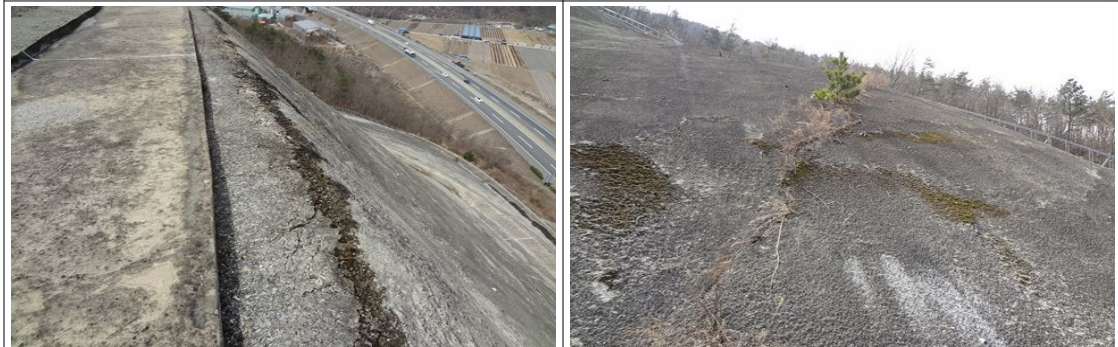
22.18K 3단 숏크리트 들뜸

22.21K 2단 콘크리트 균열

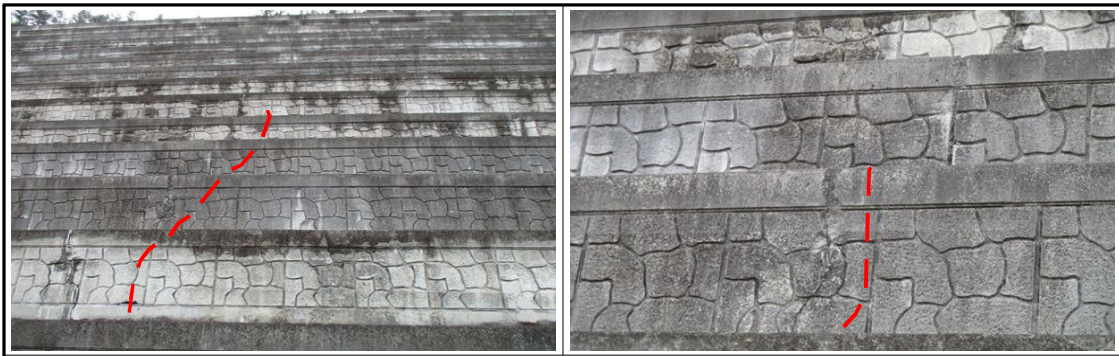
30.96K 1단 계단식옹벽 균열 및 파손

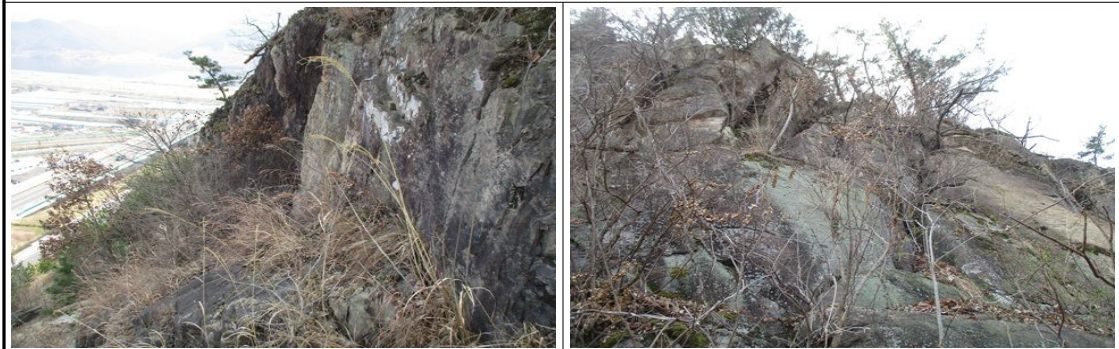
30.99K 자연사면 암괴

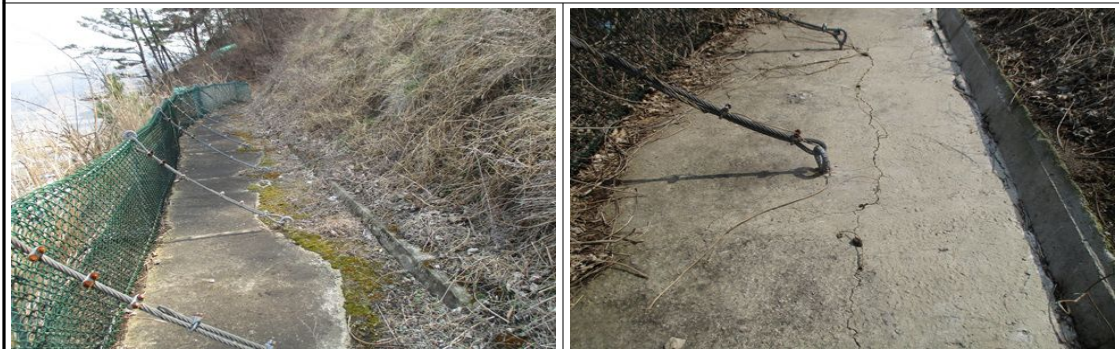
31.00K~31.04K 3소단배수로 토사퇴적

31.00K~31.08K 3소단배수로 종균열

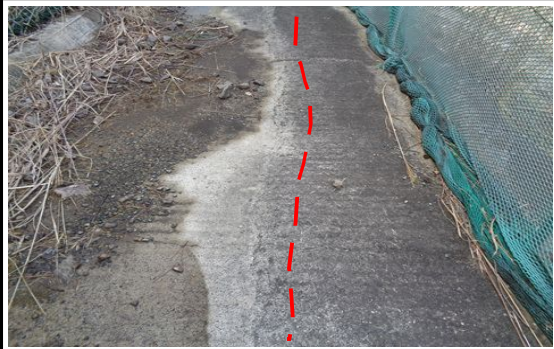
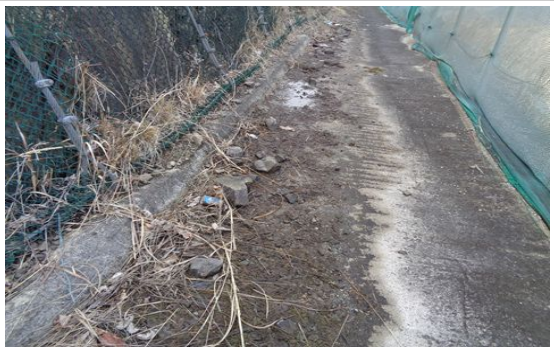
| 부산절토 8 (부산기점 31.16~31.36Km / 9공구 STA.1+540~1+740) | |
|---|---|
| 31.18K 1소단배수로 균열 | 31.20K 1소단배수로 낙석 및 토사퇴적 |

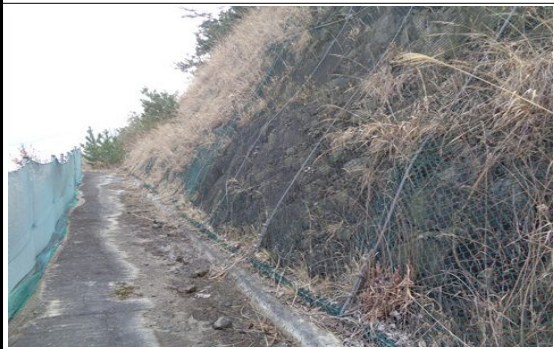
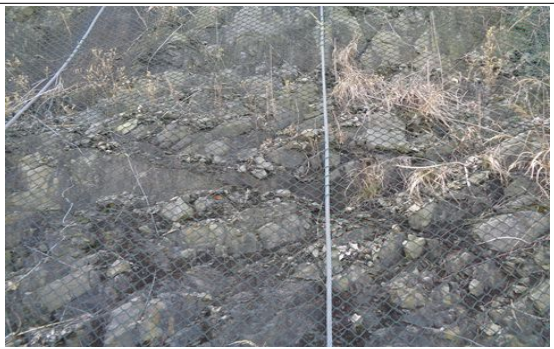
| 부산절토 8 (부산기점 31.16~31.36Km / 9공구 STA.1+540~1+740) | |
|---|---|
| 31.20K 2단 낙석위험 | |

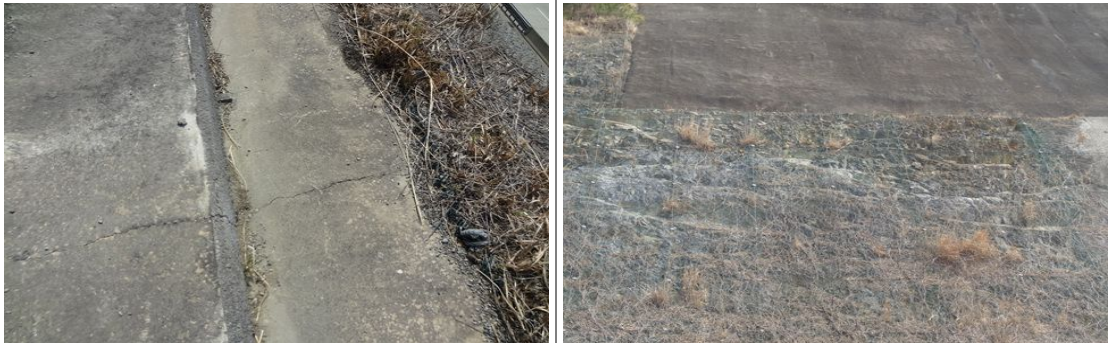
| 46.67K 1소단배수로 균열 | 46.69K 1단 절리 및 이완암 |

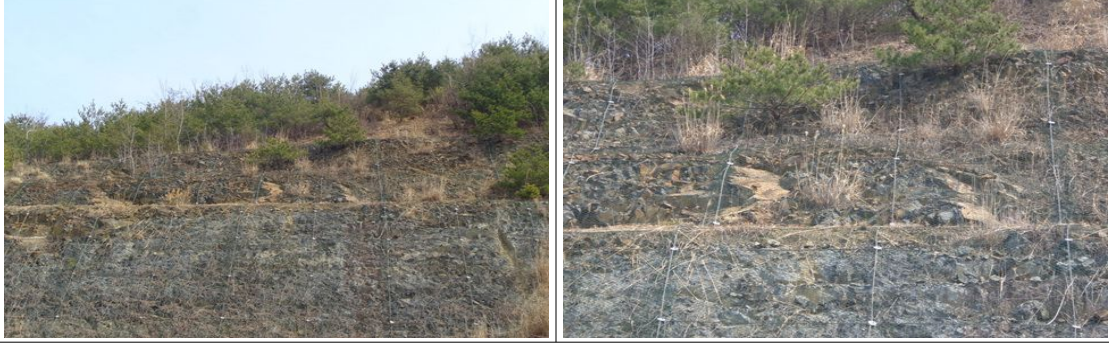
| 46.70~46.75K 2단 심한풍화 및 이완암 | |

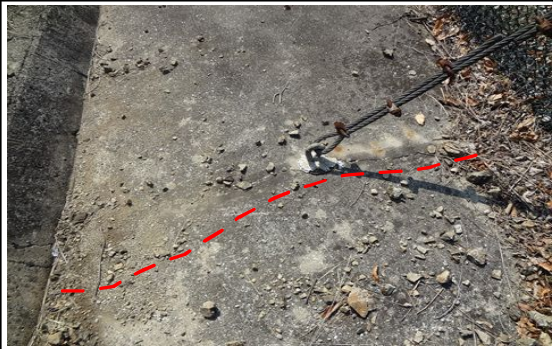
| 59.51K 3소단배수로 균열 0.5 | 59.53K 2소단배수로 체수 |

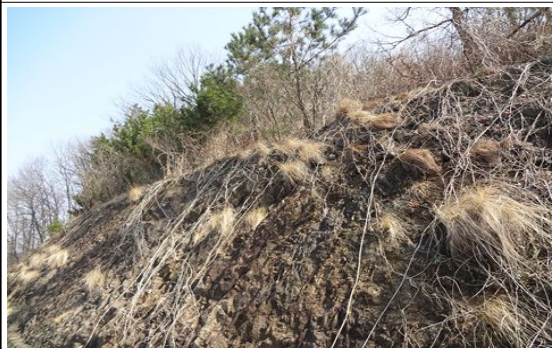
| 59.49K 4단 이완암, 퇴적 | |

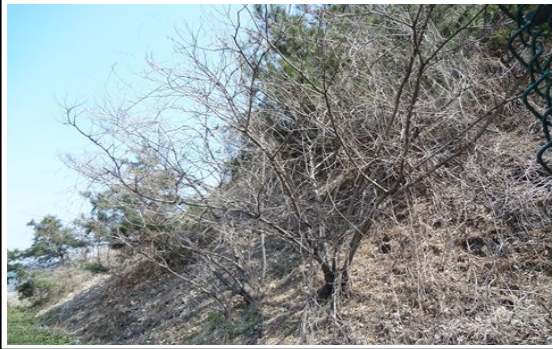
| 59.59K 1단 수목 | 59.55K 2단 수목 |

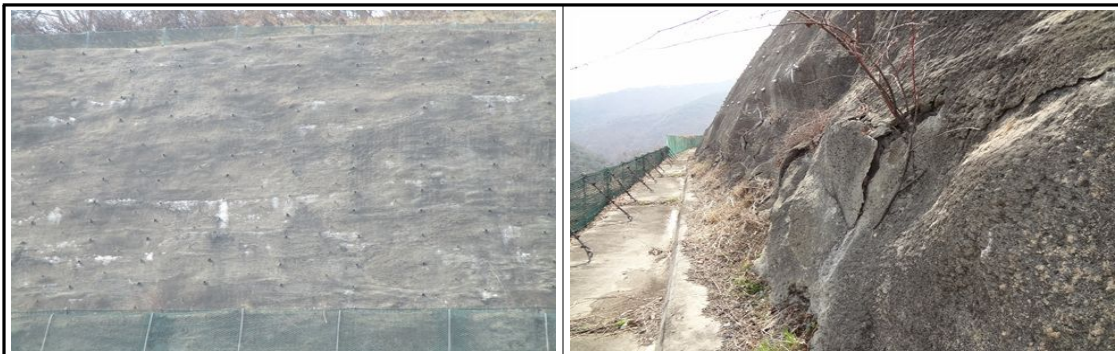
70.84K 3단 숏크리트 들뜸, 탈락

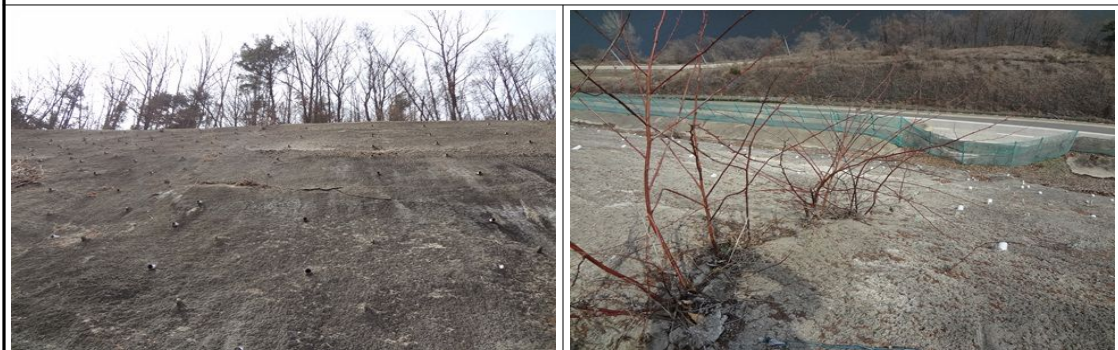
70.88K 4단 숏크리트 균열

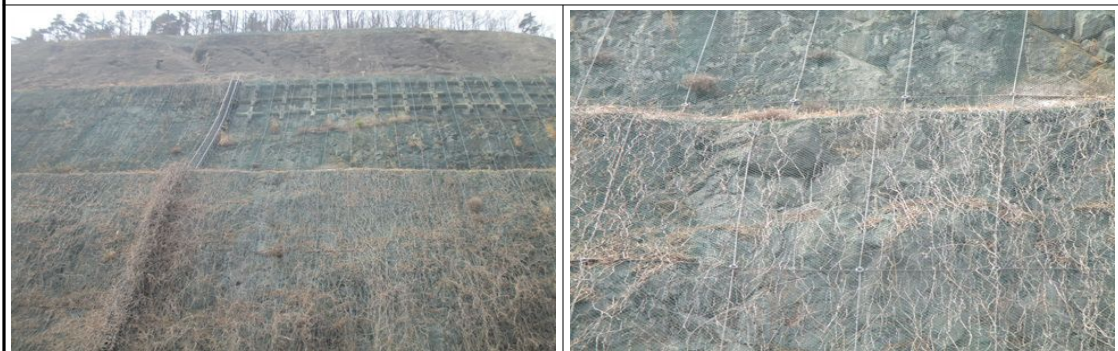
70.90K 1단 이완암

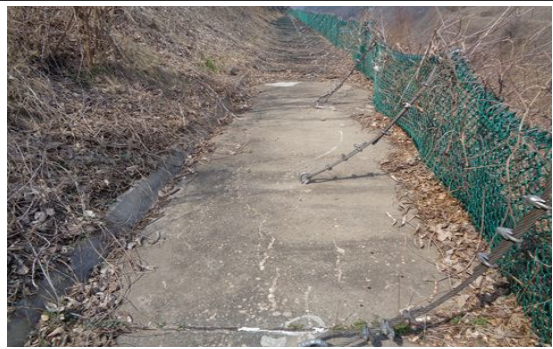
71.60K 1소단배수로 균열 0.3

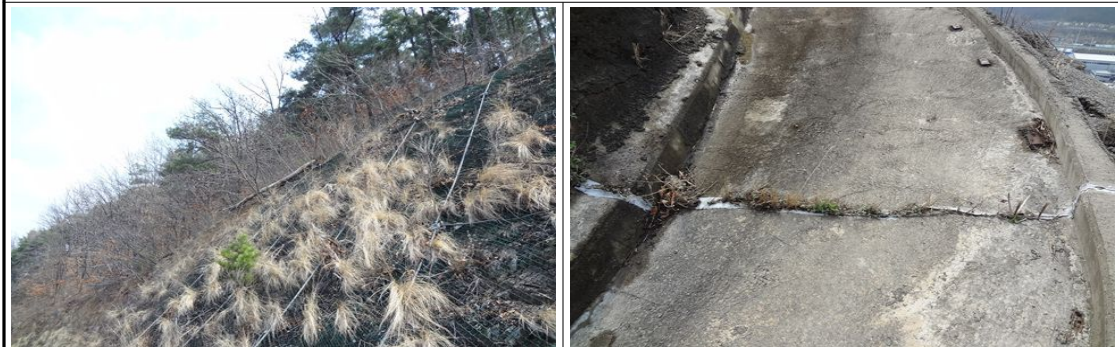
76.41K 자연사면 폐목적치

76.43K 1소단배수로 균열

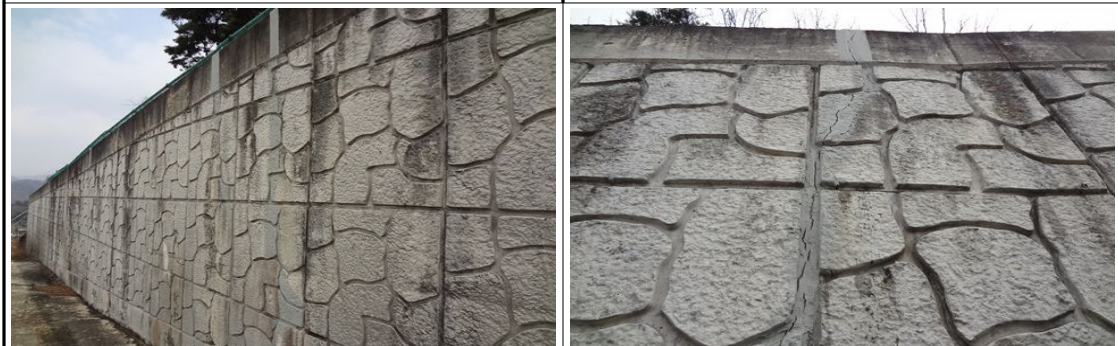
76.42~76.55K 3단 옹벽 재균열

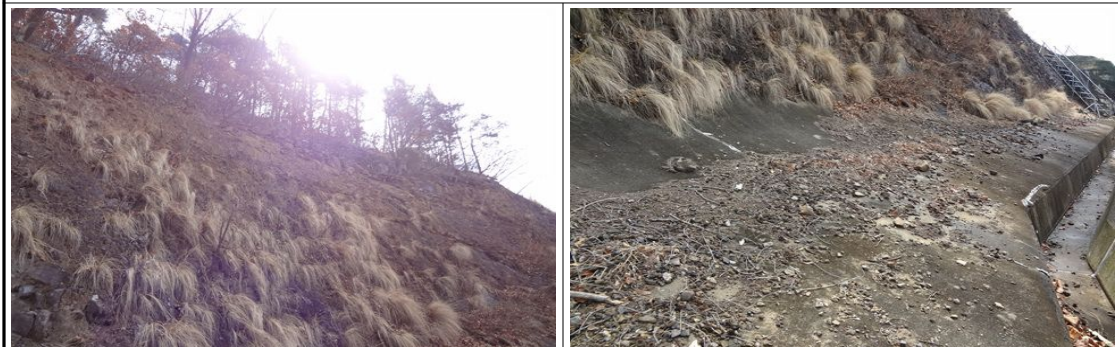
76.44K 자연사면 표층유실

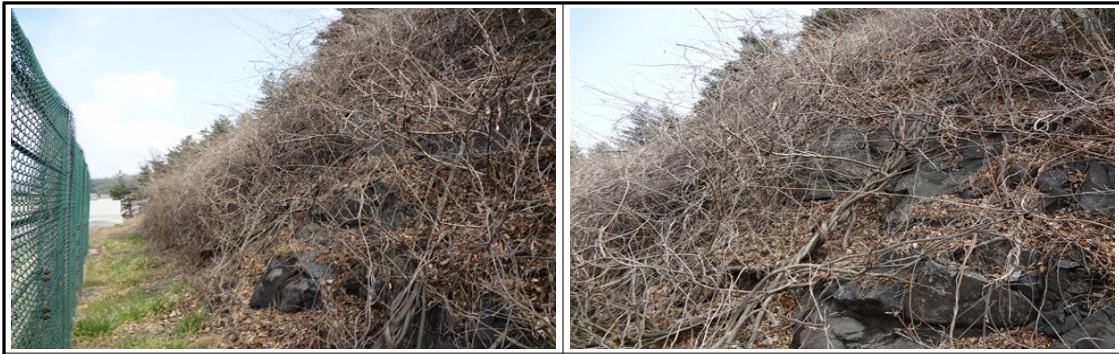
76.60K 1단 이완암

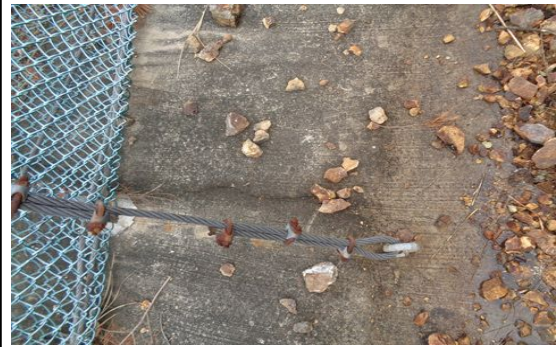
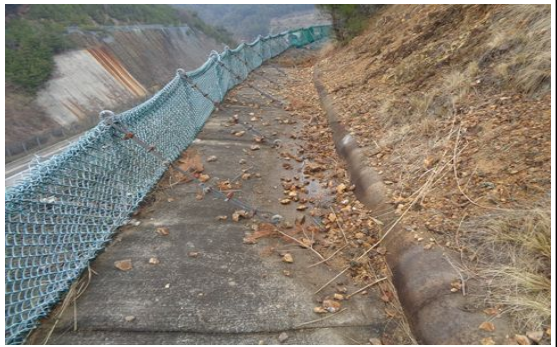
| 대구절토 21 (부산기점 77.99~78.37km / 3공구 STA.12+880~13+260) | |
|---|---|
| 78.11K 1소단배수로 균열 1.0 | 78.11K 1소단배수로 체수 |

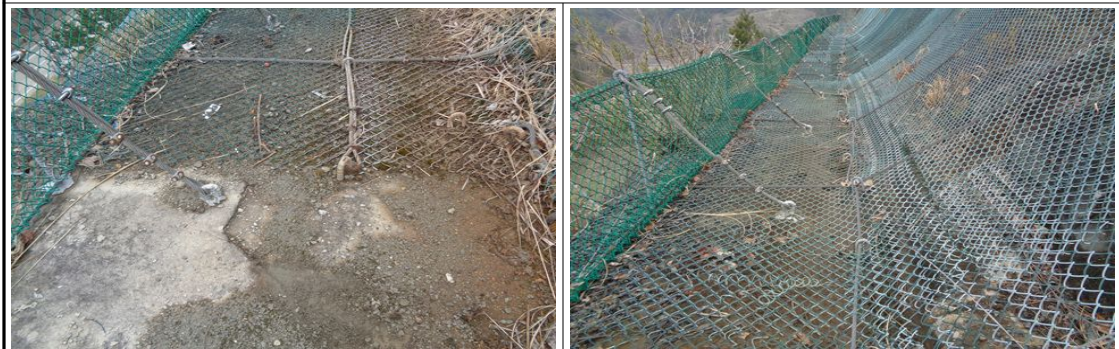
78.19K 1소단배수로 균열 1.0

78.21~78.25K 1소단배수로 토사퇴적

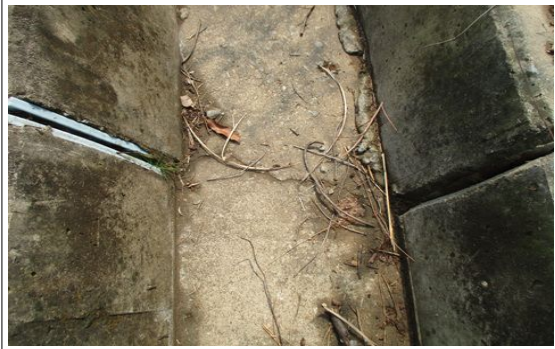
12.83K 산마루측구 균열 0.3

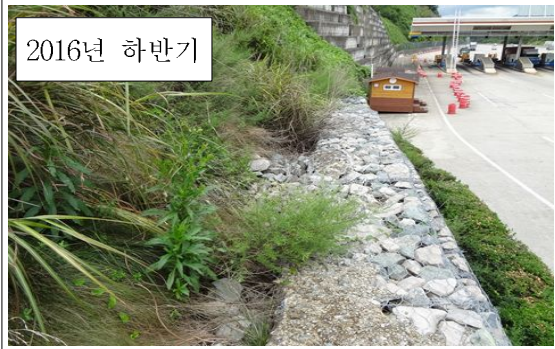
12.81K 1단 개비온 배면 표층유실

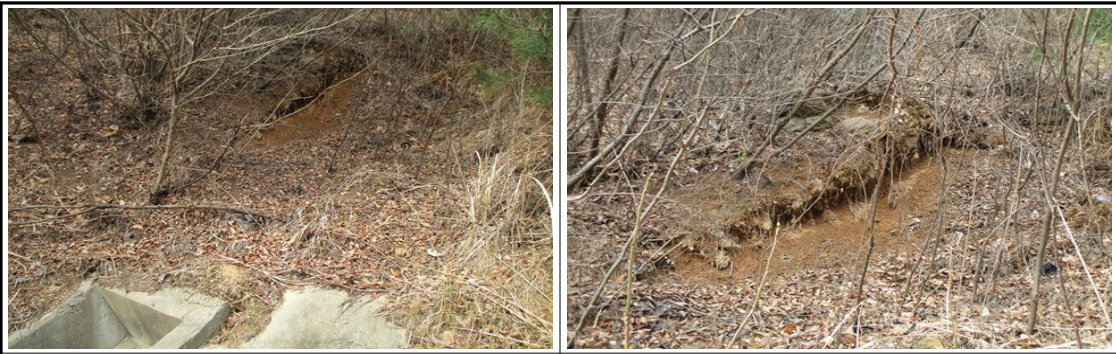
19.39K 자연사면 표층유실

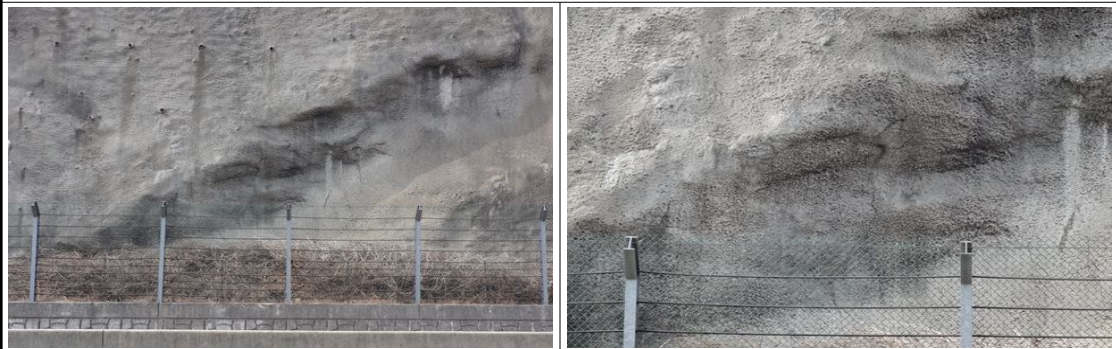
19.44K 1단 슛크리트 균열

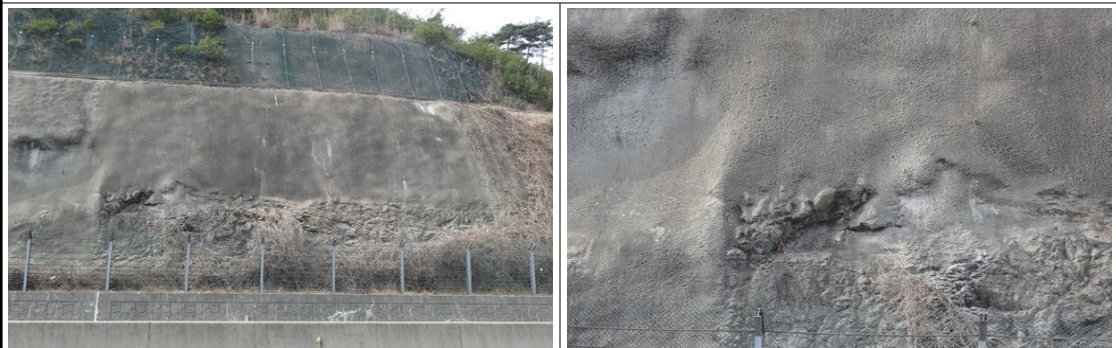
19.47K 1단 이완암

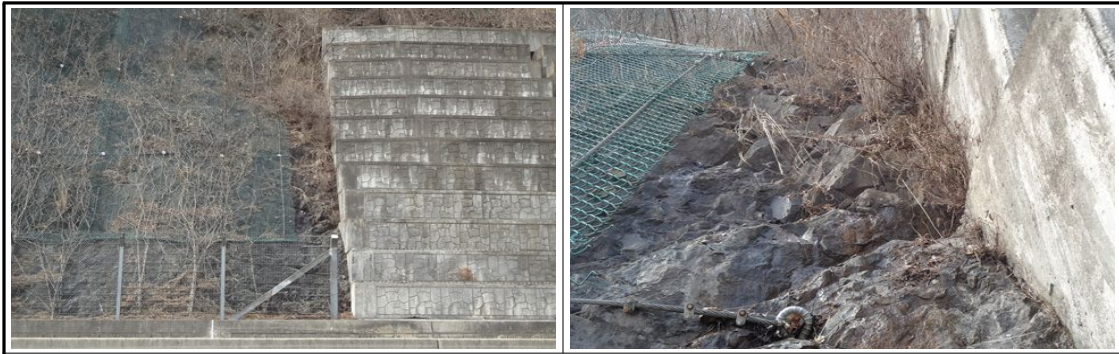
21.12K 1단 이완암

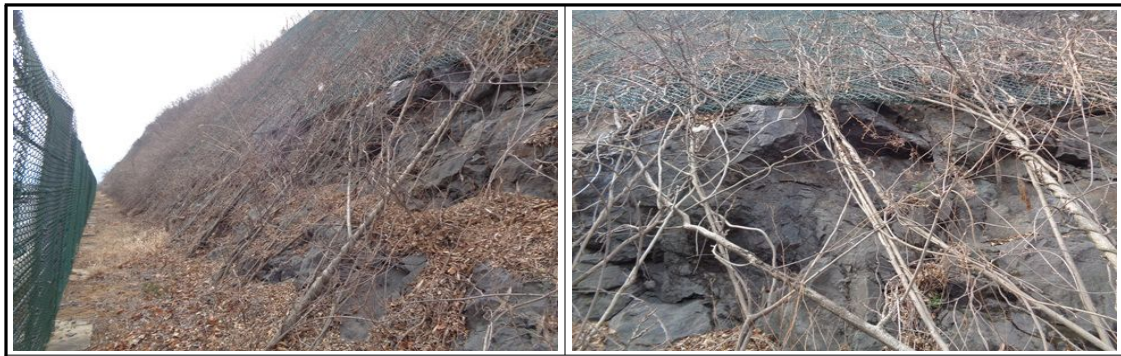
21.30K 1단 절리부 누수

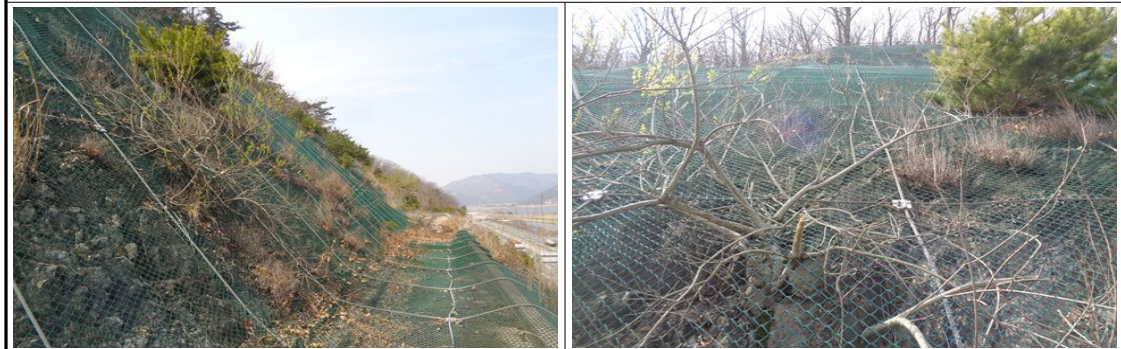
21.30K 2단 이완암 및 수목

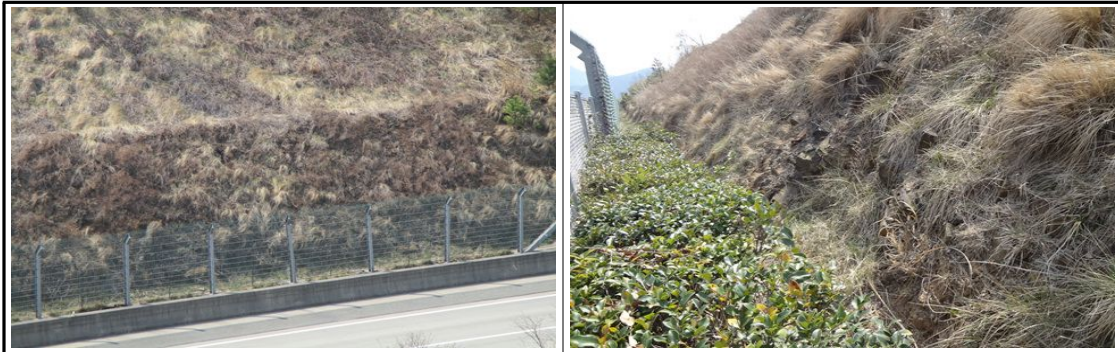
54.48K 1단 뜯돌

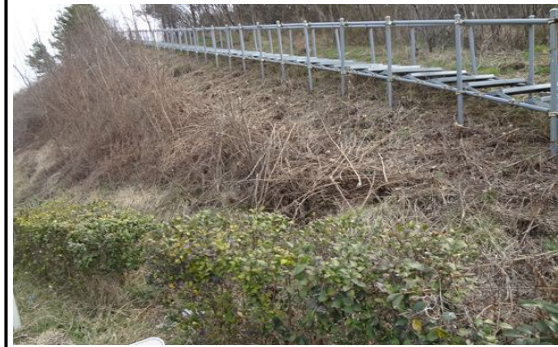
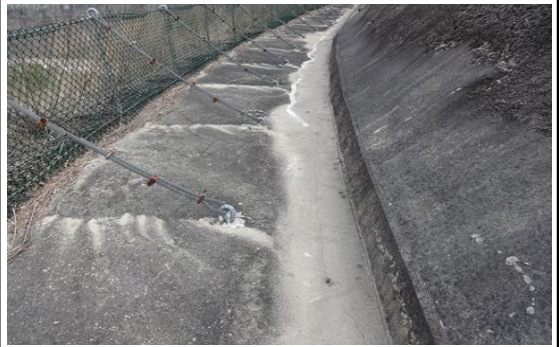
| 대구절토 41 (청도IC Ramp-G, F / 5공구 STA.청도IC Ramp-G, F) | |
|---|---|
| STA.0+180 1단 심한침화 및 유실 | STA.0+260 1소단배수로 종균열 |

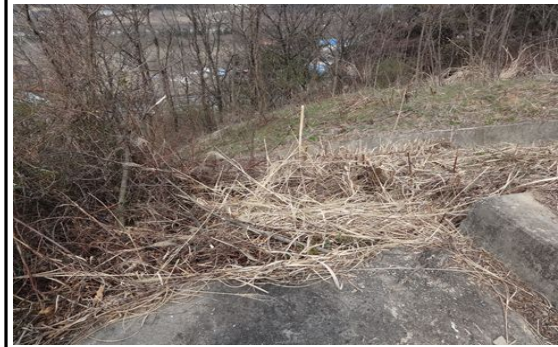
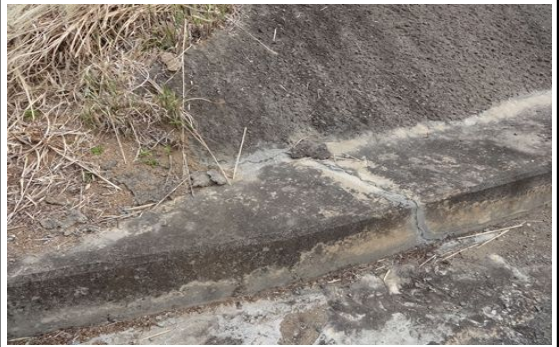
| 대구절토 41 (청도IC Ramp-G, F / 5공구 STA.청도IC Ramp-G, F) | |
|---|---|
| STA.0+580 1소단배수로~산마루측구 연결불량 | STA.0+580 2단 숯크리트 파손 |

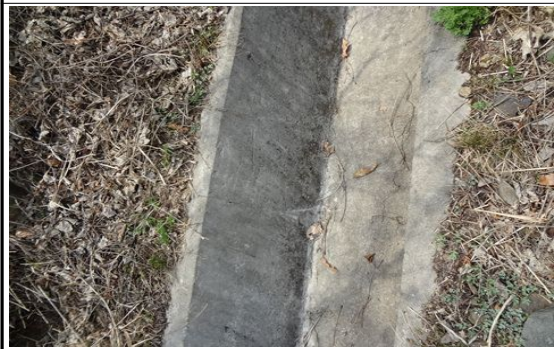
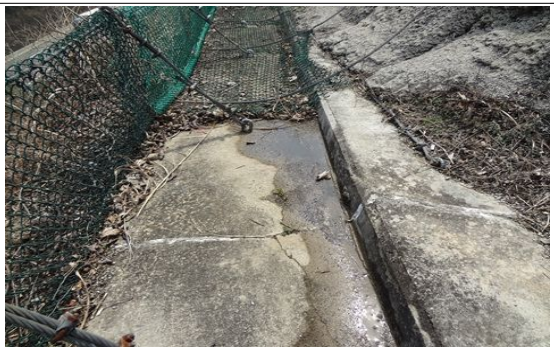
| 부산절토 43 (부산기점 70.57~70.77Km / 4공구 STA.5+690~5+890) | |
|---|---|
| 70.68K 산마루측구 균열 | 70.72K 1소단배수로 균열 |

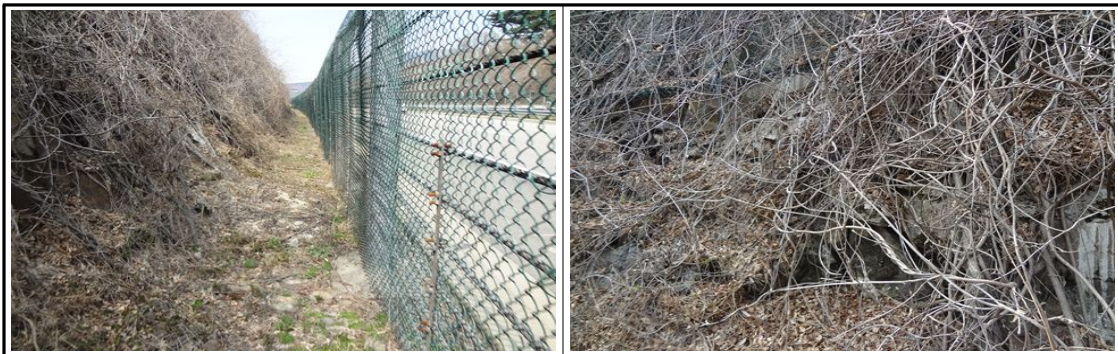
70.72K 1단 이완암

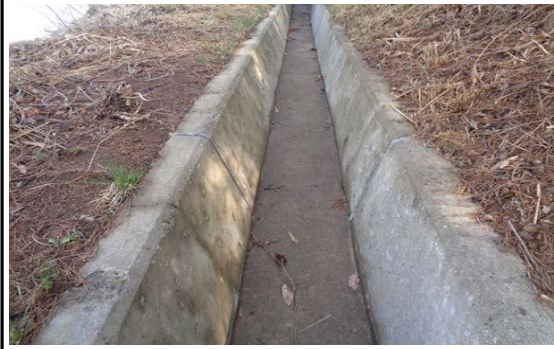
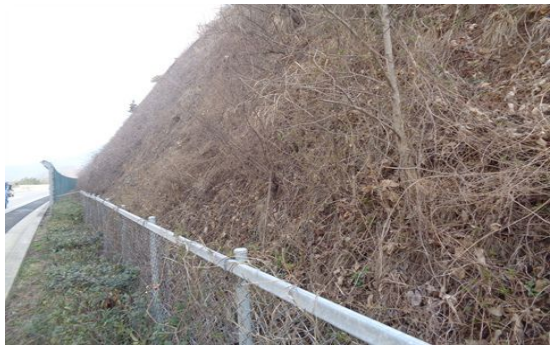
| 대구절토 46 (부산기점 77.09~77.31Km / 3공구 STA.13+940~14+160) | |
|---|---|
| 77.11K 산마루측구 균열 1.0 | 77.12K 1단 이완암 |

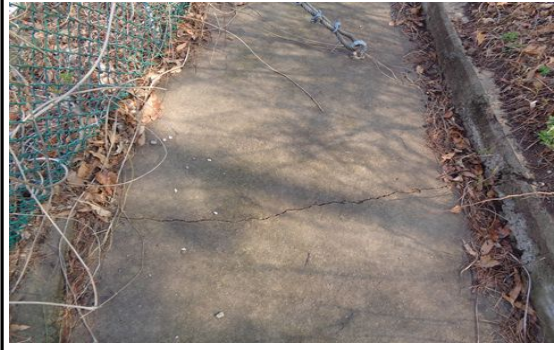
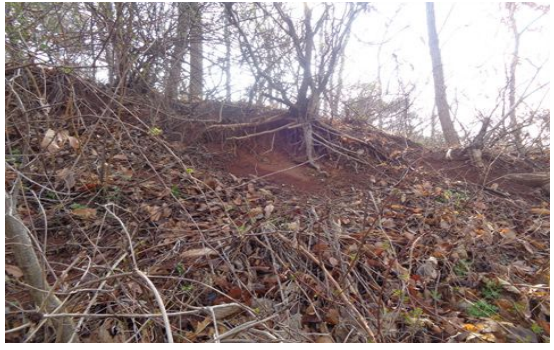
| 대구절토 46 (부산기점 77.09~77.31Km / 3공구 STA.13+940~14+160) | |
|---|---|
| 77.14K 1소단배수로 종균열 | 77.16K 2단 표층유실 및 수목전도 위험 |

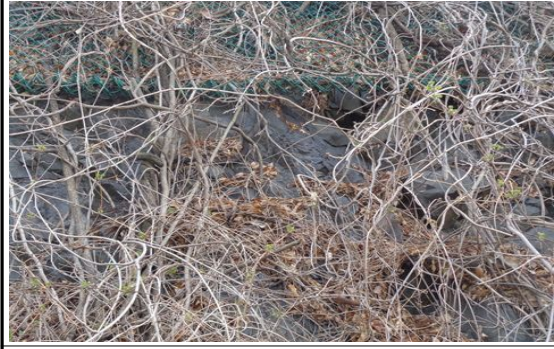
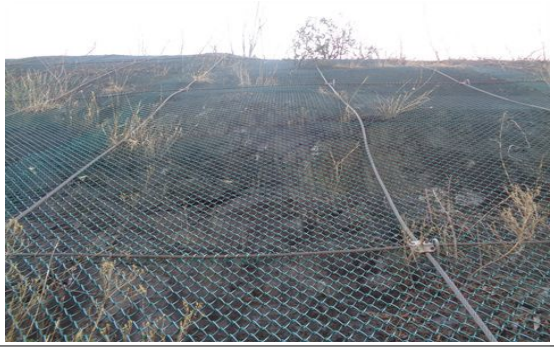
| 대구절토 46 (부산기점 77.09~77.31Km / 3공구 STA.13+940~14+160) | |
|---|---|
| 대구절토46 77.17K 1단 누수 | 77.21K 2단 절리 및 이완암 |

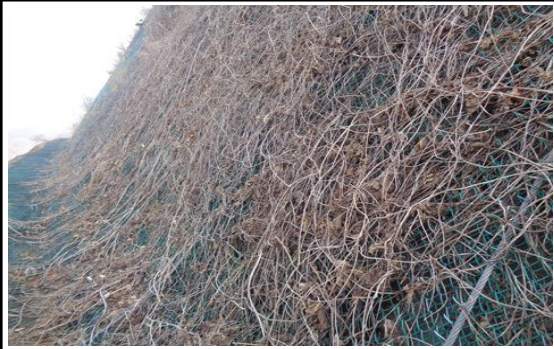
| 77.20K 1~2단 점토충전물 유실 | |

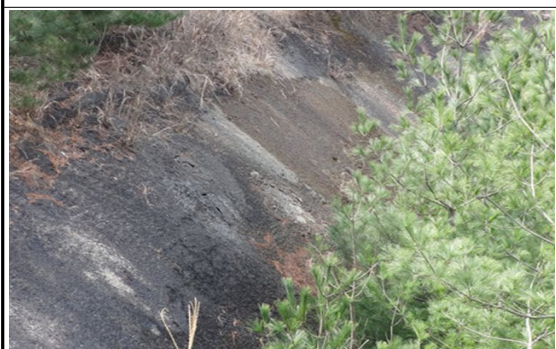
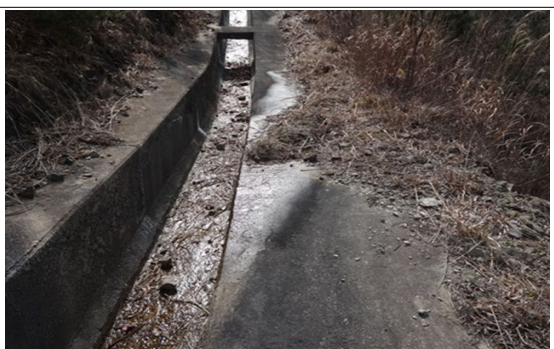
| STA.0+090 1단 숯크리트 파손 및 들뜸 | STA.0+090 2단 누수 |

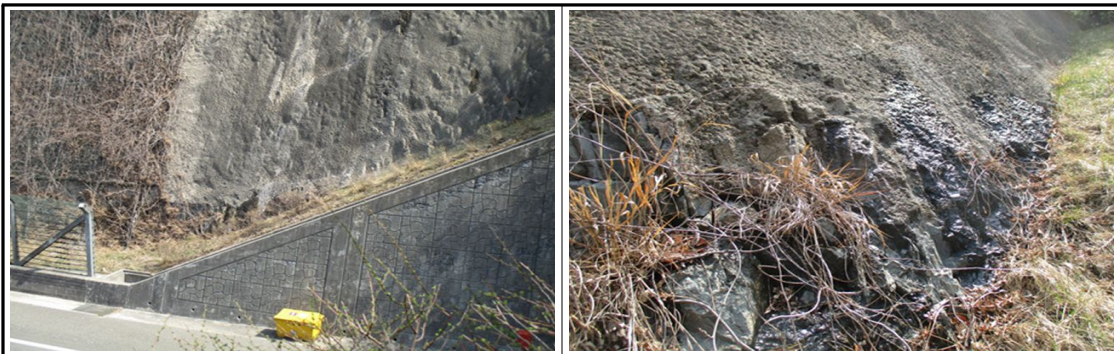
STA.0+040 1단 누수

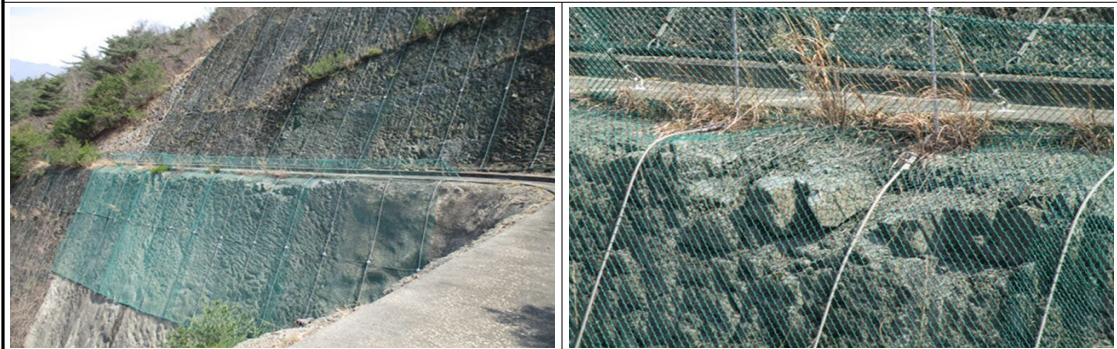
STA.0+040 낙석 위험

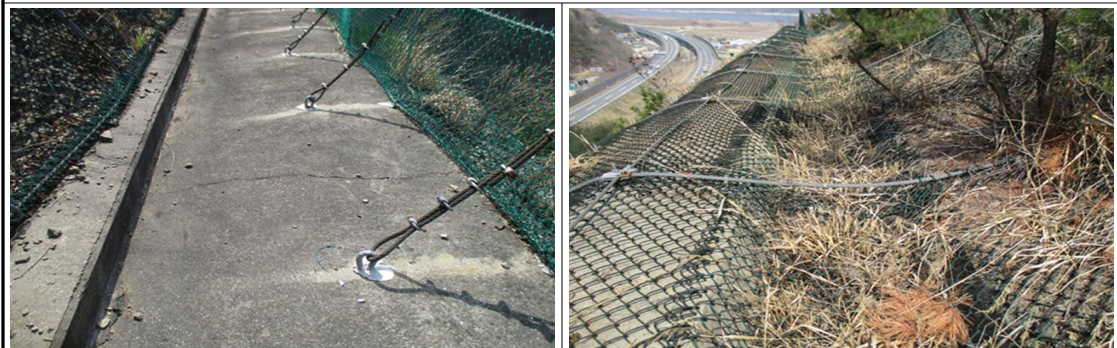
STA.0+050 1소단배수로 균열

STA.0+050 배수로 토사퇴적

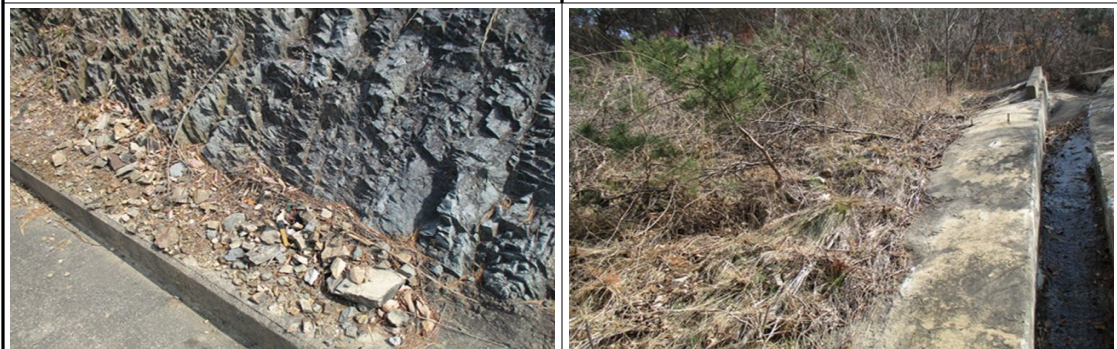
STA.0+065 2단 뜯돌

STA.0+095 1단 표층유실

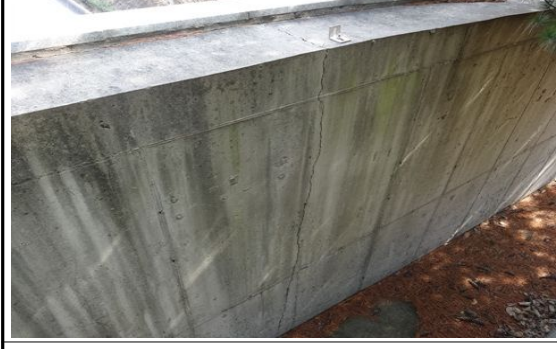
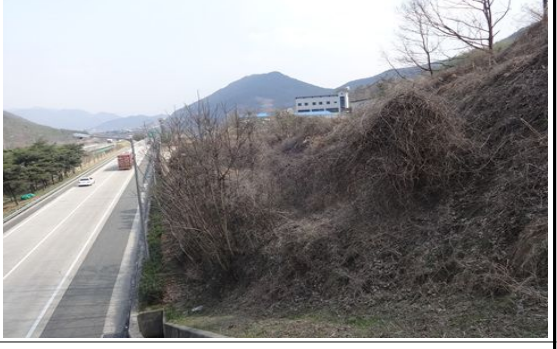
| 대구절토 61 (부산기점 33.27Km / 8공구 STA.9+125) | |
|---|---|
| STA.0-10 갯문배면배수로 균열 | STA.23+060 좌측사면 1단 수목 |

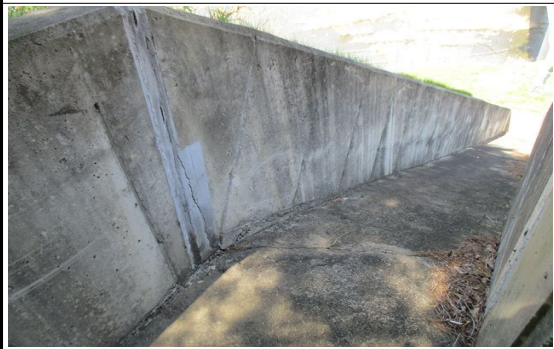
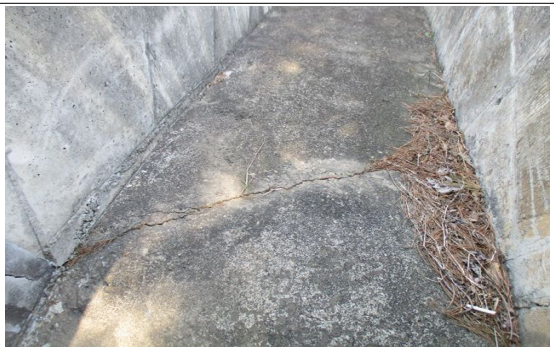
| STA.0+20 배수로 균열 | |

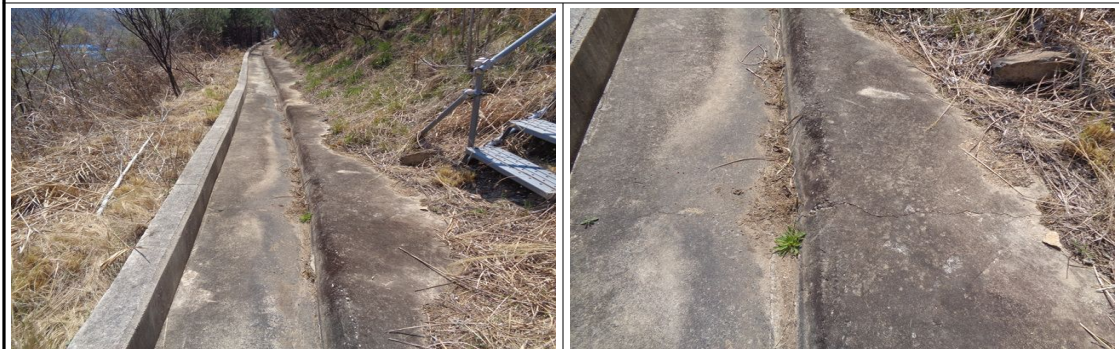
STA.38+550 1소단배수로 균열 (0.5)

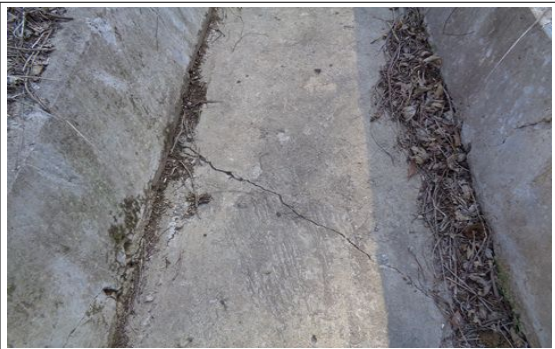
| STA.0-25 산마루측구 균열 | STA.0-30 산마루측구 균열 |

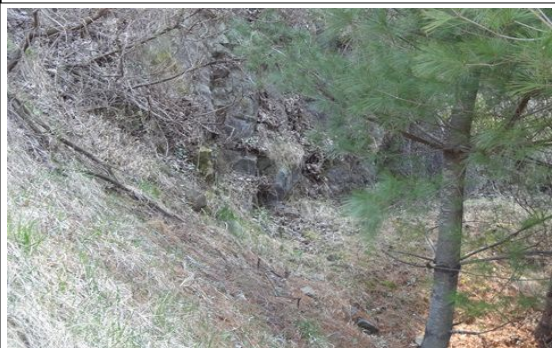
| STA.0-18 1소단배수로 파손 | STA.0-20 1단 암반노출 |
