## 22. 회룡터널 토공노반(G57)

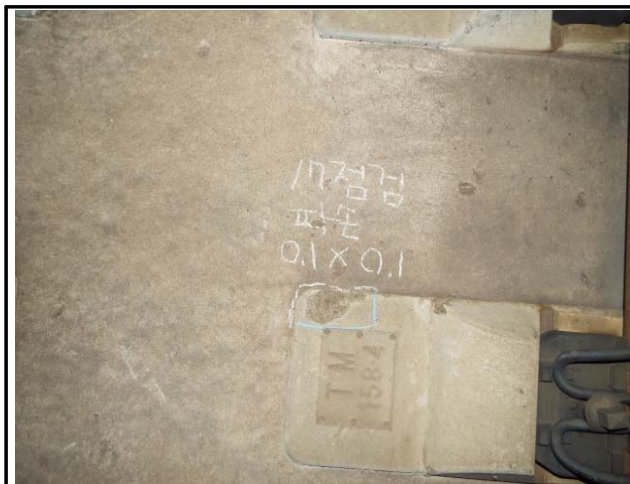
| 위치 | STA. 122K160-170 | 선별 | T1 | 위치 | TCL |

| 내용 | 파손 | A= 0.1x0.1 | | | |

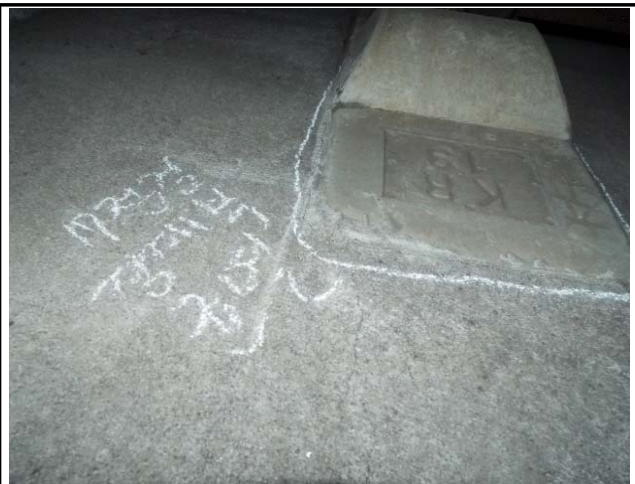
| 위치 | STA. 122K380-390 | 선별 | T1 | 위치 | 침목 |

| 내용 | 경계부 균열 | Cw= 0.2/2.2 | | | |

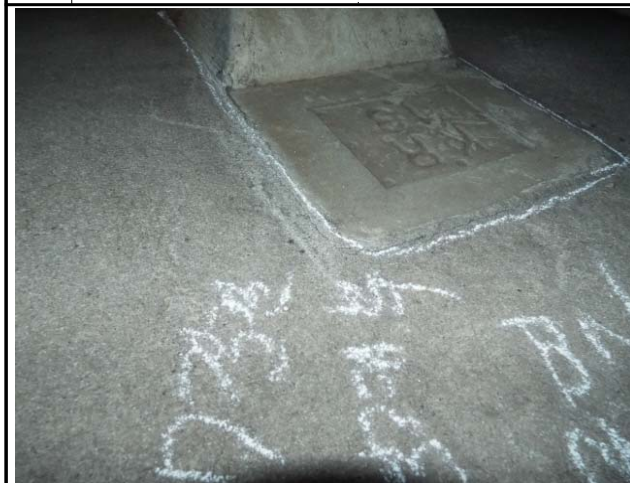
| 위치 | STA. 122K250-260 | 선별 | T2 | 위치 | 침목 |

| 내용 | 경계부 균열 | Cw= 0.2/2.2 | | | |

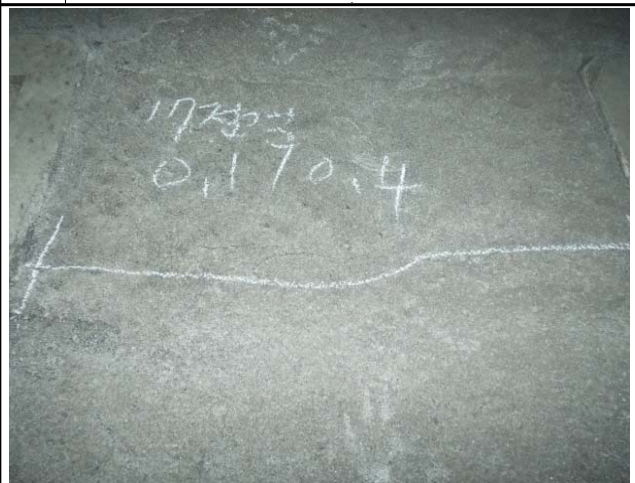
| 위치 | STA. 122K140-150 | 선별 | T1 | 위치 | TCL |

| 내용 | 균열 | Cw= 0.1/0.4 | | | |

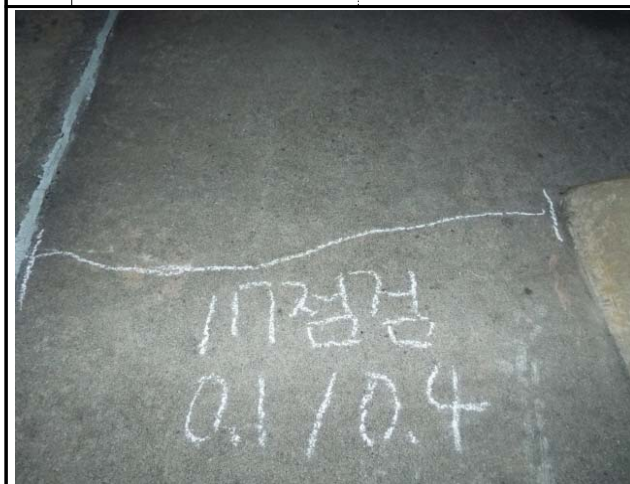
| 위치 | STA. 122K350-360 | 선별 | T2 | 위치 | TCL |

| 내용 | 균열 | Cw= 0.1/0.4 | | | |

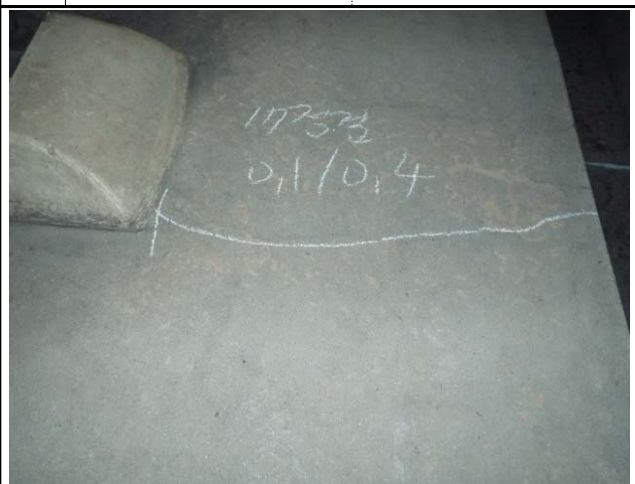
| 위치 | STA. 122K150-160 | 선별 | T2 | 위치 | TCL |

| 내용 | 균열 | Cw= 0.1/0.4 | | | |
