# 호남고속선 오송고가(T1)\_56(1.956~1.970km, S15-12,S16-1)

| 시행 | 사 | 공역명 | 공역사 | 관련 책임자 | | 구분 | | |
|---|---|---|---|---|---|---|---|---|
| 한국철도공사<br>KOREA RAILROAD | 2017년도 호남고속선 오송-광주승장간 콘크리트케도 점검용역 | (주) 한국구조물안전연구원<br>(주) 한국토목안전연구원<br>(재) 한국건설품질연구원 | 이복영 | 간윤강<br>김경기<br>원석기 | 원형 | 022.0 (0.3mm이하 : 녹색) | 원목도상분리 | |

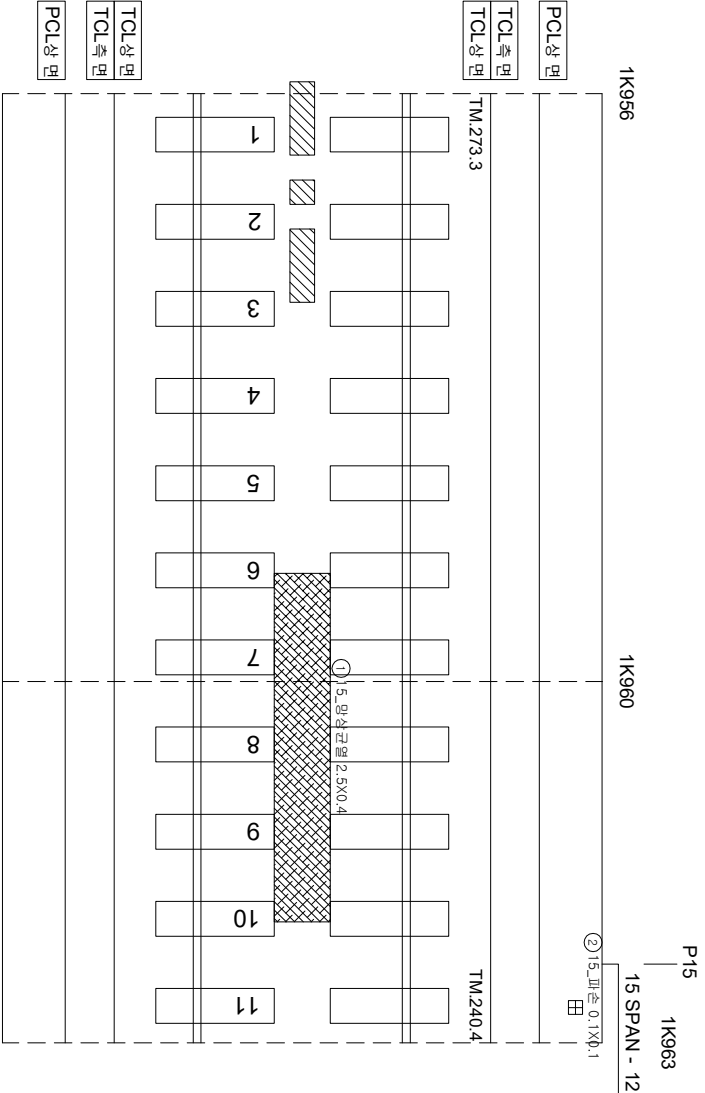
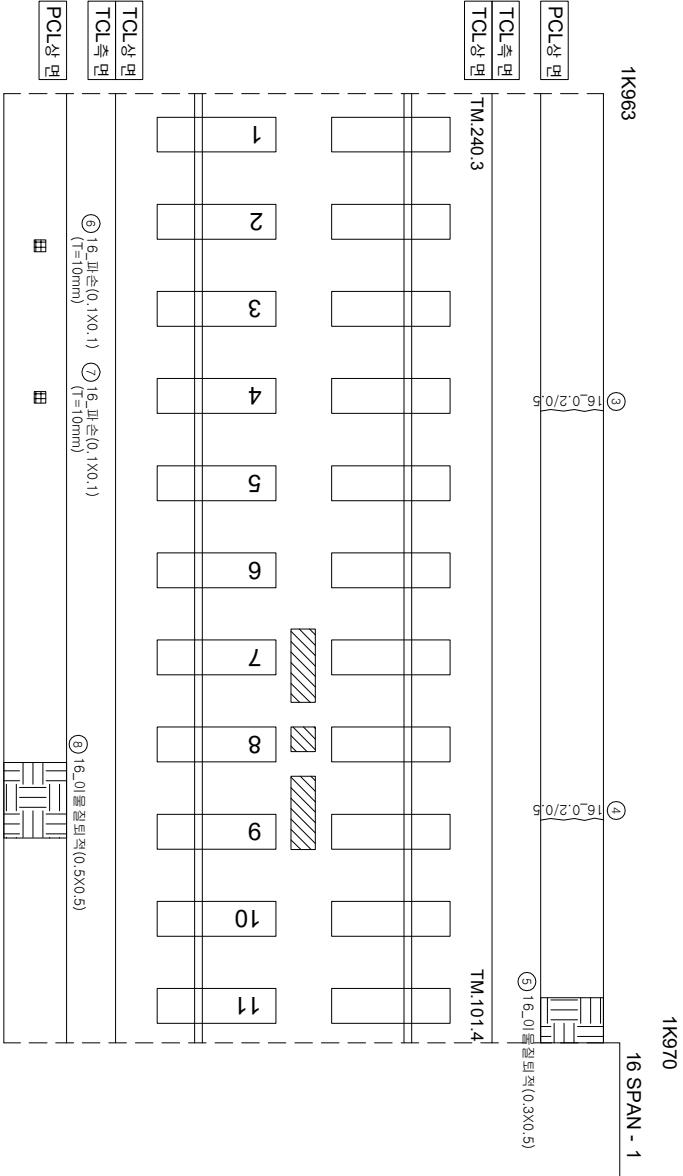
| 연번 | 손상 | 폭 | 연장 | 비고 | 연번 | 손상 | 폭 | 연장 | 비고 |
|---|---|---|---|---|---|---|---|---|---|
| 1 | 양상균열 | 2.5 m | 0.4 m | | 56 | | | | |
| 2 | 피손 | 0.1 m | 0.1 m | | 57 | | | | |
| 3 | 균열 | 0.2 mm | 0.5 m | | 58 | | | | |
| 4 | 균열 | 0.2 mm | 0.5 m | | 59 | | | | |
| 5 | 이물결형태적 | 0.3 m | 0.5 m | | 60 | | | | |
| 6 | 피손 | 0.1 m | 0.1 m | | 61 | | | | |
| 7 | 피손 | 0.1 m | 0.1 m | | 62 | | | | |
| 8 | 이물결형태적 | 0.5 m | 0.5 m | | 63 | | | | |
