호남고속선 오송고가(T2)\_토공노반\_12(3.260~3.280km, L=20m)

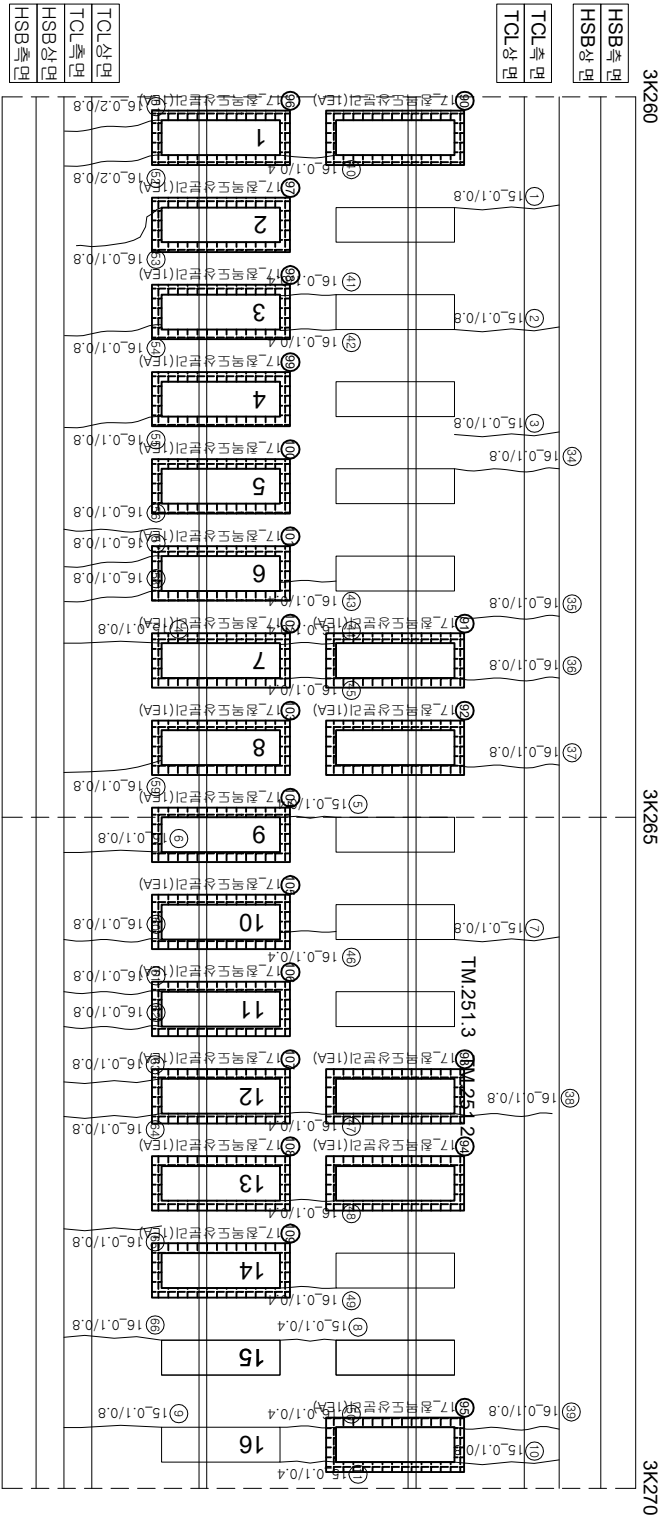
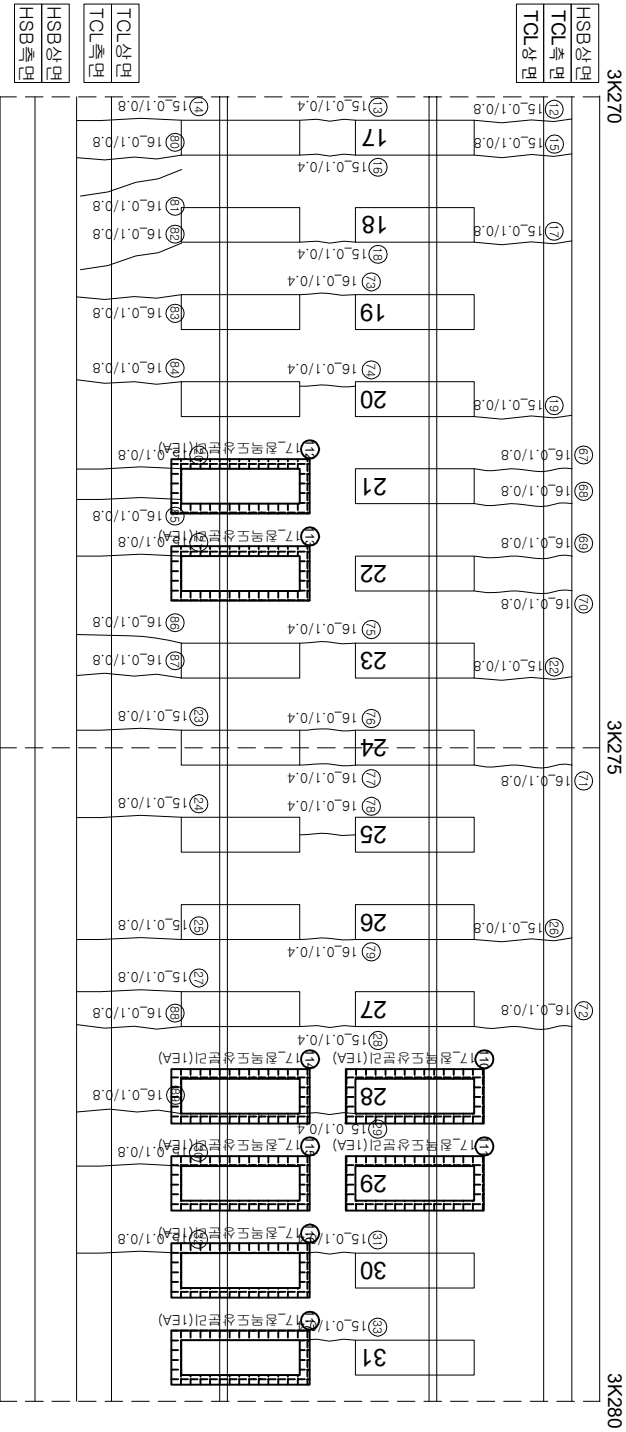
| 연번 | 순상 | 폭 | 연장 | 비고 | 연번 | 순상 | 폭 | 연장 | 비고 |
|---|---|---|---|---|---|---|---|---|---|
| 1 | 균열 0.1 | mm | 0.8 m | | 61 | 균열 0.1 | mm | 0.8 m | |
| 30 | 균열 0.1 | mm | 0.4 m | | 90 | 정목도상분리 | | 1.0 66 | 신구 |
| 50 | 균열 0.2 | mm | 0.4 m | | 110 | 정목도상분리 | | 1.0 66 | 신구 |
| 51 | 균열 0.2 | mm | 0.8 m | | 111 | 정목도상분리 | | 1.0 66 | 신구 |
