호남고속선 오송고가(T2)\_토공노반\_36(3.740~3.760km, L=20m)

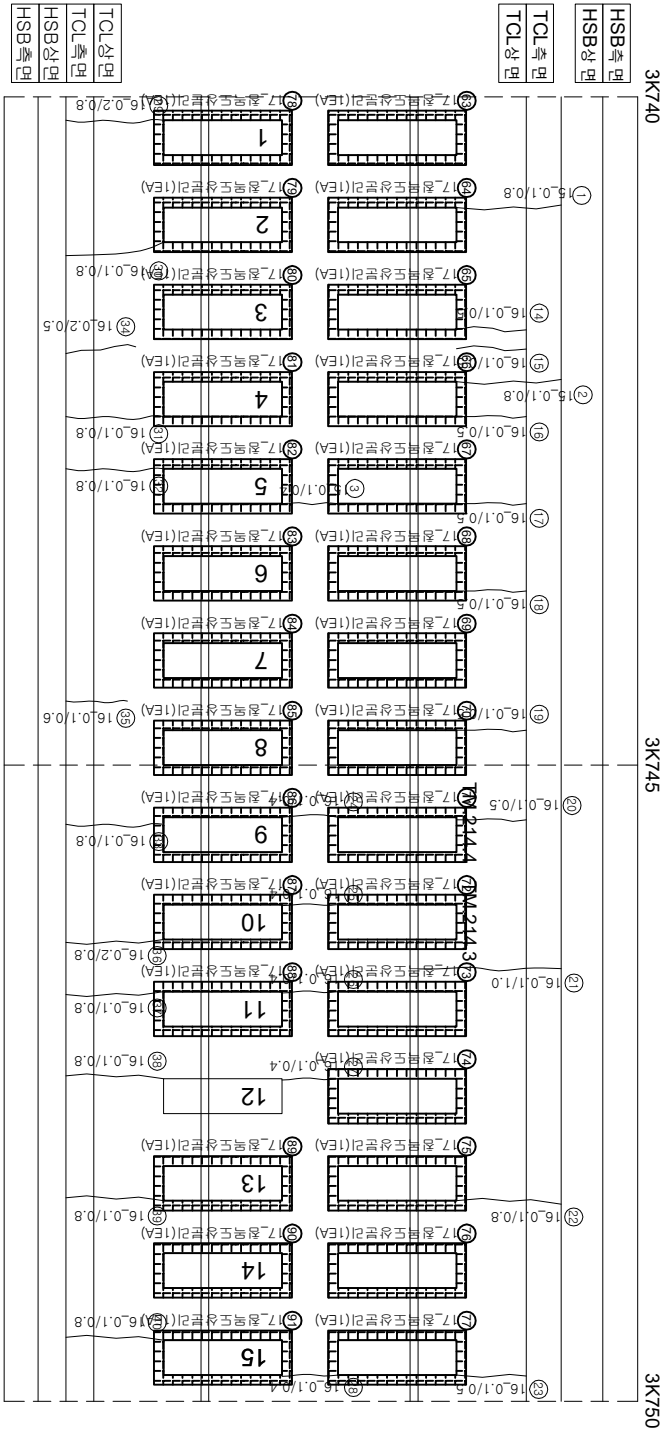
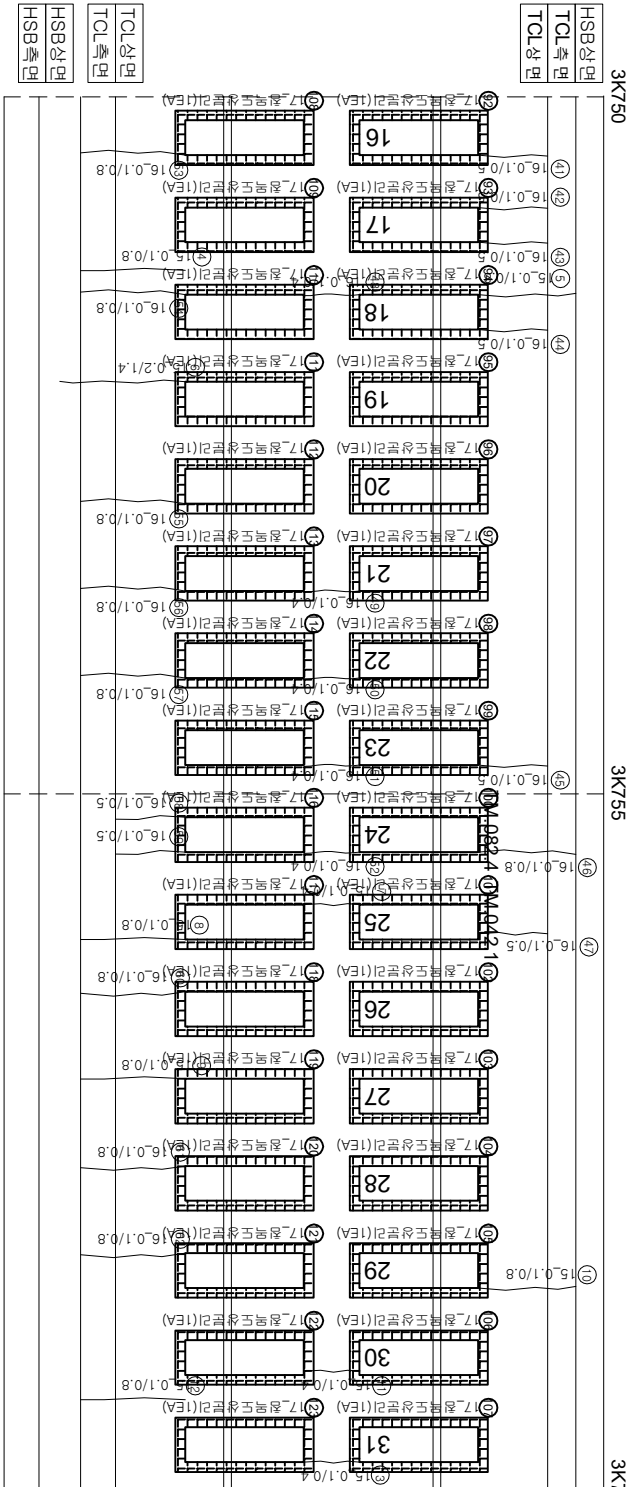
| 연번 | 순상 | 폭 | 연장 | 비고 | 연번 | 순상 | 폭 | 연장 | 비고 | 연번 | 순상 | 폭 | 연장 | 비고 |
|---|---|---|---|---|---|---|---|---|---|---|---|---|---|---|
| 1 | 균열 | 0.1 mm | 0.8 m | | 61 | 균열 | 0.1 mm | 0.8 m | | 121 | 침목도상본리 | | 1.0 ea | 신규 |
| 2 | 균열 | 0.1 mm | 0.6 m | | 62 | 균열 | 0.1 mm | 0.8 m | | 122 | 침목도상본리 | | 1.0 ea | 신규 |
| 3 | 균열 | 0.1 mm | 0.4 m | | 63 | 침목도상본리 | | 1.0 ea | | | | | | |
| 4 | 균열 | 0.1 mm | 0.8 m | | 64 | 침목도상본리 | | 1.0 ea | | 123 | 침목도상본리 | | 1.0 ea | 신규 |
| 5 | 균열 | 0.1 mm | 0.8 m | | 65 | 침목도상본리 | | 1.0 ea | | | | | | |
| 6 | 균열 | 0.2 mm | 1.4 m | | 66 | 침목도상본리 | | 1.0 ea | | | | | | |
| 7 | 균열 | 0.1 mm | 0.4 m | | 67 | 침목도상본리 | | 1.0 ea | | | | | | |
| 8 | 균열 | 0.1 mm | 0.8 m | | 68 | 침목도상본리 | | 1.0 ea | | | | | | |
| 9 | 균열 | 0.1 mm | 0.8 m | | 69 | 침목도상본리 | | 1.0 ea | | | | | | |
| 10 | 균열 | 0.1 mm | 0.8 m | | 70 | 침목도상본리 | | 1.0 ea | | | | | | |
| 11 | 균열 | 0.1 mm | 0.4 m | | 71 | 침목도상본리 | | 1.0 ea | | | | | | |
| 12 | 균열 | 0.1 mm | 0.8 m | | 72 | 침목도상본리 | | 1.0 ea | | | | | | |
| 13 | 균열 | 0.1 mm | 0.4 m | | 73 | 침목도상본리 | | 1.0 ea | | | | | | |
| 14 | 균열 | 0.1 mm | 0.5 m | | 74 | 침목도상본리 | | 1.0 ea | | | | | | |
| 15 | 균열 | 0.1 mm | 0.5 m | | 75 | 침목도상본리 | | 1.0 ea | | | | | | |
| 16 | 균열 | 0.1 mm | 0.5 m | | 76 | 침목도상본리 | | 1.0 ea | | | | | | |
| 17 | 균열 | 0.1 mm | 0.5 m | | 77 | 침목도상본리 | | 1.0 ea | | | | | | |
| 18 | 균열 | 0.1 mm | 0.5 m | | 78 | 침목도상본리 | | 1.0 ea | | | | | | |
| 19 | 균열 | 0.1 mm | 0.5 m | | 79 | 침목도상본리 | | 1.0 ea | | | | | | |
| 20 | 균열 | 0.1 mm | 0.5 m | | 80 | 침목도상본리 | | 1.0 ea | | | | | | |
| 21 | 균열 | 0.1 mm | 1 m | | 81 | 침목도상본리 | | 1.0 ea | | | | | | |
| 22 | 균열 | 0.1 mm | 0.8 m | | 82 | 침목도상본리 | | 1.0 ea | | | | | | |
| 23 | 균열 | 0.1 mm | 0.5 m | | 83 | 침목도상본리 | | 1.0 ea | | | | | | |
| 24 | 균열 | 0.1 mm | 0.4 m | | 84 | 침목도상본리 | | 1.0 ea | | | | | | |
| 25 | 균열 | 0.1 mm | 0.4 m | | 85 | 침목도상본리 | | 1.0 ea | | | | | | |
| 26 | 균열 | 0.1 mm | 0.4 m | | 86 | 침목도상본리 | | 1.0 ea | | | | | | |
| 27 | 균열 | 0.1 mm | 0.4 m | | 87 | 침목도상본리 | | 1.0 ea | | | | | | |
| 28 | 균열 | 0.1 mm | 0.4 m | | 88 | 침목도상본리 | | 1.0 ea | | | | | | |
| 29 | 균열 | 0.2 mm | 0.8 m | | 89 | 침목도상본리 | | 1.0 ea | | | | | | |
| 30 | 균열 | 0.1 mm | 0.8 m | | 90 | 침목도상본리 | | 1.0 ea | | | | | | |
| 31 | 균열 | 0.1 mm | 0.8 m | | 91 | 침목도상본리 | | 1.0 ea | | | | | | |
| 32 | 균열 | 0.1 mm | 0.8 m | | 92 | 침목도상본리 | | 1.0 ea | | | | | | |
| 33 | 균열 | 0.1 mm | 0.8 m | | 93 | 침목도상본리 | | 1.0 ea | | | | | | |
| 34 | 균열 | 0.2 mm | 0.5 m | | 94 | 침목도상본리 | | 1.0 ea | | | | | | |
| 35 | 균열 | 0.1 mm | 0.6 m | | 95 | 침목도상본리 | | 1.0 ea | | | | | | |
| 36 | 균열 | 0.2 mm | 0.8 m | | 96 | 침목도상본리 | | 1.0 ea | | | | | | |
| 37 | 균열 | 0.1 mm | 0.8 m | | 97 | 침목도상본리 | | 1.0 ea | | | | | | |
| 38 | 균열 | 0.1 mm | 0.8 m | | 98 | 침목도상본리 | | 1.0 ea | | | | | | |
| 39 | 균열 | 0.1 mm | 0.8 m | | 99 | 침목도상본리 | | 1.0 ea | | | | | | |
| 40 | 균열 | 0.1 mm | 0.8 m | | 100 | 침목도상본리 | | 1.0 ea | | | | | | |
| 41 | 균열 | 0.1 mm | 0.5 m | | 101 | 침목도상본리 | | 1.0 ea | | | | | | |
| 42 | 균열 | 0.1 mm | 0.5 m | | 102 | 침목도상본리 | | 1.0 ea | | | | | | |
| 43 | 균열 | 0.1 mm | 0.5 m | | 103 | 침목도상본리 | | 1.0 ea | | | | | | |
| 44 | 균열 | 0.1 mm | 0.5 m | | 104 | 침목도상본리 | | 1.0 ea | | | | | | |
| 45 | 균열 | 0.1 mm | 0.5 m | | 105 | 침목도상본리 | | 1.0 ea | | | | | | |
| 46 | 균열 | 0.1 mm | 0.8 m | | 106 | 침목도상본리 | | 1.0 ea | | | | | | |
| 47 | 균열 | 0.1 mm | 0.5 m | | 107 | 침목도상본리 | | 1.0 ea | | | | | | |
| 48 | 균열 | 0.1 mm | 0.4 m | | 108 | 침목도상본리 | | 1.0 ea | | | | | | |
| 49 | 균열 | 0.1 mm | 0.4 m | | 109 | 침목도상본리 | | 1.0 ea | | | | | | |
| 50 | 균열 | 0.1 mm | 0.4 m | | 110 | 침목도상본리 | | 1.0 ea | | | | | | |
| 51 | 균열 | 0.1 mm | 0.4 m | | 111 | 침목도상본리 | | 1.0 ea | | | | | | |
| 52 | 균열 | 0.1 mm | 0.4 m | | 112 | 침목도상본리 | | 1.0 ea | | | | | | |
| 53 | 균열 | 0.1 mm | 0.8 m | | 113 | 침목도상본리 | | 1.0 ea | | | | | | |
| 54 | 균열 | 0.1 mm | 0.8 m | | 114 | 침목도상본리 | | 1.0 ea | | | | | | |
| 55 | 균열 | 0.1 mm | 0.8 m | | 115 | 침목도상본리 | | 1.0 ea | | | | | | |
| 56 | 균열 | 0.1 mm | 0.8 m | | 116 | 침목도상본리 | | 1.0 ea | | | | | | |
| 57 | 균열 | 0.1 mm | 0.8 m | | 117 | 침목도상본리 | | 1.0 ea | | | | | | |
| 58 | 균열 | 0.1 mm | 0.5 m | | 118 | 침목도상본리 | | 1.0 ea | | | | | | |
| 59 | 균열 | 0.1 mm | 0.5 m | | 119 | 침목도상본리 | | 1.0 ea | | | | | | |
| 60 | 균열 | 0.1 mm | 0.8 m | | 120 | 침목도상본리 | | 1.0 ea | | | | | | |
