호남고속선 태성고가(T1)\_3(4.611~4.623km, S1-3,S1-4)

| 시 | 행 사 | 영 역 | 영 역 | 영 역 | 사 | 인 지 | | 구 간 | | | | | |
|---|---|---|---|---|---|---|---|---|---|---|---|---|---|
| KORAIL<br>KOREA RAILROAD | 한국철도공사 | 2017년도 호남고속선 오송-광주승정간 콘크리트케도 점경용역 | (주) 한국구조물안전연구원<br>(주) 한국도로안전연구원<br>(재) 한국건설품질연구원 | 이 박 영 | 간 원 강<br>김 경 기<br>윤 석 기 | 영역 | | 0.220 (0.3m이하 : 폭식) | | 참목도상본리 | | | |

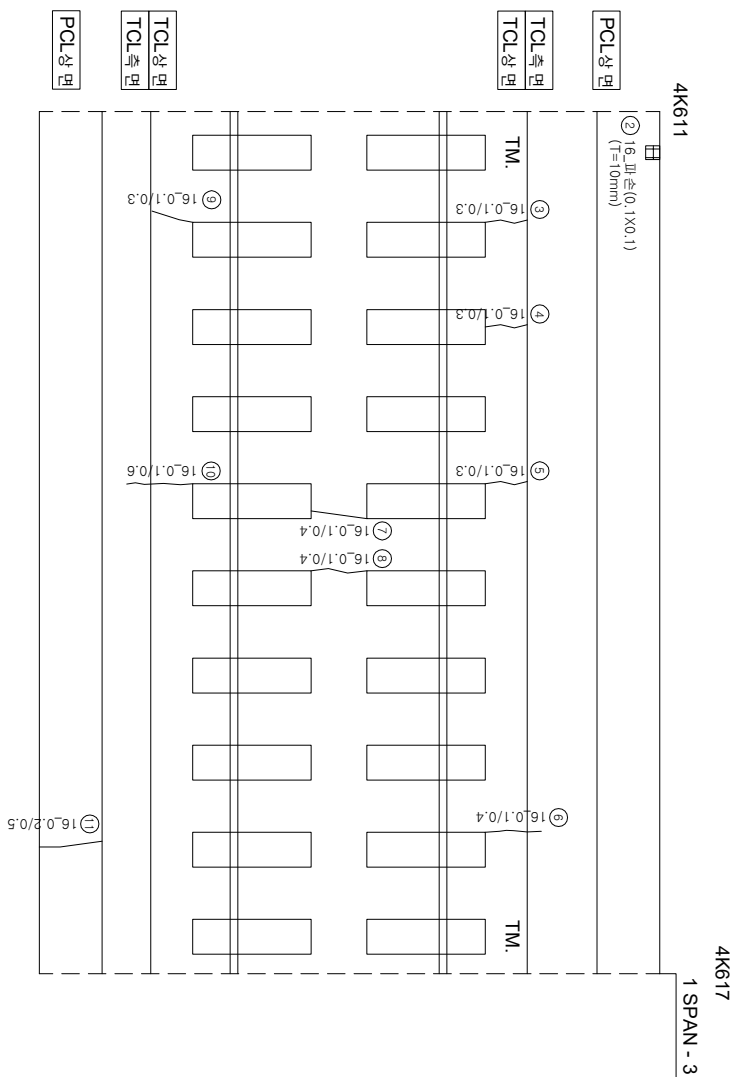
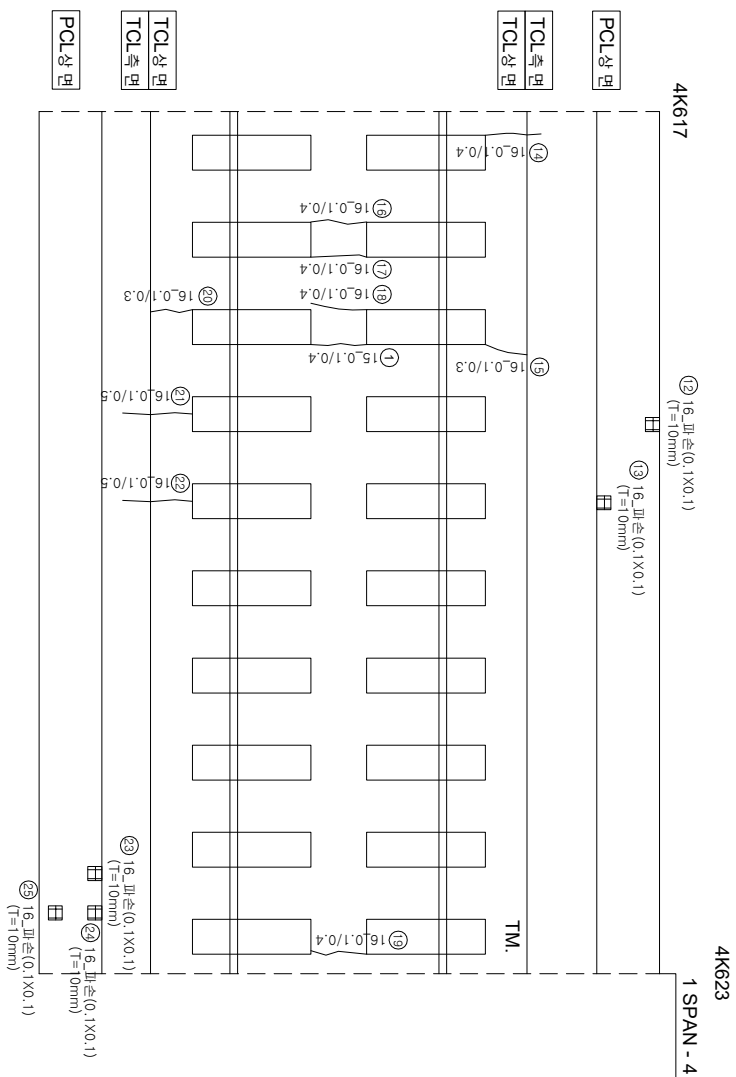
| 연번 | 순차 | 특 | 연장 | 비고 | 연번 | 순차 | 특 | 연장 | 비고 |
|---|---|---|---|---|---|---|---|---|---|
| 1 | 균열 | 0.1 mm | 0.4 m | m | 56 | | | | |
| 2 | 파손 | 0.1 m | 0.1 m | | 57 | | | | |
| 3 | 균열 | 0.1 mm | 0.3 m | | 58 | | | | |
| 4 | 균열 | 0.1 mm | 0.3 m | | 59 | | | | |
| 5 | 균열 | 0.1 mm | 0.3 m | | 60 | | | | |
| 6 | 균열 | 0.1 mm | 0.4 m | | 61 | | | | |
| 7 | 균열 | 0.1 mm | 0.4 m | | 62 | | | | |
| 8 | 균열 | 0.1 mm | 0.4 m | | 63 | | | | |
| 9 | 균열 | 0.1 mm | 0.3 m | | 64 | | | | |
| 10 | 균열 | 0.1 mm | 0.6 m | | 65 | | | | |
| 11 | 균열 | 0.2 mm | 0.5 m | | 66 | | | | |
| 12 | 파손 | 0.1 m | 0.1 m | | 67 | | | | |
| 13 | 파손 | 0.1 m | 0.1 m | | 68 | | | | |
| 14 | 균열 | 0.1 mm | 0.4 m | | 69 | | | | |
| 15 | 균열 | 0.1 mm | 0.3 m | | 70 | | | | |
| 16 | 균열 | 0.1 mm | 0.4 m | | 71 | | | | |
| 17 | 균열 | 0.1 mm | 0.4 m | | 72 | | | | |
| 18 | 균열 | 0.1 mm | 0.4 m | | 73 | | | | |
| 19 | 균열 | 0.1 mm | 0.4 m | | 74 | | | | |
| 20 | 균열 | 0.1 mm | 0.4 m | | 75 | | | | |
| 21 | 균열 | 0.1 mm | 0.4 m | | 76 | | | | |
| 22 | 균열 | 0.1 mm | 0.4 m | | 77 | | | | |
| 23 | 파손 | 0.1 m | 0.1 m | | 78 | | | | |
| 24 | 파손 | 0.1 m | 0.1 m | | 79 | | | | |
| 25 | 파손 | 0.1 m | 0.1 m | | 80 | | | | |
