한남고속선 구간 - 34(9.020~9.030km, L=10m)

| 시 | 행 | 사 | 용 | 역 | 영 | 사 | 단 | | |
|---|---|---|---|---|---|---|---|---|---|
| KORAIL<br>KOREA RAILROAD | 한국철도공사 | 2017년도 호남고속선 오송-광주승정간 콘크리트케도 점검용역 | (주) 한국구조물안전연구원<br>(주) 한국도로안전연구원<br>(재) 한국건설품질연구원 | 이 복 영 | 간윤강<br>김경기<br>문석기 | 영남 | 0220 (0.3m이하 : 목책) | 영문도강방리 | 차로방리 |

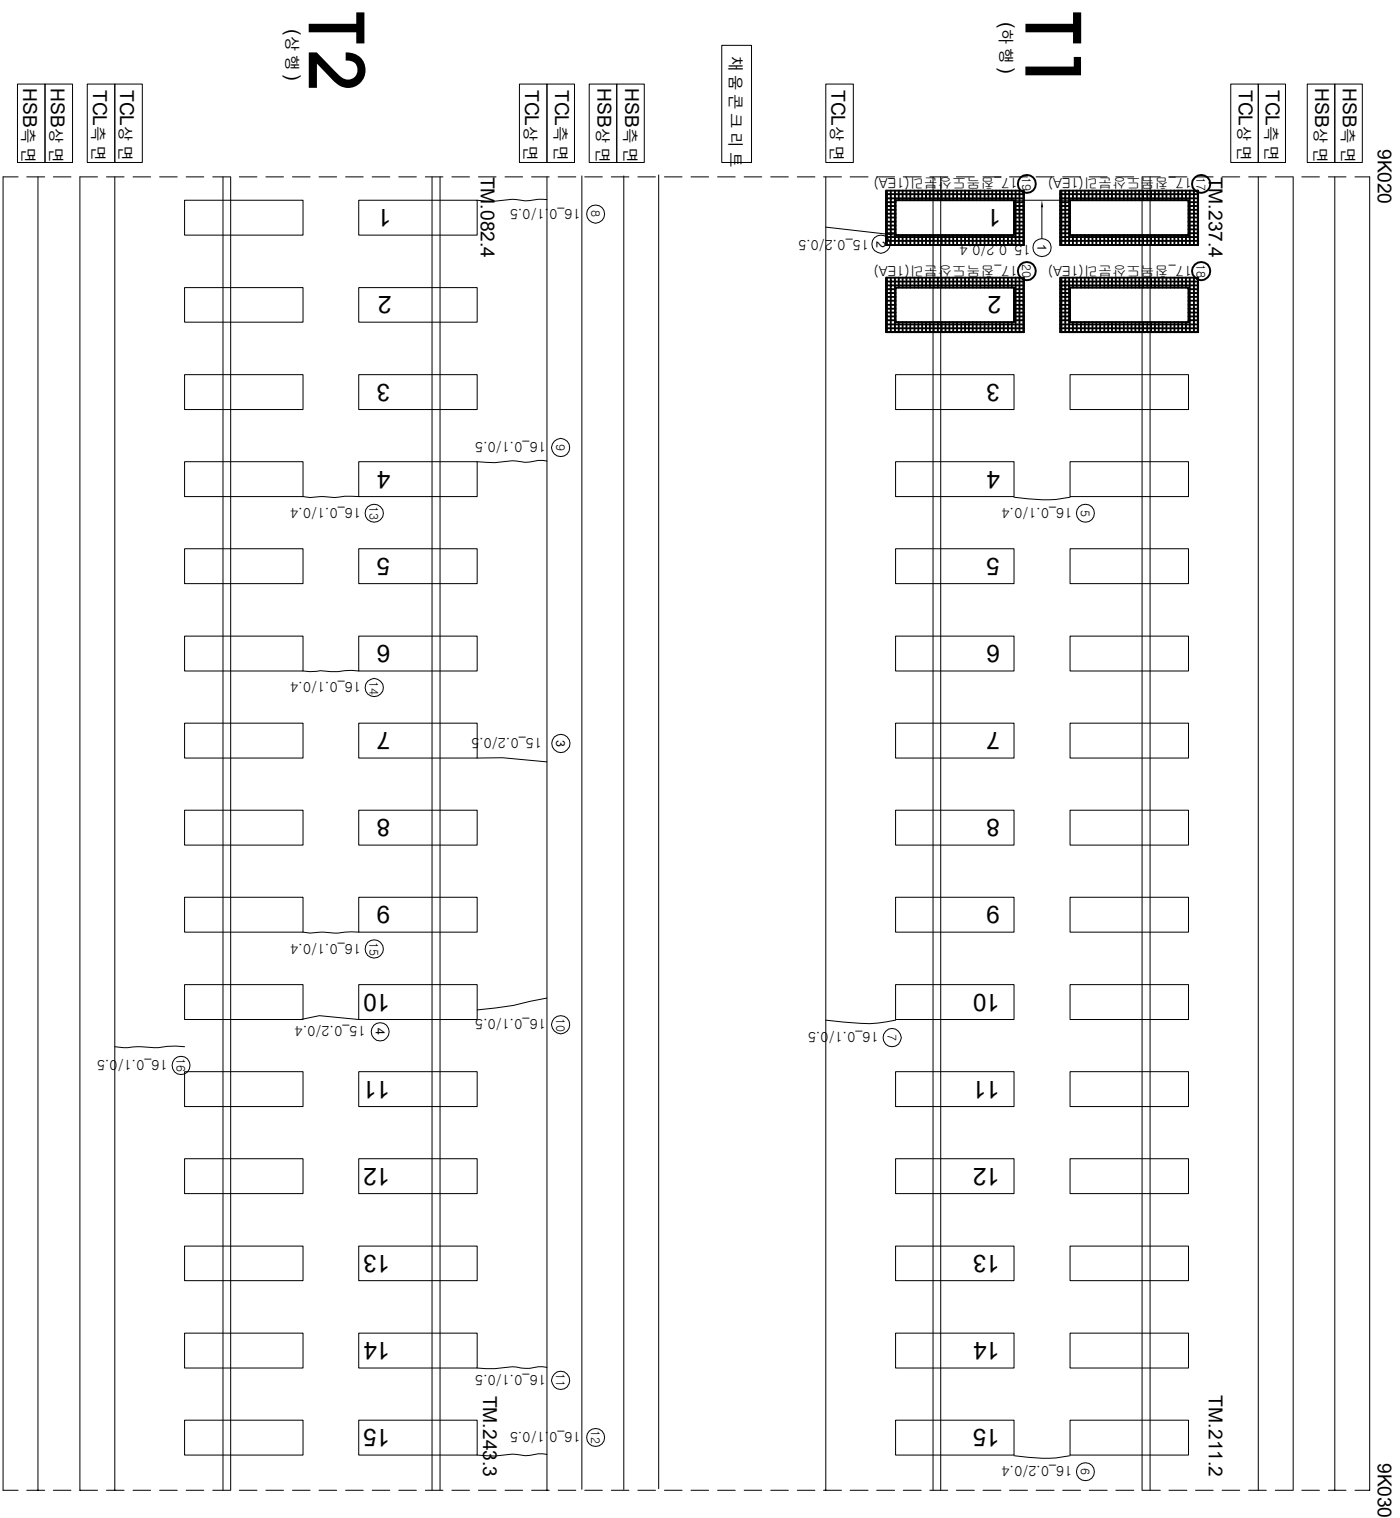
| 연번 | 손상 | 폭 | 연장 | 비고 | 연번 | 손상 | 폭 | 연장 | 비고 |
|---|---|---|---|---|---|---|---|---|---|
| 1 | 균열 | 0.2 mm | 0.4 m | | 66 | | | | |
| 2 | 균열 | 0.2 mm | 0.5 m | | 67 | | | | |
| 3 | 균열 | 0.1 mm | 0.5 m | | 68 | | | | |
| 4 | 균열 | 0.1 mm | 0.5 m | | 69 | | | | |
| 5 | 균열 | 0.1 mm | 0.4 m | | 70 | | | | |
| 6 | 균열 | 0.2 mm | 0.4 m | | 71 | | | | |
| 7 | 균열 | 0.1 mm | 0.5 m | | 72 | | | | |
| 8 | 균열 | 0.1 mm | 0.5 m | | 73 | | | | |
| 9 | 균열 | 0.1 mm | 0.5 m | | 74 | | | | |
| 10 | 균열 | 0.1 mm | 0.5 m | | 75 | | | | |
| 11 | 균열 | 0.1 mm | 0.5 m | | 76 | | | | |
| 12 | 균열 | 0.1 mm | 0.5 m | | 77 | | | | |
| 13 | 균열 | 0.1 mm | 0.4 m | | 78 | | | | |
| 14 | 균열 | 0.1 mm | 0.4 m | | 79 | | | | |
| 15 | 균열 | 0.1 mm | 0.4 m | | 80 | | | | |
| 16 | 균열 | 0.1 mm | 0.5 m | | 81 | | | | |
| 17 | 절개도상분리 | | 1.0 ea | 신규 | 82 | | | | |
| 18 | 절개도상분리 | | 1.0 ea | 신규 | 83 | | | | |
| 19 | 절개도상분리 | | 1.0 ea | 신규 | 84 | | | | |
| 20 | 절개도상분리 | | 1.0 ea | 신규 | 85 | | | | |
