호남고속선 부용터널-11(12.940~12.950km, S9)

| 시 | 행 | 사 | 용 | 역 | 영 | 사 | 단 | | |
|---|---|---|---|---|---|---|---|---|---|
| KORAIL<br>KOREA RAILROAD | 한국철도공사 | 2017년도 호남고속선 오송-광주승강간 콘크리트케도 점검용역 | (주) 한국구조물안전연구원<br>(주) 한국도로안전연구원<br>(재) 한국건설품질연구원 | 이 복 영 | 간원강<br>김 경 기<br>문 준 기 | 영원 | 02220 (0.3m이하 : 목박) | 철로받판리 | 철로받판리 |

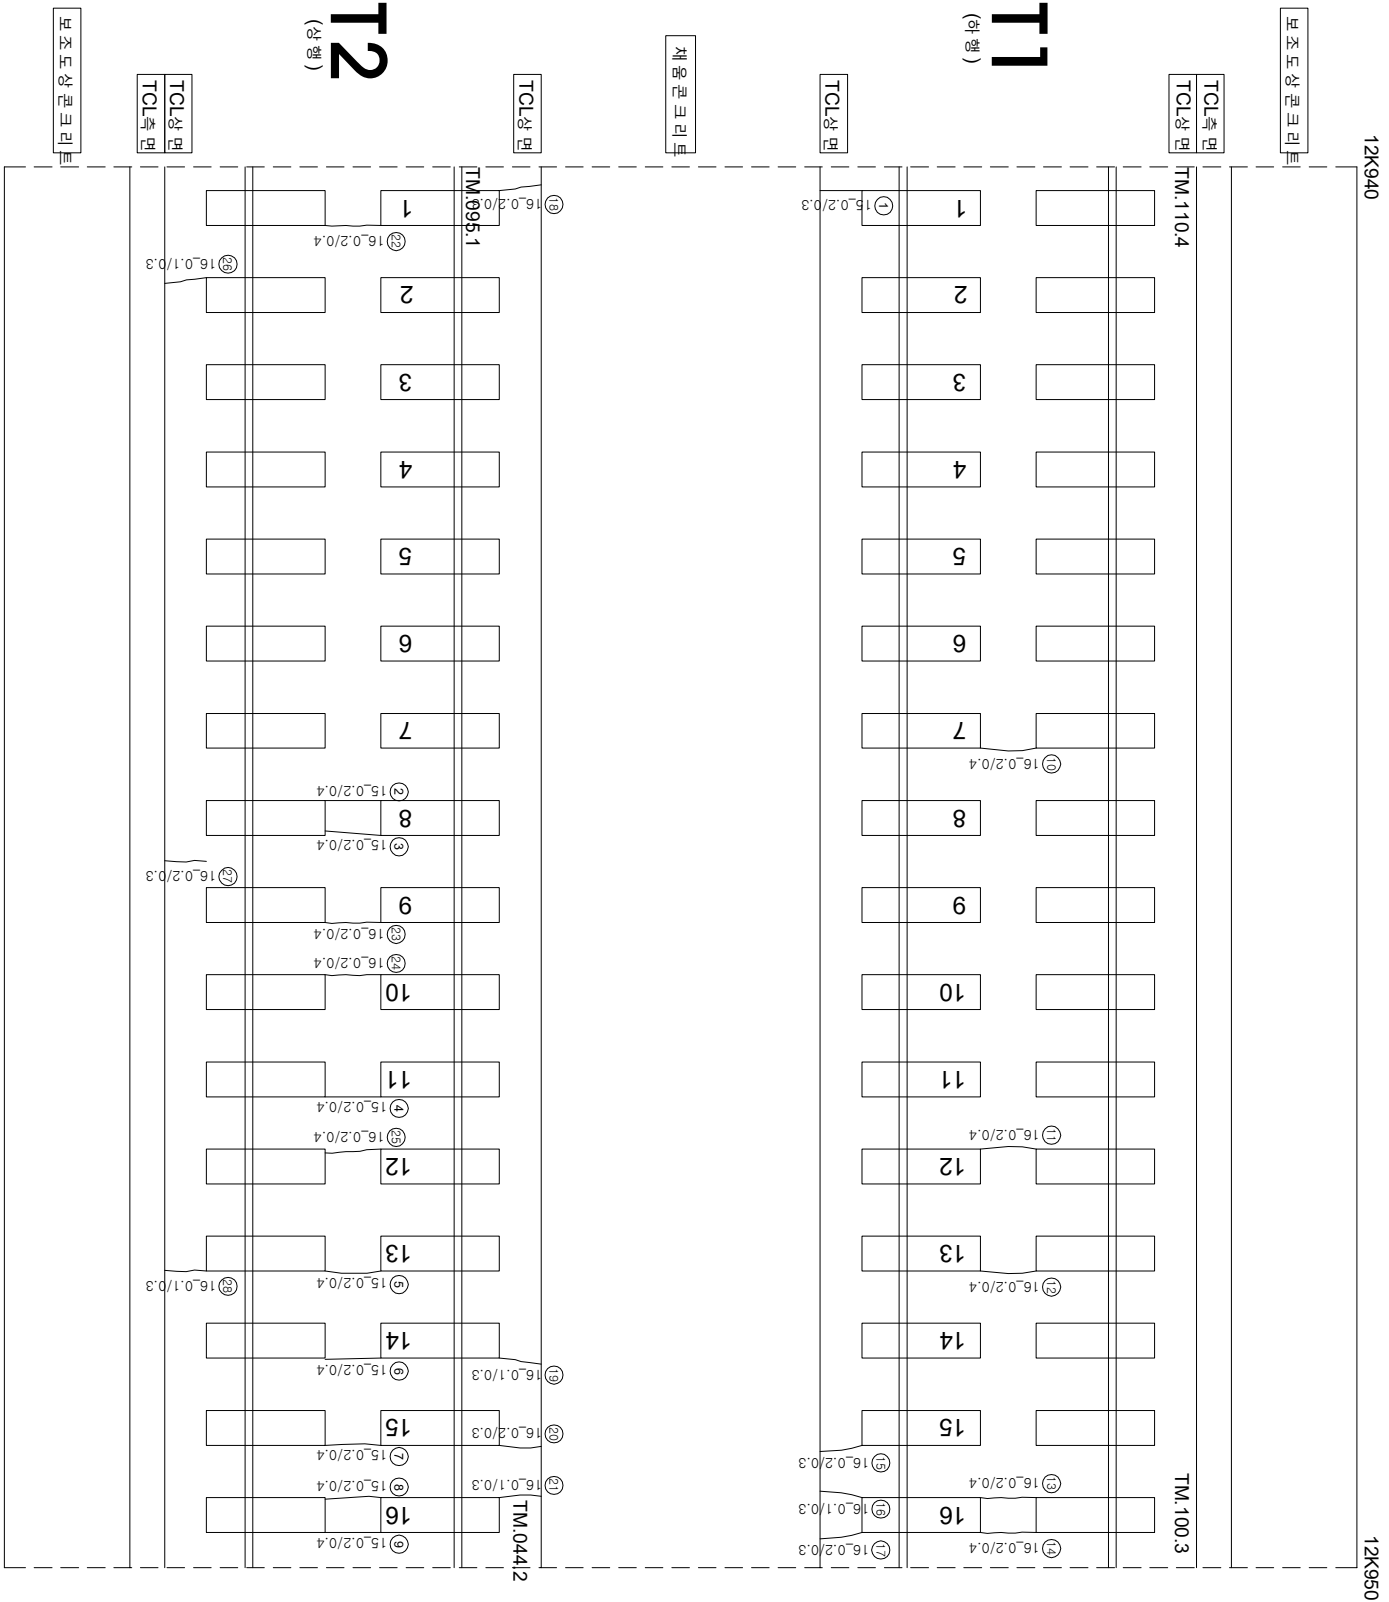
| 연번 | 산선 | 폭 | 연장 | 비고 | 연번 | 산선 | 폭 | 연장 | 비고 |
|---|---|---|---|---|---|---|---|---|---|
| 1 | 균열 | 0.2 mm | 0.3 m | | 56 | | | | |
| 2 | 균열 | 0.2 mm | 0.4 m | | 57 | | | | |
| 3 | 균열 | 0.2 mm | 0.4 m | | 58 | | | | |
| 4 | 균열 | 0.2 mm | 0.4 m | | 59 | | | | |
| 5 | 균열 | 0.2 mm | 0.4 m | | 60 | | | | |
| 6 | 균열 | 0.2 mm | 0.4 m | | 61 | | | | |
| 7 | 균열 | 0.2 mm | 0.4 m | | 62 | | | | |
| 8 | 균열 | 0.2 mm | 0.4 m | | 63 | | | | |
| 9 | 균열 | 0.2 mm | 0.4 m | | 64 | | | | |
| 10 | 균열 | 0.2 mm | 0.4 m | | 65 | | | | |
| 11 | 균열 | 0.2 mm | 0.4 m | | 66 | | | | |
| 12 | 균열 | 0.2 mm | 0.4 m | | 67 | | | | |
| 13 | 균열 | 0.2 mm | 0.4 m | | 68 | | | | |
| 14 | 균열 | 0.2 mm | 0.4 m | | 69 | | | | |
| 15 | 균열 | 0.2 mm | 0.3 m | | 70 | | | | |
| 16 | 균열 | 0.1 mm | 0.3 m | | 71 | | | | |
| 17 | 균열 | 0.2 mm | 0.3 m | | 72 | | | | |
| 18 | 균열 | 0.2 mm | 0.3 m | | 73 | | | | |
| 19 | 균열 | 0.1 mm | 0.3 m | | 74 | | | | |
| 20 | 균열 | 0.2 mm | 0.3 m | | 75 | | | | |
| 21 | 균열 | 0.1 mm | 0.3 m | | 76 | | | | |
| 22 | 균열 | 0.2 mm | 0.4 m | | 77 | | | | |
| 23 | 균열 | 0.2 mm | 0.4 m | | 78 | | | | |
| 24 | 균열 | 0.2 mm | 0.4 m | | 79 | | | | |
| 25 | 균열 | 0.2 mm | 0.4 m | | 80 | | | | |
| 26 | 균열 | 0.1 mm | 0.3 m | | 81 | | | | |
| 27 | 균열 | 0.2 mm | 0.3 m | | 82 | | | | |
| 28 | 균열 | 0.1 mm | 0.3 m | | 83 | | | | |
