호남고속선 부용터널-13(12.960~12.970km, S11)

| 시 | 행 사 | 영 역 | 영 역 | 영 역 | 사 | 인 지 | | 단 |
|---|---|---|---|---|---|---|---|---|
| | 한국철도공사 | 2017년도 호남고속선 오송-광주승강간 콘크리트케도 정검용역 | (주) 한국구조물안전연구원<br>(주) 한국도로안전연구원<br>(재) 한국건설품질연구원 | 이 박 영 | 간 원 강<br>김 경 기<br>윤 석 기 | 영역 | 0220 (0.3mm이하 : 흑색) | 참목도상문리 |

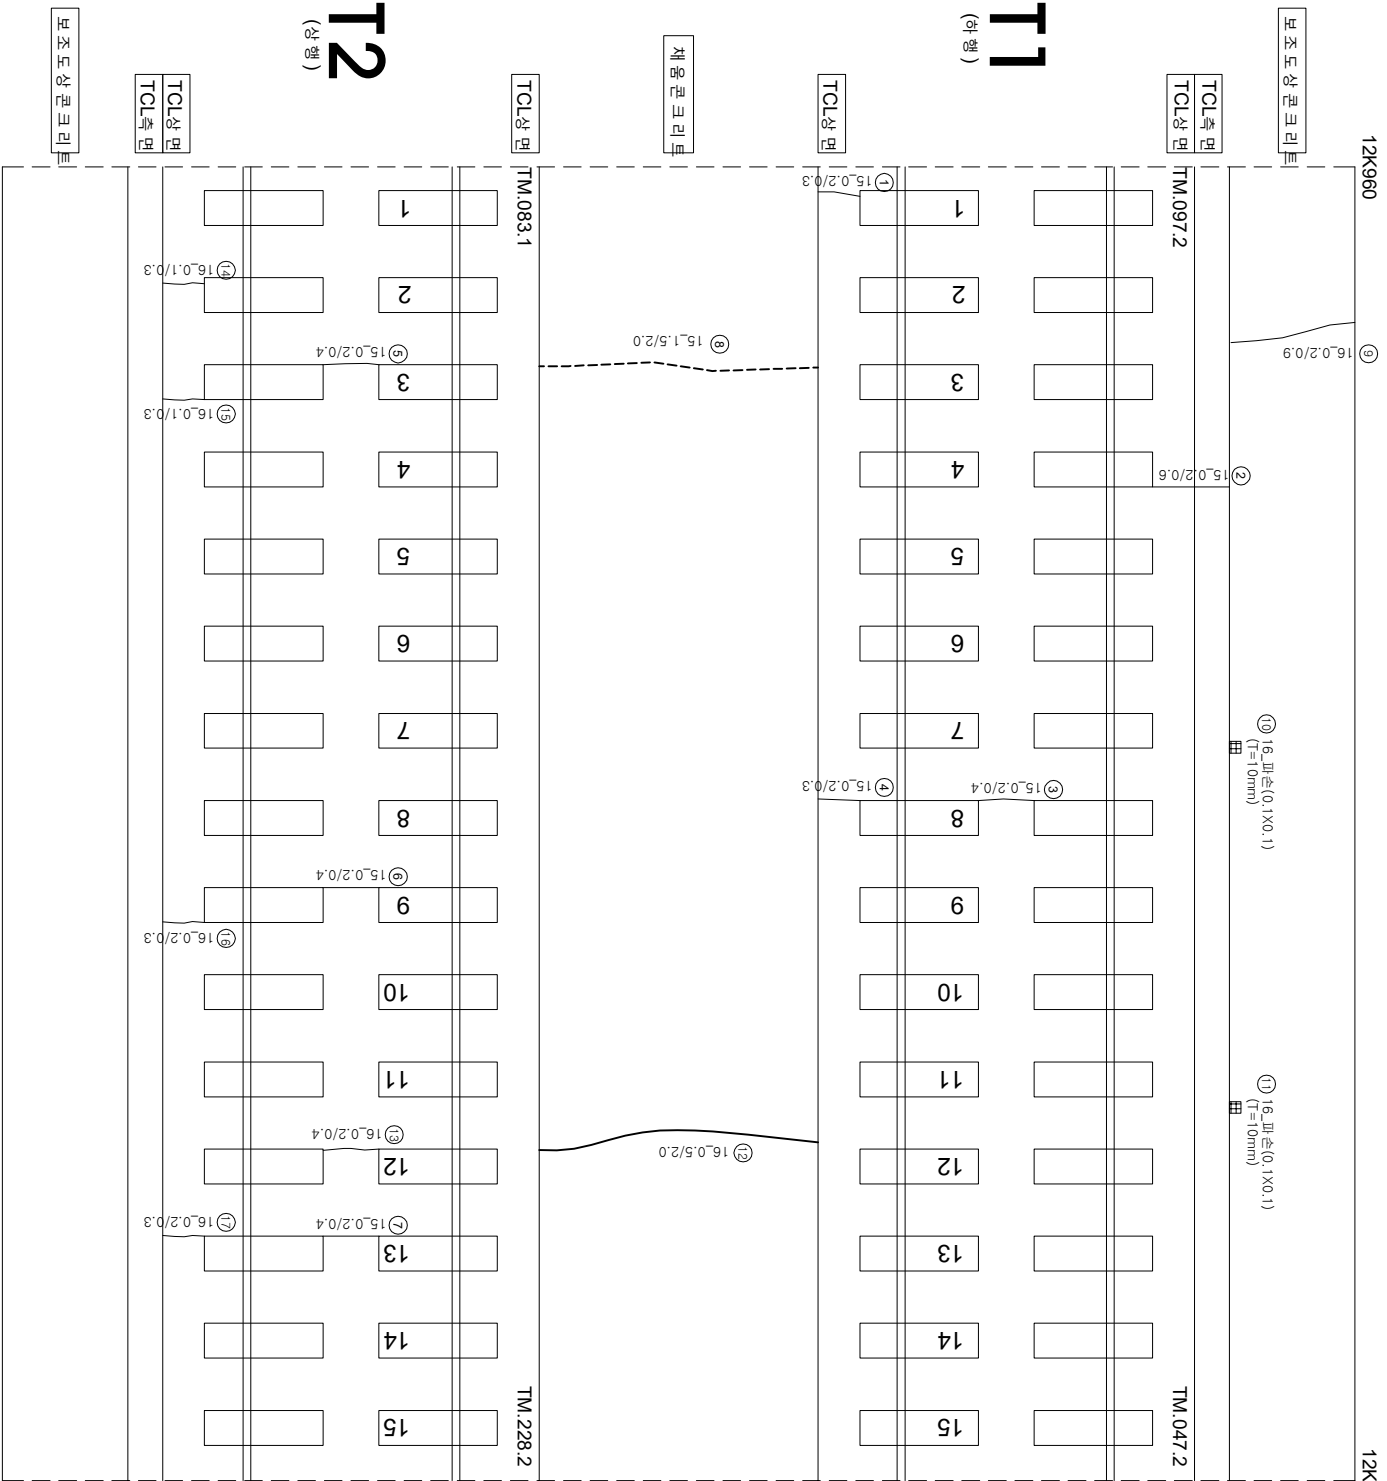
| 연번 | 순상 | 폭 | 연장 | 비고 | 연번 | 순상 | 폭 | 연장 | 비고 |
|---|---|---|---|---|---|---|---|---|---|
| 1 | 균열 | 0.2 mm | 0.3 m | | 56 | | | | |
| 2 | 균열 | 0.2 mm | 0.6 m | | 57 | | | | |
| 3 | 균열 | 0.2 mm | 0.4 m | | 58 | | | | |
| 4 | 균열 | 0.2 mm | 0.3 m | | 59 | | | | |
| 5 | 균열 | 0.2 mm | 0.4 m | | 60 | | | | |
| 6 | 균열 | 0.2 mm | 0.4 m | | 61 | | | | |
| 7 | 균열 | 0.2 mm | 0.4 m | | 62 | | | | |
| 8 | 균열 | 1.5 mm | 2.0 m | | 63 | | | | |
| 9 | 균열 | 0.2 mm | 0.9 m | | 64 | | | | |
| 10 | 파손 | 0.1 m | 0.1 m | | 65 | | | | |
| 11 | 파손 | 0.1 m | 0.1 m | | 66 | | | | |
| 12 | 균열 | 0.5 mm | 2.0 m | | 67 | | | | |
| 13 | 균열 | 0.2 mm | 0.4 m | | 68 | | | | |
| 14 | 균열 | 0.1 mm | 0.3 m | | 69 | | | | |
| 15 | 균열 | 0.1 mm | 0.3 m | | 70 | | | | |
| 16 | 균열 | 0.2 mm | 0.3 m | | 71 | | | | |
| 17 | 균열 | 0.2 mm | 0.3 m | | 72 | | | | |
