호남고속선 부용터널\_19(13.020~13.030km, S17)

외관조사망도 번호

U3\_부용터널\_19(13K020~13K030)

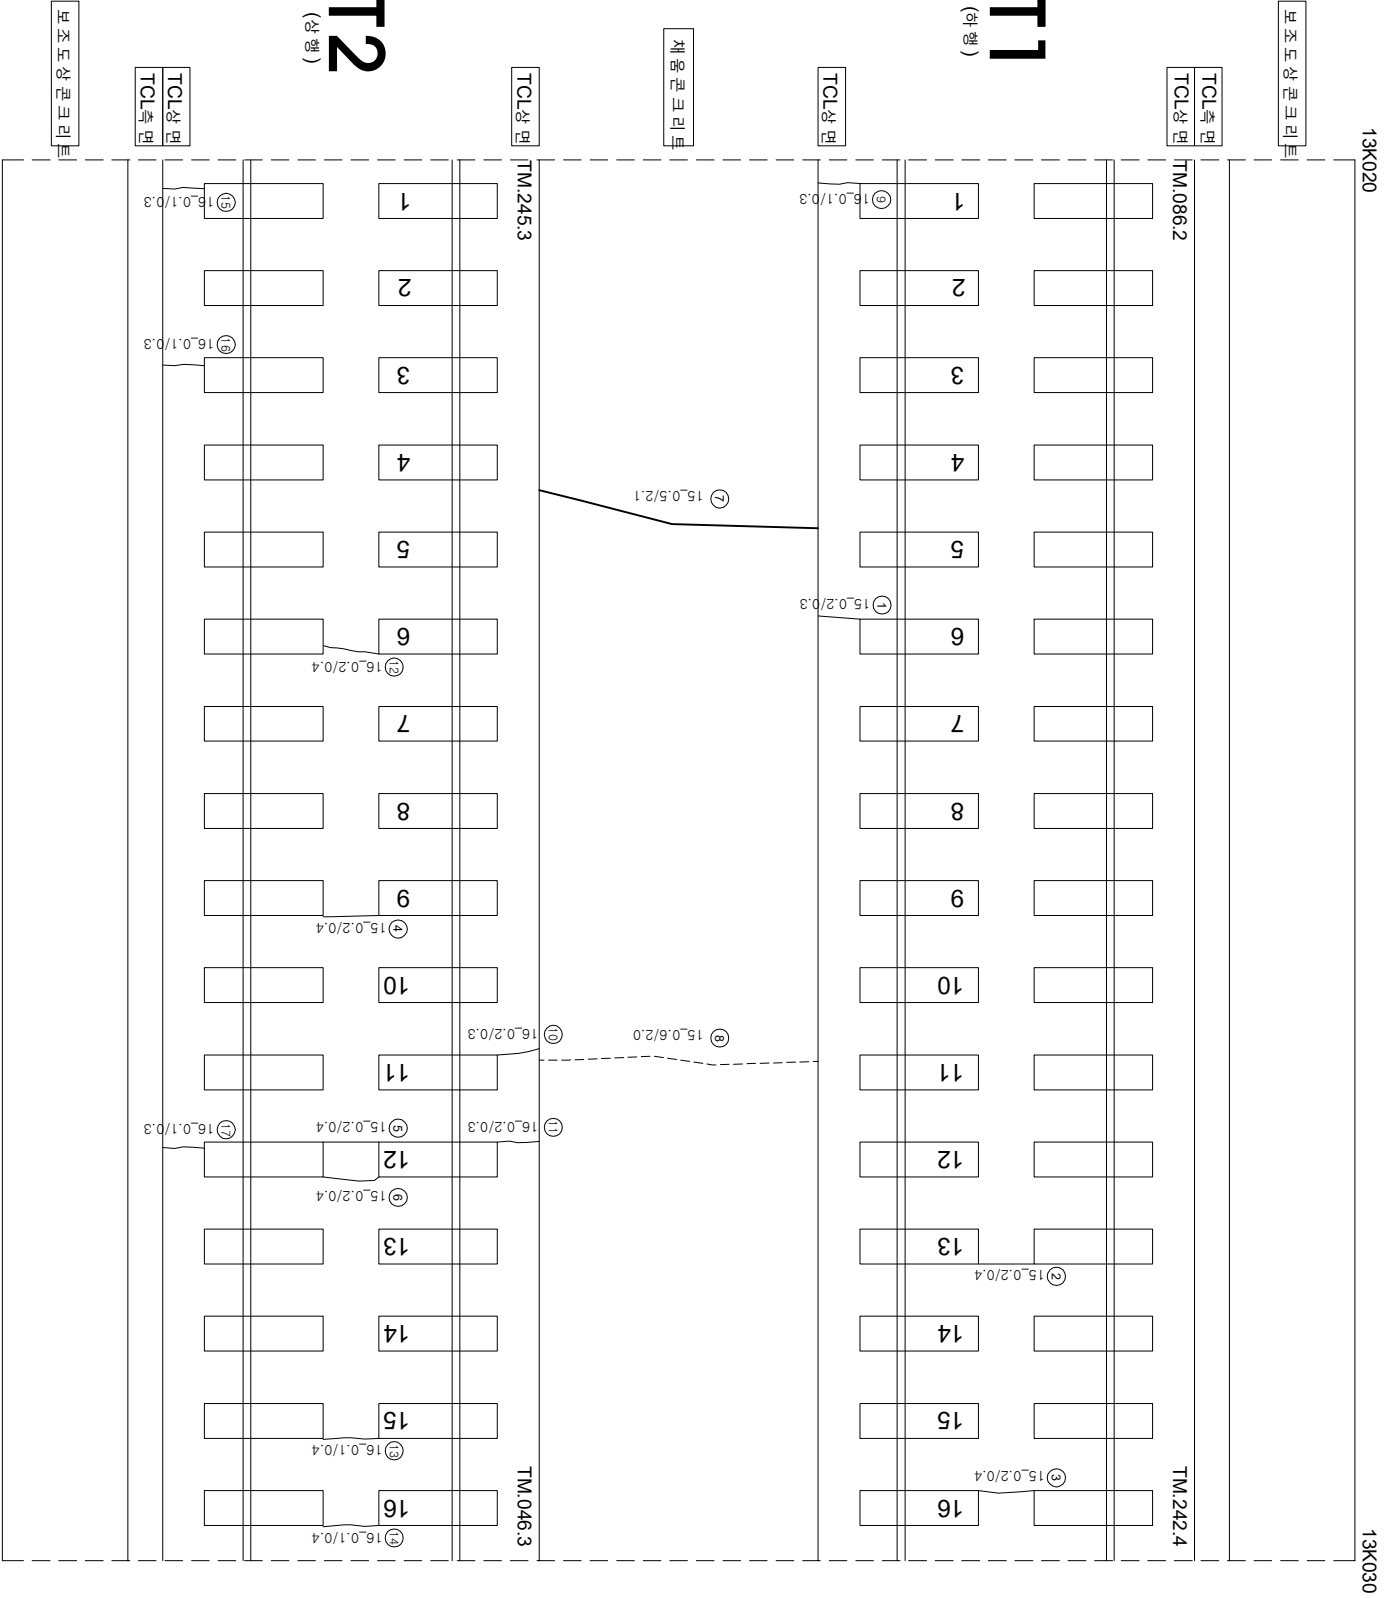
| 연번 | 순상 | 폭 | 연장 | 비고 | 연번 | 순상 | 폭 | 연장 | 비고 |
|---|---|---|---|---|---|---|---|---|---|
| 1 | 균열 0.2 mm | 0.3 m | | 56 | | | | | |
| 2 | 균열 0.2 mm | 0.4 m | | 57 | | | | | |
| 3 | 균열 0.2 mm | 0.4 m | | 58 | | | | | |
| 4 | 균열 0.2 mm | 0.4 m | | 59 | | | | | |
| 5 | 균열 0.2 mm | 0.4 m | | 60 | | | | | |
| 6 | 균열 0.2 mm | 0.4 m | | 61 | | | | | |
| 7 | 균열 0.5 mm | 2.1 m | | 62 | | | | | |
| 8 | 균열 0.6 mm | 2.0 m | | 63 | | | | | |
| 9 | 균열 0.1 mm | 0.3 m | | 64 | | | | | |
| 10 | 균열 0.2 mm | 0.3 m | | 65 | | | | | |
| 11 | 균열 0.2 mm | 0.3 m | | 66 | | | | | |
| 12 | 균열 0.2 mm | 0.4 m | | 67 | | | | | |
| 13 | 균열 0.1 mm | 0.4 m | | 68 | | | | | |
| 14 | 균열 0.1 mm | 0.4 m | | 69 | | | | | |
| 15 | 균열 0.1 mm | 0.3 m | | 70 | | | | | |
| 16 | 균열 0.1 mm | 0.3 m | | 71 | | | | | |
| 17 | 균열 0.1 mm | 0.3 m | | 72 | | | | | |
