호남고속선 부용터널\_33(13.160~13.171km, S31)

| 시 | 행 | 사 | 용 | 역 | 영 | 사 | 단 | | |
|---|---|---|---|---|---|---|---|---|---|
| KORAIL<br>KOREA RAILROAD | 한국철도공사 | 2017년도 호남고속선 오송-광주승강간 콘크리트케도 점검용역 | (주) 한국구조물안전연구원<br>(주) 한국도로안전연구원<br>(재) 한국건설품질연구원 | 이 복 영 | 간원강<br>김 경 기<br>문 준 기 | 영원 | 02220 (0.3m이하 : 목박) | 철로받판리 | 철로받판리 |

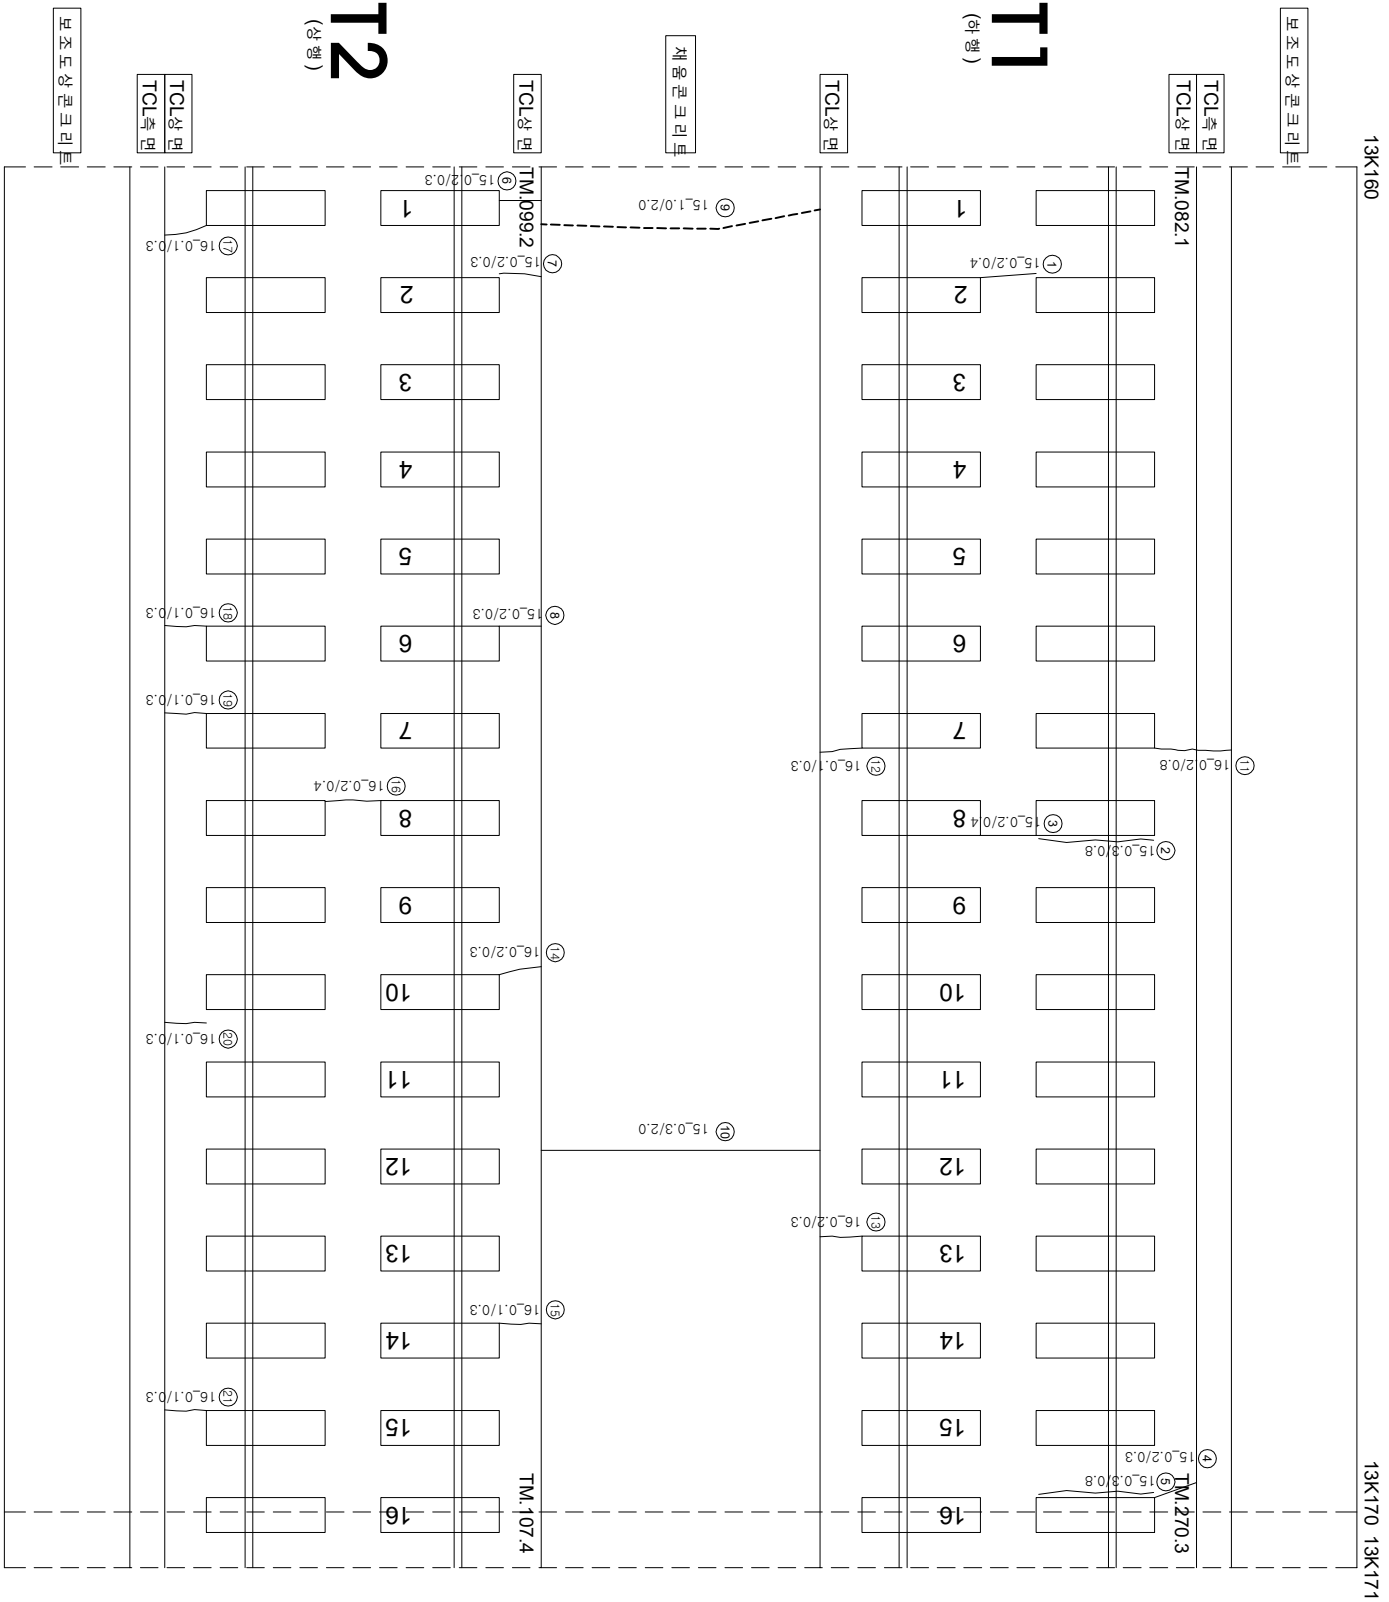
| 연번 | 순상 | 폭 | 연장 | 비고 | 연번 | 순상 | 폭 | 연장 | 비고 |
|---|---|---|---|---|---|---|---|---|---|
| 1 | 균열 | 0.2 mm | 0.4 m | | 56 | | | | |
| 2 | 경계부 균열 | 0.3 mm | 0.8 m | | 57 | | | | |
| 3 | 균열 | 0.2 mm | 0.4 m | | 58 | | | | |
| 4 | 균열 | 0.2 mm | 0.3 m | | 59 | | | | |
| 5 | 경계부 균열 | 0.3 mm | 0.8 m | | 60 | | | | |
| 6 | 균열 | 0.2 mm | 0.3 m | | 61 | | | | |
| 7 | 균열 | 0.2 mm | 0.3 m | | 62 | | | | |
| 8 | 균열 | 0.2 mm | 0.3 m | | 63 | | | | |
| 9 | 균열 | 1.0 mm | 2.0 m | | 64 | | | | |
| 10 | 균열 | 0.3 mm | 2.0 m | | 65 | | | | |
| 11 | 균열 | 0.2 mm | 0.8 m | | 66 | | | | |
| 12 | 균열 | 0.1 mm | 0.3 m | | 67 | | | | |
| 13 | 균열 | 0.2 mm | 0.3 m | | 68 | | | | |
| 14 | 균열 | 0.2 mm | 0.3 m | | 69 | | | | |
| 15 | 균열 | 0.1 mm | 0.3 m | | 70 | | | | |
| 16 | 균열 | 0.2 mm | 0.4 m | | 71 | | | | |
| 17 | 균열 | 0.1 mm | 0.3 m | | 72 | | | | |
| 18 | 균열 | 0.1 mm | 0.3 m | | 73 | | | | |
| 19 | 균열 | 0.1 mm | 0.3 m | | 74 | | | | |
| 20 | 균열 | 0.1 mm | 0.3 m | | 75 | | | | |
| 21 | 균열 | 0.1 mm | 0.3 m | | 76 | | | | |
