호남고속선 부용터널-66(13k490~13k501km, S64)

| 시 | 행 | 사 | 용 | 역 | 영 | 사 | 단 | | |
|---|---|---|---|---|---|---|---|---|---|
| KORAIL<br>KOREA RAILROAD | 한국철도공사 | 2017년도 호남고속선 오송-광주승강간 콘크리트케도 점검용역 | (주) 한국구조물안전연구원<br>(주) 한국도로안전연구원<br>(재) 한국건설품질연구원 | 이 복 영 | 간 윤 강<br>김 경 기<br>문 준 기 | 영원 | 02220 (0.3m이하 : 목책) | 침목도상반리 | 재료반리 |

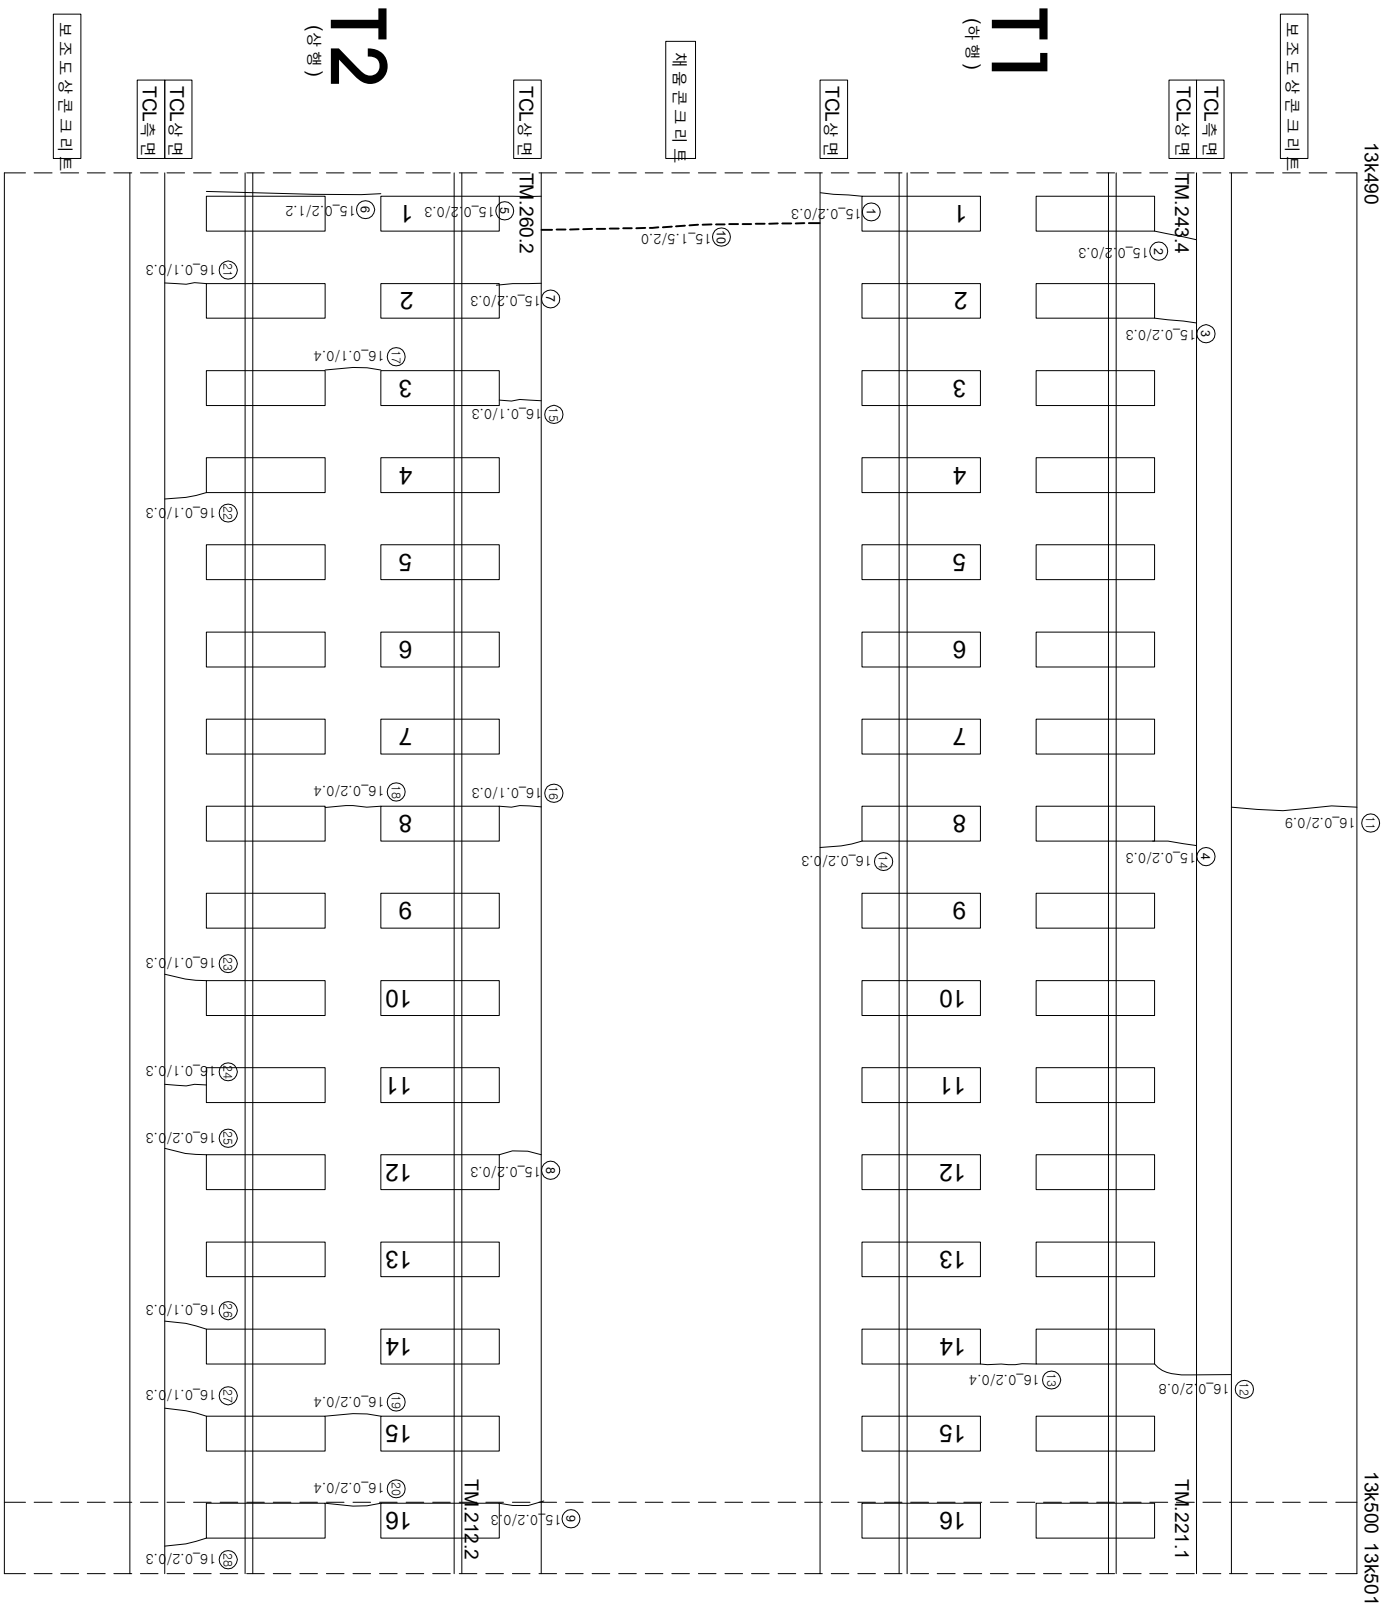
| 연번 | 순차 | 폭 | 연장 | 비고 | 연번 | 순차 | 폭 | 연장 | 비고 |
|---|---|---|---|---|---|---|---|---|---|
| 1 | 균열 | 0.2 mm | 0.3 m | | 56 | | | | |
| 2 | 균열 | 0.2 mm | 0.3 m | | 57 | | | | |
| 3 | 균열 | 0.2 mm | 0.3 m | | 58 | | | | |
| 4 | 균열 | 0.2 mm | 0.3 m | | 59 | | | | |
| 5 | 균열 | 0.2 mm | 0.3 m | | 60 | | | | |
| 6 | 경계부 균열 | 0.2 mm | 1.2 m | | 61 | | | | |
| 7 | 균열 | 0.2 mm | 0.3 m | | 62 | | | | |
| 8 | 균열 | 0.2 mm | 0.3 m | | 63 | | | | |
| 9 | 균열 | 0.2 mm | 0.3 m | | 64 | | | | |
| 10 | 균열 | 1.5 mm | 2.0 m | | 65 | | | | |
| 11 | 균열 | 0.2 mm | 0.9 m | | 66 | | | | |
| 12 | 균열 | 0.2 mm | 0.8 m | | 67 | | | | |
| 13 | 균열 | 0.2 mm | 0.4 m | | 68 | | | | |
| 14 | 균열 | 0.2 mm | 0.3 m | | 69 | | | | |
| 15 | 균열 | 0.1 mm | 0.3 m | | 70 | | | | |
| 16 | 균열 | 0.1 mm | 0.3 m | | 71 | | | | |
| 17 | 균열 | 0.1 mm | 0.4 m | | 72 | | | | |
| 18 | 균열 | 0.2 mm | 0.4 m | | 73 | | | | |
| 19 | 균열 | 0.2 mm | 0.4 m | | 74 | | | | |
| 20 | 균열 | 0.2 mm | 0.4 m | | 75 | | | | |
| 21 | 균열 | 0.1 mm | 0.3 m | | 76 | | | | |
| 22 | 균열 | 0.1 mm | 0.3 m | | 77 | | | | |
| 23 | 균열 | 0.1 mm | 0.3 m | | 78 | | | | |
| 24 | 균열 | 0.1 mm | 0.3 m | | 79 | | | | |
| 25 | 균열 | 0.2 mm | 0.3 m | | 80 | | | | |
| 26 | 균열 | 0.1 mm | 0.3 m | | 81 | | | | |
| 27 | 균열 | 0.1 mm | 0.3 m | | 82 | | | | |
| 28 | 균열 | 0.2 mm | 0.3 m | | 83 | | | | |
