호남고속선 부용터널\_92(13k750.~13k760.km, S90)

| 시 | 행 | 사 | 용 | 역 | 영 | 사 | 단 | | |
|---|---|---|---|---|---|---|---|---|---|
| KORAIL<br>KOREA RAILROAD | 한국철도공사 | 2017년도 호남고속선 오송-광주승강간 콘크리트케도 점검용역 | (주) 한국구조물안전연구원<br>(주) 한국도로안전연구원<br>(재) 한국건설품질연구원 | 이 복 영 | 간원강<br>김 경 기<br>문 준 기 | 영원 | 02220 (0.3m이하 : 목박) | 철로받판리 | 철로받판리 |

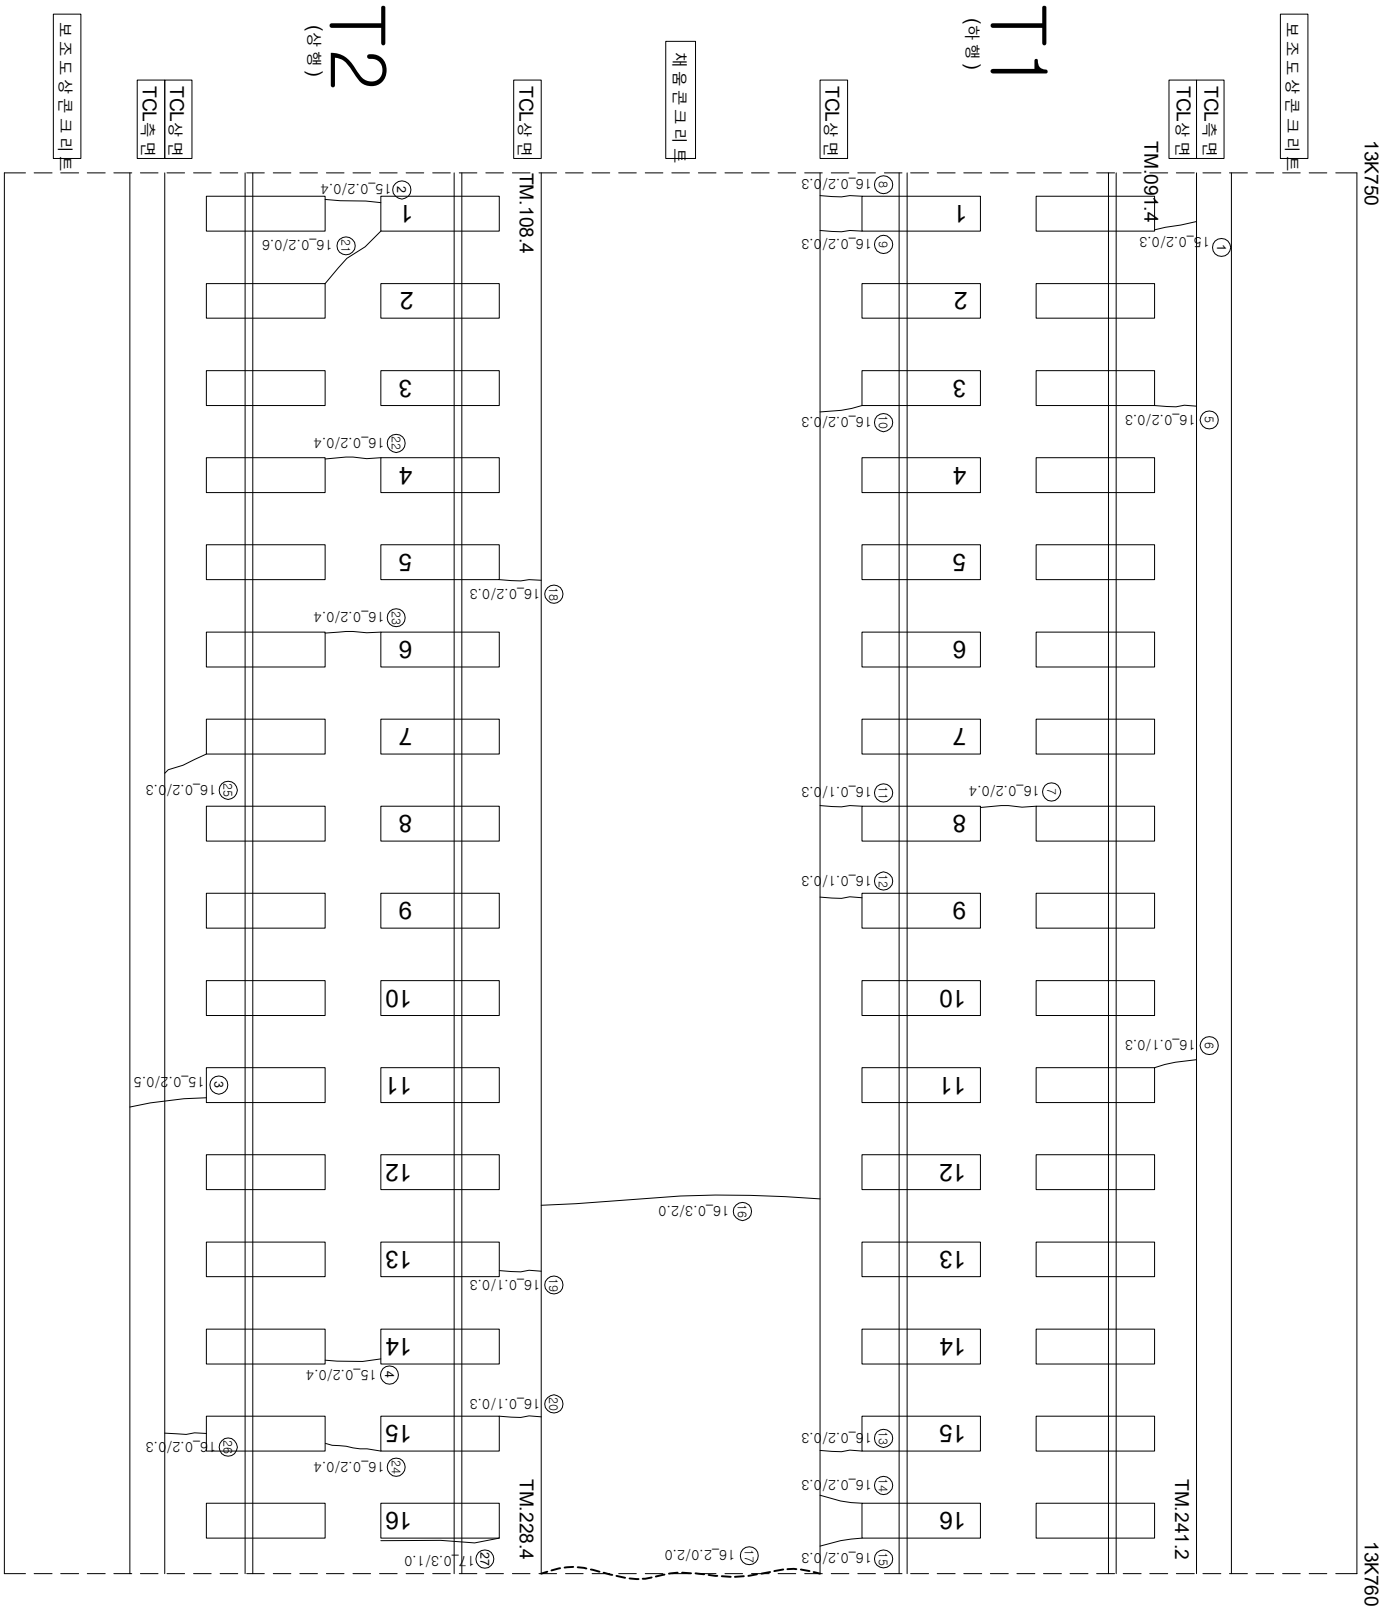
| 연번 | 순상 | 폭 | 연장 | 비고 | 연번 | 순상 | 폭 | 연장 | 비고 |
|---|---|---|---|---|---|---|---|---|---|
| 1 | 균열 | 0.2 mm | 0.3 m | | 56 | | | | |
| 2 | 균열 | 0.2 mm | 0.4 m | | 57 | | | | |
| 3 | 균열 | 0.2 mm | 0.5 m | | 58 | | | | |
| 4 | 균열 | 0.2 mm | 0.4 m | | 59 | | | | |
| 5 | 균열 | 0.2 mm | 0.3 m | | 60 | | | | |
| 6 | 균열 | 0.1 mm | 0.3 m | | 61 | | | | |
| 7 | 균열 | 0.2 mm | 0.4 m | | 62 | | | | |
| 8 | 균열 | 0.2 mm | 0.3 m | | 63 | | | | |
| 9 | 균열 | 0.2 mm | 0.3 m | | 64 | | | | |
| 10 | 균열 | 0.2 mm | 0.3 m | | 65 | | | | |
| 11 | 균열 | 0.1 mm | 0.3 m | | 66 | | | | |
| 12 | 균열 | 0.1 mm | 0.3 m | | 67 | | | | |
| 13 | 균열 | 0.2 mm | 0.3 m | | 68 | | | | |
| 14 | 균열 | 0.2 mm | 0.3 m | | 69 | | | | |
| 15 | 균열 | 0.2 mm | 0.3 m | | 70 | | | | |
| 16 | 균열 | 0.3 mm | 2.0 m | | 71 | | | | |
| 17 | 균열 | 2.0 mm | 2.0 m | | 72 | | | | |
| 18 | 균열 | 0.2 mm | 0.3 m | | 73 | | | | |
| 19 | 균열 | 0.1 mm | 0.3 m | | 74 | | | | |
| 20 | 균열 | 0.1 mm | 0.3 m | | 75 | | | | |
| 21 | 균열 | 0.2 mm | 0.6 m | | 76 | | | | |
| 22 | 균열 | 0.2 mm | 0.4 m | | 77 | | | | |
| 23 | 균열 | 0.2 mm | 0.4 m | | 78 | | | | |
| 24 | 균열 | 0.2 mm | 0.4 m | | 79 | | | | |
| 25 | 균열 | 0.2 mm | 0.3 m | | 80 | | | | |
| 26 | 균열 | 0.2 mm | 0.3 m | | 81 | | | | |
| 27 | 장계부 균열 | 0.3 mm | 1.0 m | 신규 | 82 | | | | |
