호남고속선 부용터널\_96(13k790.~13k800.km, S94)

| 시 | 행 사 | 영 역 | 영 역 | 영 역 | 사 | 인 지 | | 단 | |
|---|---|---|---|---|---|---|---|---|---|
| | 한국철도공사<br>KOREA RAILROAD | 2017년도 호남고속선 오송-광주승강간 콘크리트케도 정검용역 | (주) 한국구조물안전연구원<br>(주) 한국도로안전연구원<br>(재) 한국건설품질연구원 | 이 박 영 | 간 원 강<br>김 경 기<br>윤 석 기 | 영역 | 0220 (0.3m이하 : 흑색) | 참목도상문리 | |

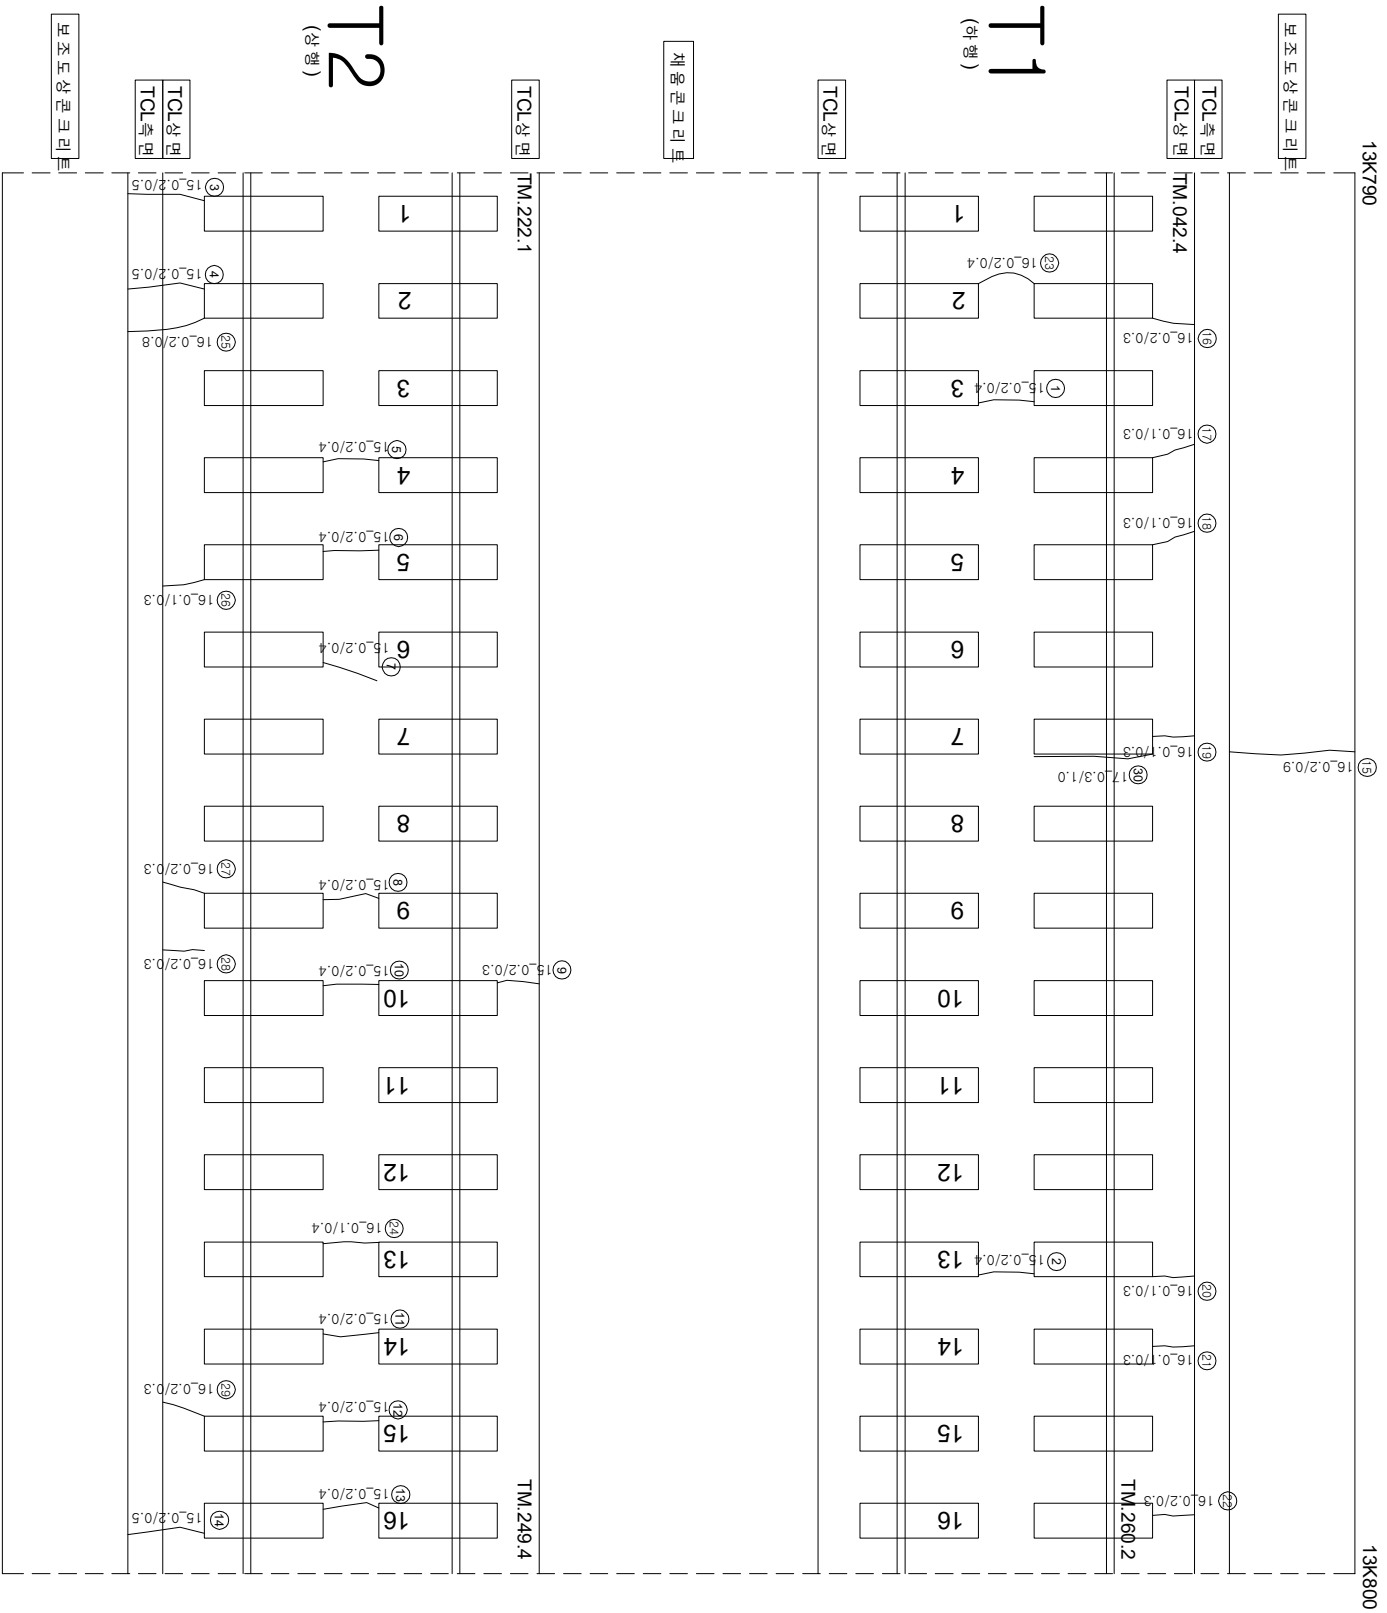
| 연번 | 순상 | 폭 | 연장 | 비고 | 연번 | 순상 | 폭 | 연장 | 비고 |
|---|---|---|---|---|---|---|---|---|---|
| 1 | 균열 | 0.2 mm | 0.4 m | | 56 | | | | |
| 2 | 균열 | 0.2 mm | 0.4 m | | 57 | | | | |
| 3 | 균열 | 0.2 mm | 0.5 m | | 58 | | | | |
| 4 | 균열 | 0.2 mm | 0.5 m | | 59 | | | | |
| 5 | 균열 | 0.2 mm | 0.4 m | | 60 | | | | |
| 6 | 균열 | 0.2 mm | 0.4 m | | 61 | | | | |
| 7 | 균열 | 0.2 mm | 0.4 m | | 62 | | | | |
| 8 | 균열 | 0.2 mm | 0.4 m | | 63 | | | | |
| 9 | 균열 | 0.2 mm | 0.3 m | | 64 | | | | |
| 10 | 균열 | 0.2 mm | 0.4 m | | 65 | | | | |
| 11 | 균열 | 0.2 mm | 0.4 m | | 66 | | | | |
| 12 | 균열 | 0.2 mm | 0.4 m | | 67 | | | | |
| 13 | 균열 | 0.2 mm | 0.4 m | | 68 | | | | |
| 14 | 균열 | 0.2 mm | 0.5 m | | 69 | | | | |
| 15 | 균열 | 0.2 mm | 0.9 m | | 70 | | | | |
| 16 | 균열 | 0.2 mm | 0.3 m | | 71 | | | | |
| 17 | 균열 | 0.1 mm | 0.3 m | | 72 | | | | |
| 18 | 균열 | 0.1 mm | 0.3 m | | 73 | | | | |
| 19 | 균열 | 0.1 mm | 0.3 m | | 74 | | | | |
| 20 | 균열 | 0.1 mm | 0.3 m | | 75 | | | | |
| 21 | 균열 | 0.1 mm | 0.3 m | | 76 | | | | |
| 22 | 균열 | 0.2 mm | 0.3 m | | 77 | | | | |
| 23 | 균열 | 0.2 mm | 0.4 m | | 78 | | | | |
| 24 | 균열 | 0.1 mm | 0.4 m | | 79 | | | | |
| 25 | 균열 | 0.2 mm | 0.8 m | | 80 | | | | |
| 26 | 균열 | 0.1 mm | 0.3 m | | 81 | | | | |
| 27 | 균열 | 0.2 mm | 0.3 m | | 82 | | | | |
| 28 | 균열 | 0.2 mm | 0.3 m | | 83 | | | | |
| 29 | 균열 | 0.2 mm | 0.3 m | | 84 | | | | |
| 30 | 관계부 균열 | 0.3 mm | 1.0 m | 신구 | 85 | | | | |
