한남고속선 부용터널-100(13K830.~13K840.km, S98)

| 시 | 행 | 사 | 용 | 역 | 영 | 사 | 단 | | |
|---|---|---|---|---|---|---|---|---|---|
| KORAIL<br>KOREA RAILROAD | 한국철도공사 | 2017년도 호남고속선 오송-광주승강간 콘크리트케도 점검용역 | (주) 한국구조물안전연구원<br>(주) 한국도로안전연구원<br>(재) 한국건설품질연구원 | 이 복 영 | 간윤강<br>김경기<br>문석기 | 영남 | 02220 (0.3m이하 : 목박) | 침목도상반리 | 재료반리 |

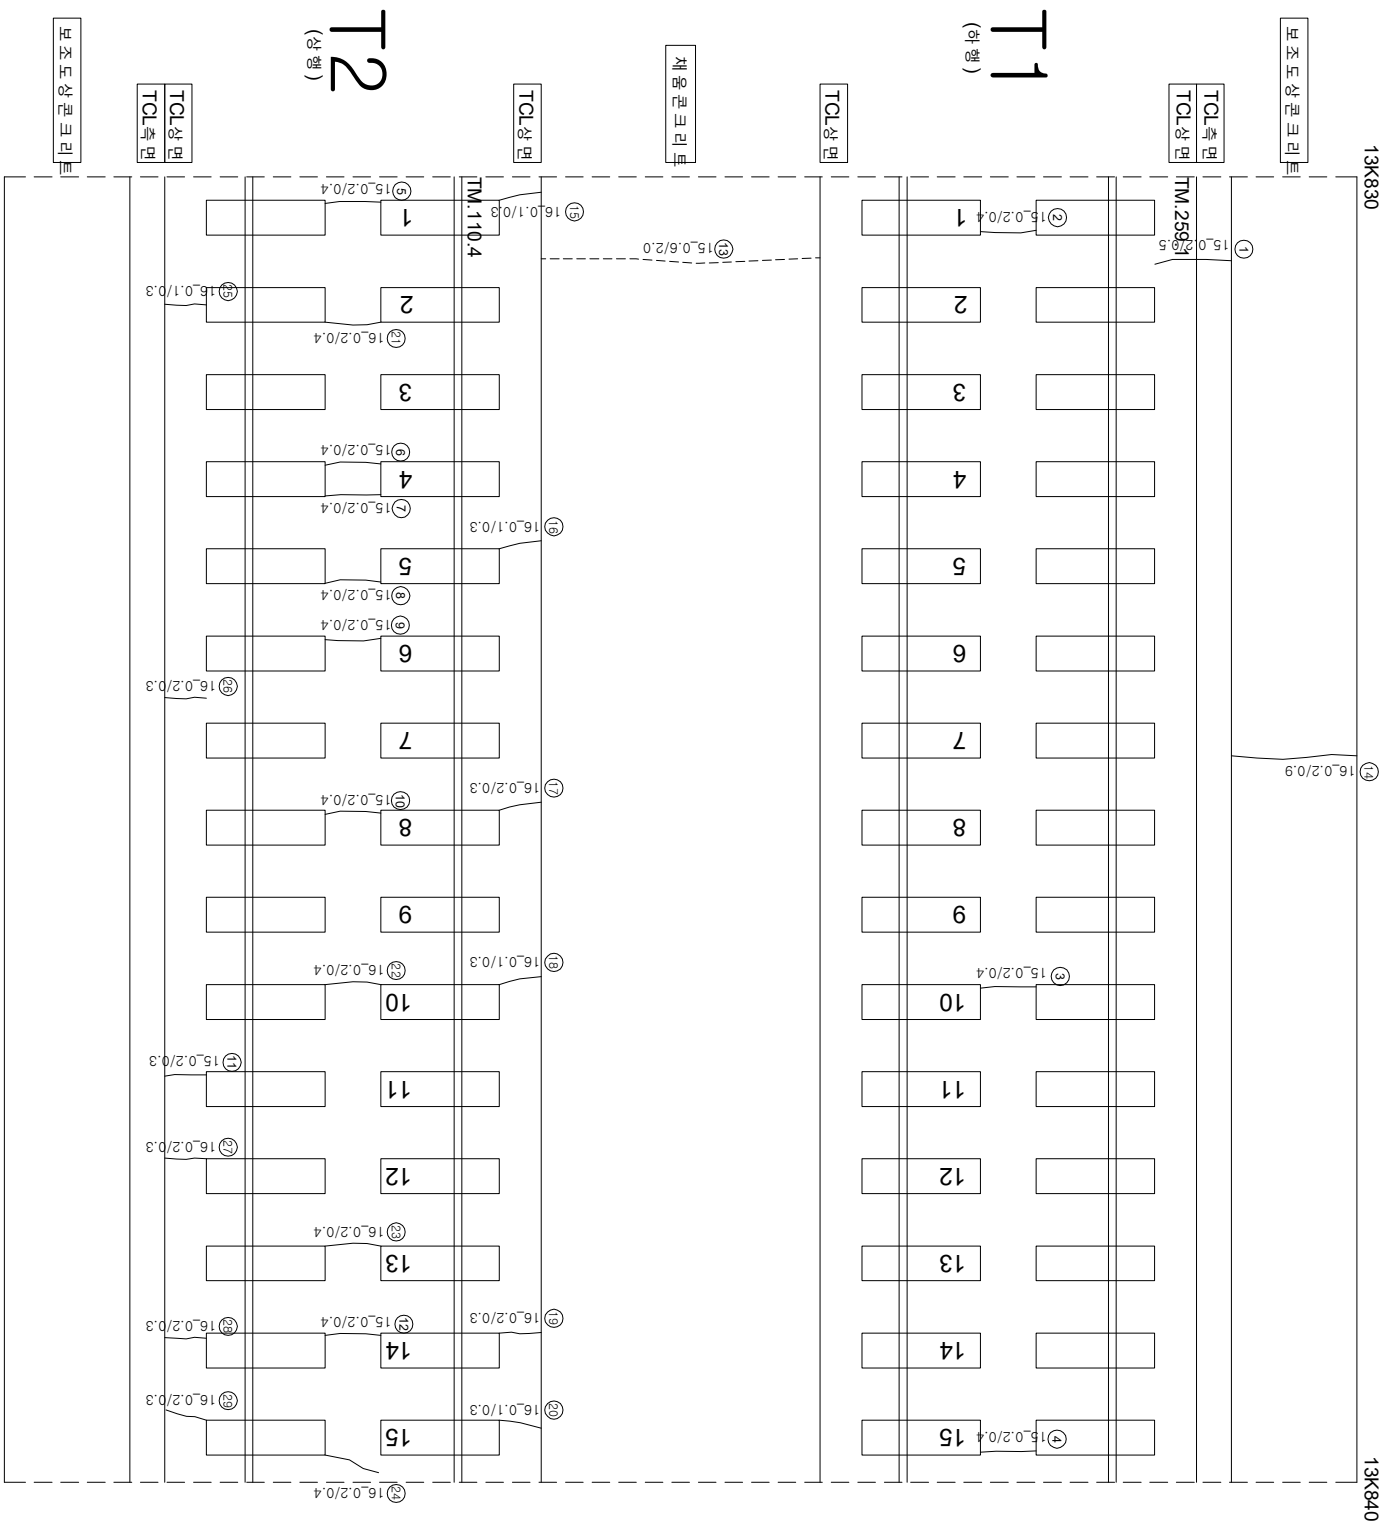
| 연번 | 순상 | 폭 | 연장 | 비고 | 연번 | 순상 | 폭 | 연장 | 비고 |
|---|---|---|---|---|---|---|---|---|---|
| 1 | 균열 | 0.2 mm | 0.5 m | | 56 | | | | |
| 2 | 균열 | 0.2 mm | 0.4 m | | 57 | | | | |
| 3 | 균열 | 0.2 mm | 0.4 m | | 58 | | | | |
| 4 | 균열 | 0.2 mm | 0.4 m | | 59 | | | | |
| 5 | 균열 | 0.2 mm | 0.4 m | | 60 | | | | |
| 6 | 균열 | 0.2 mm | 0.4 m | | 61 | | | | |
| 7 | 균열 | 0.2 mm | 0.4 m | | 62 | | | | |
| 8 | 균열 | 0.2 mm | 0.4 m | | 63 | | | | |
| 9 | 균열 | 0.2 mm | 0.4 m | | 64 | | | | |
| 10 | 균열 | 0.2 mm | 0.4 m | | 65 | | | | |
| 11 | 균열 | 0.2 mm | 0.3 m | | 66 | | | | |
| 12 | 균열 | 0.2 mm | 0.4 m | | 67 | | | | |
| 13 | 균열 | 0.6 mm | 2.0 m | | 68 | | | | |
| 14 | 균열 | 0.2 mm | 0.9 m | | 69 | | | | |
| 15 | 균열 | 0.1 mm | 0.3 m | | 70 | | | | |
| 16 | 균열 | 0.1 mm | 0.3 m | | 71 | | | | |
| 17 | 균열 | 0.2 mm | 0.3 m | | 72 | | | | |
| 18 | 균열 | 0.1 mm | 0.3 m | | 73 | | | | |
| 19 | 균열 | 0.2 mm | 0.3 m | | 74 | | | | |
| 20 | 균열 | 0.1 mm | 0.3 m | | 75 | | | | |
| 21 | 균열 | 0.2 mm | 0.4 m | | 76 | | | | |
| 22 | 균열 | 0.2 mm | 0.4 m | | 77 | | | | |
| 23 | 균열 | 0.2 mm | 0.4 m | | 78 | | | | |
| 24 | 균열 | 0.2 mm | 0.4 m | | 79 | | | | |
| 25 | 균열 | 0.1 mm | 0.3 m | | 80 | | | | |
| 26 | 균열 | 0.2 mm | 0.3 m | | 81 | | | | |
| 27 | 균열 | 0.2 mm | 0.3 m | | 82 | | | | |
| 28 | 균열 | 0.2 mm | 0.3 m | | 83 | | | | |
| 29 | 균열 | 0.2 mm | 0.3 m | | 84 | | | | |
