호남고속선 부용터널\_113(13.960~13.970km, S111)

| 시 | 행 | 사 | 용 | 역 | 영 | 사 | 단 | | |
|---|---|---|---|---|---|---|---|---|---|
| KORAIL<br>KOREA RAILROAD | 한국철도공사 | 2017년도 호남고속선 오송-광주승정간 콘크리트케도 점검용역 | (주) 한국구조물안전연구원<br>(주) 한국도로안전연구원<br>(재) 한국건설품질연구원 | 이 복 영 | 간 원 강<br>김 경 기<br>문 준 기 | 영원 | 02220 (0.3m이하 : 목박) | 철로받판리 | 철로받판리 |

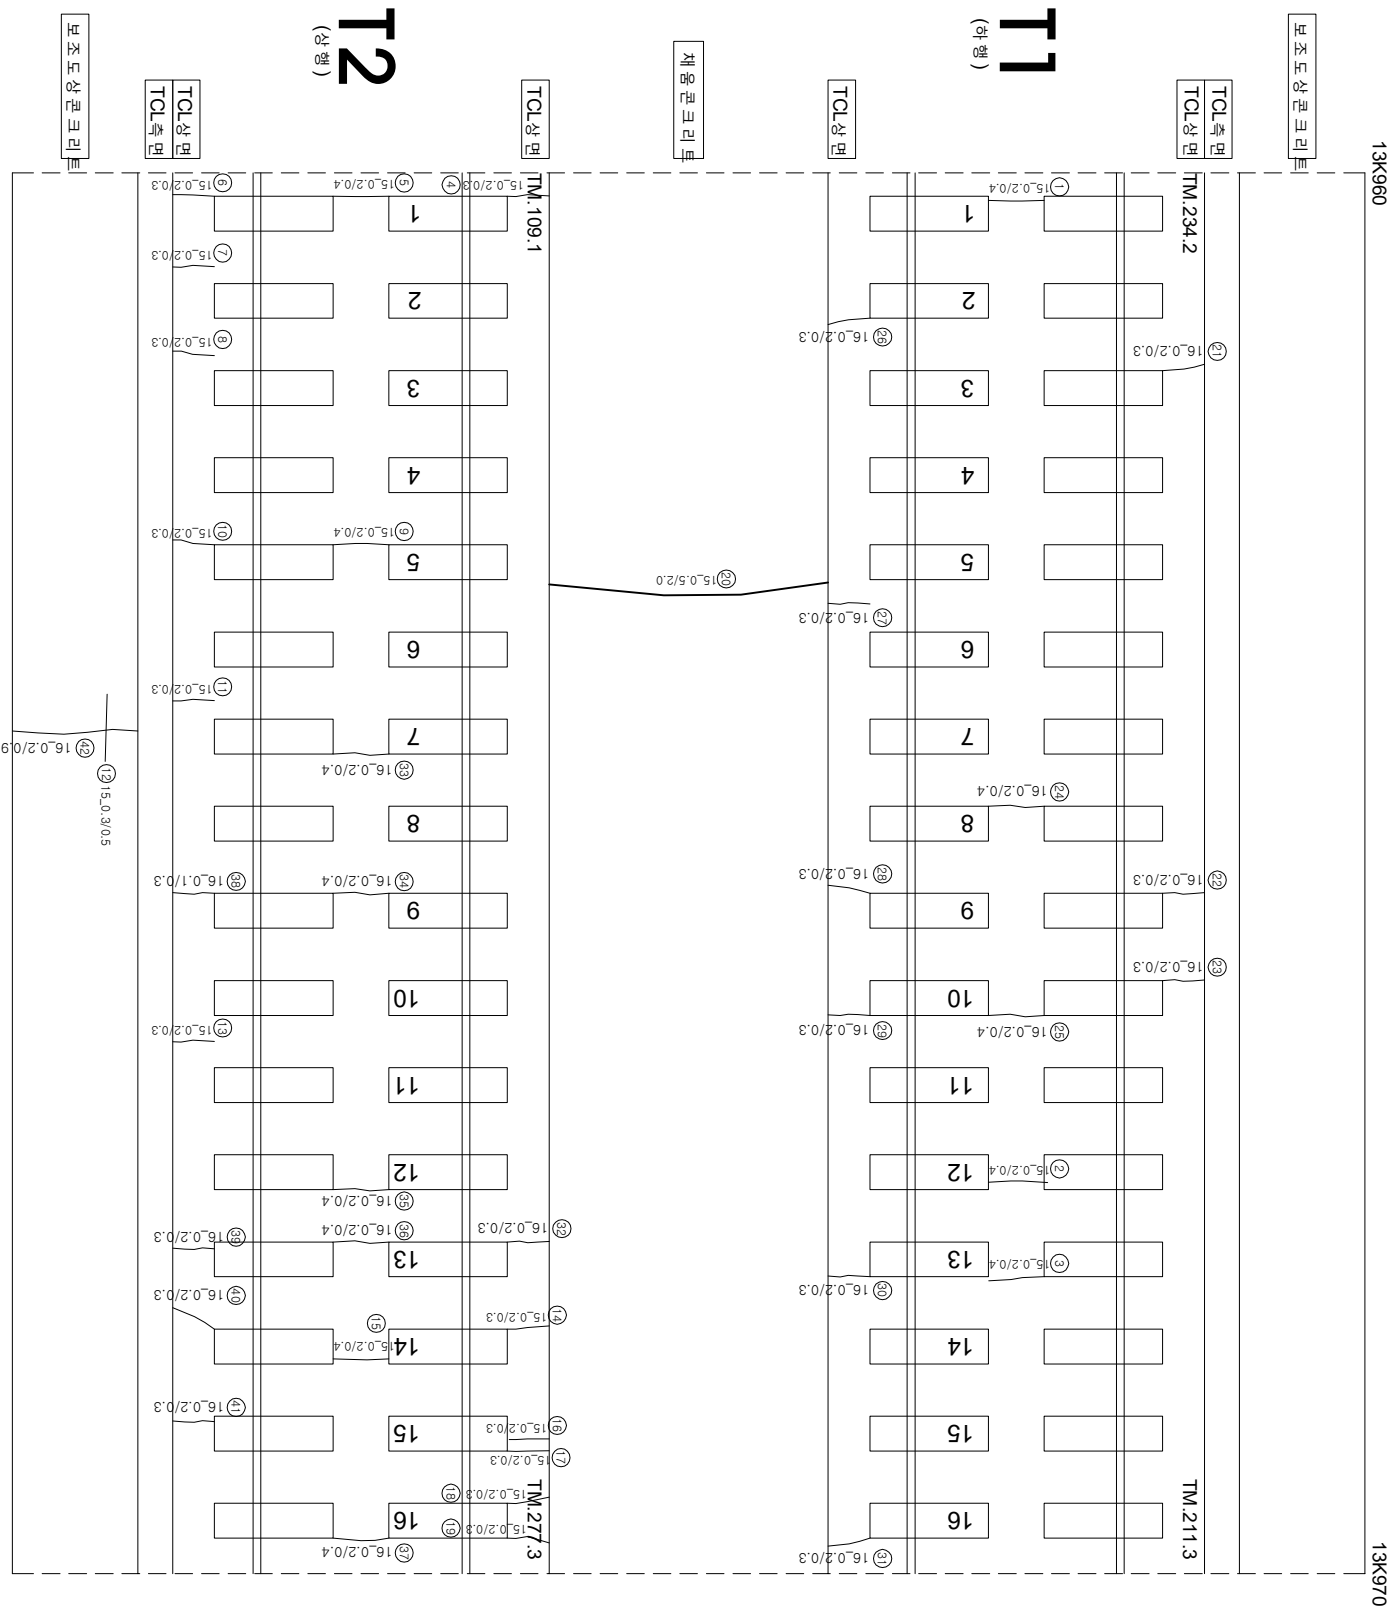
| 연번 | 순상 | 폭 | 연장 | 비고 | 연번 | 순상 | 폭 | 연장 | 비고 |
|---|---|---|---|---|---|---|---|---|---|
| 1 | 균열 | 0.2 | 0.4 | m | 56 | | | | |
| 2 | 균열 | 0.2 | 0.4 | m | 57 | | | | |
| 3 | 균열 | 0.2 | 0.4 | m | 58 | | | | |
| 4 | 균열 | 0.2 | 0.3 | m | 59 | | | | |
| 5 | 균열 | 0.2 | 0.4 | m | 60 | | | | |
| 6 | 균열 | 0.2 | 0.3 | m | 61 | | | | |
| 7 | 균열 | 0.2 | 0.3 | m | 62 | | | | |
| 8 | 균열 | 0.2 | 0.3 | m | 63 | | | | |
| 9 | 균열 | 0.2 | 0.4 | m | 64 | | | | |
| 10 | 균열 | 0.2 | 0.3 | m | 65 | | | | |
| 11 | 균열 | 0.2 | 0.3 | m | 66 | | | | |
| 12 | 균열 | 0.3 | 0.5 | m | 67 | | | | |
| 13 | 균열 | 0.2 | 0.3 | m | 68 | | | | |
| 14 | 균열 | 0.2 | 0.3 | m | 69 | | | | |
| 15 | 균열 | 0.2 | 0.4 | m | 70 | | | | |
| 16 | 균열 | 0.2 | 0.3 | m | 71 | | | | |
| 17 | 균열 | 0.2 | 0.3 | m | 72 | | | | |
| 18 | 균열 | 0.2 | 0.3 | m | 73 | | | | |
| 19 | 균열 | 0.2 | 0.3 | m | 74 | | | | |
| 20 | 균열 | 0.5 | 2.0 | m | 75 | | | | |
| 21 | 균열 | 0.2 | 0.3 | m | 76 | | | | |
| 22 | 균열 | 0.2 | 0.3 | m | 77 | | | | |
| 23 | 균열 | 0.2 | 0.3 | m | 78 | | | | |
| 24 | 균열 | 0.2 | 0.4 | m | 79 | | | | |
| 25 | 균열 | 0.2 | 0.4 | m | 80 | | | | |
| 26 | 균열 | 0.2 | 0.3 | m | 81 | | | | |
| 27 | 균열 | 0.2 | 0.3 | m | 82 | | | | |
| 28 | 균열 | 0.2 | 0.3 | m | 83 | | | | |
| 29 | 균열 | 0.2 | 0.3 | m | 84 | | | | |
| 30 | 균열 | 0.2 | 0.3 | m | 85 | | | | |
| 31 | 균열 | 0.2 | 0.3 | m | 86 | | | | |
| 32 | 균열 | 0.2 | 0.3 | m | 87 | | | | |
| 33 | 균열 | 0.2 | 0.4 | m | 88 | | | | |
| 34 | 균열 | 0.2 | 0.4 | m | 89 | | | | |
| 35 | 균열 | 0.2 | 0.4 | m | 90 | | | | |
| 36 | 균열 | 0.2 | 0.4 | m | 91 | | | | |
| 37 | 균열 | 0.2 | 0.4 | m | 92 | | | | |
| 38 | 균열 | 0.1 | 0.3 | m | 93 | | | | |
| 39 | 균열 | 0.2 | 0.3 | m | 94 | | | | |
| 40 | 균열 | 0.2 | 0.3 | m | 95 | | | | |
| 41 | 균열 | 0.2 | 0.3 | m | 96 | | | | |
| 42 | 균열 | 0.2 | 0.9 | m | 97 | | | | |
