호남고속선 부용터널\_125(14.080~14.090km, S123)

| 시 | 행 | 사 | 용 | 역 | 영 | 사 | 단 | | 영 |
|---|---|---|---|---|---|---|---|---|---|
| KORAIL<br>KOREA RAILROAD | 한국철도공사 | 2017년도 호남고속선 오송-광주승정간 콘크리트케도 점검용역 | (주) 한국구조물안전연구원<br>(주) 한국도로안전연구원<br>(재) 한국건설품질연구원 | 이 복 영 | 간 원 강<br>김 경 기<br>문 준 기 | 영 | 02220 (0.3mm이하 : 흑색) | 침목도상판리 | |

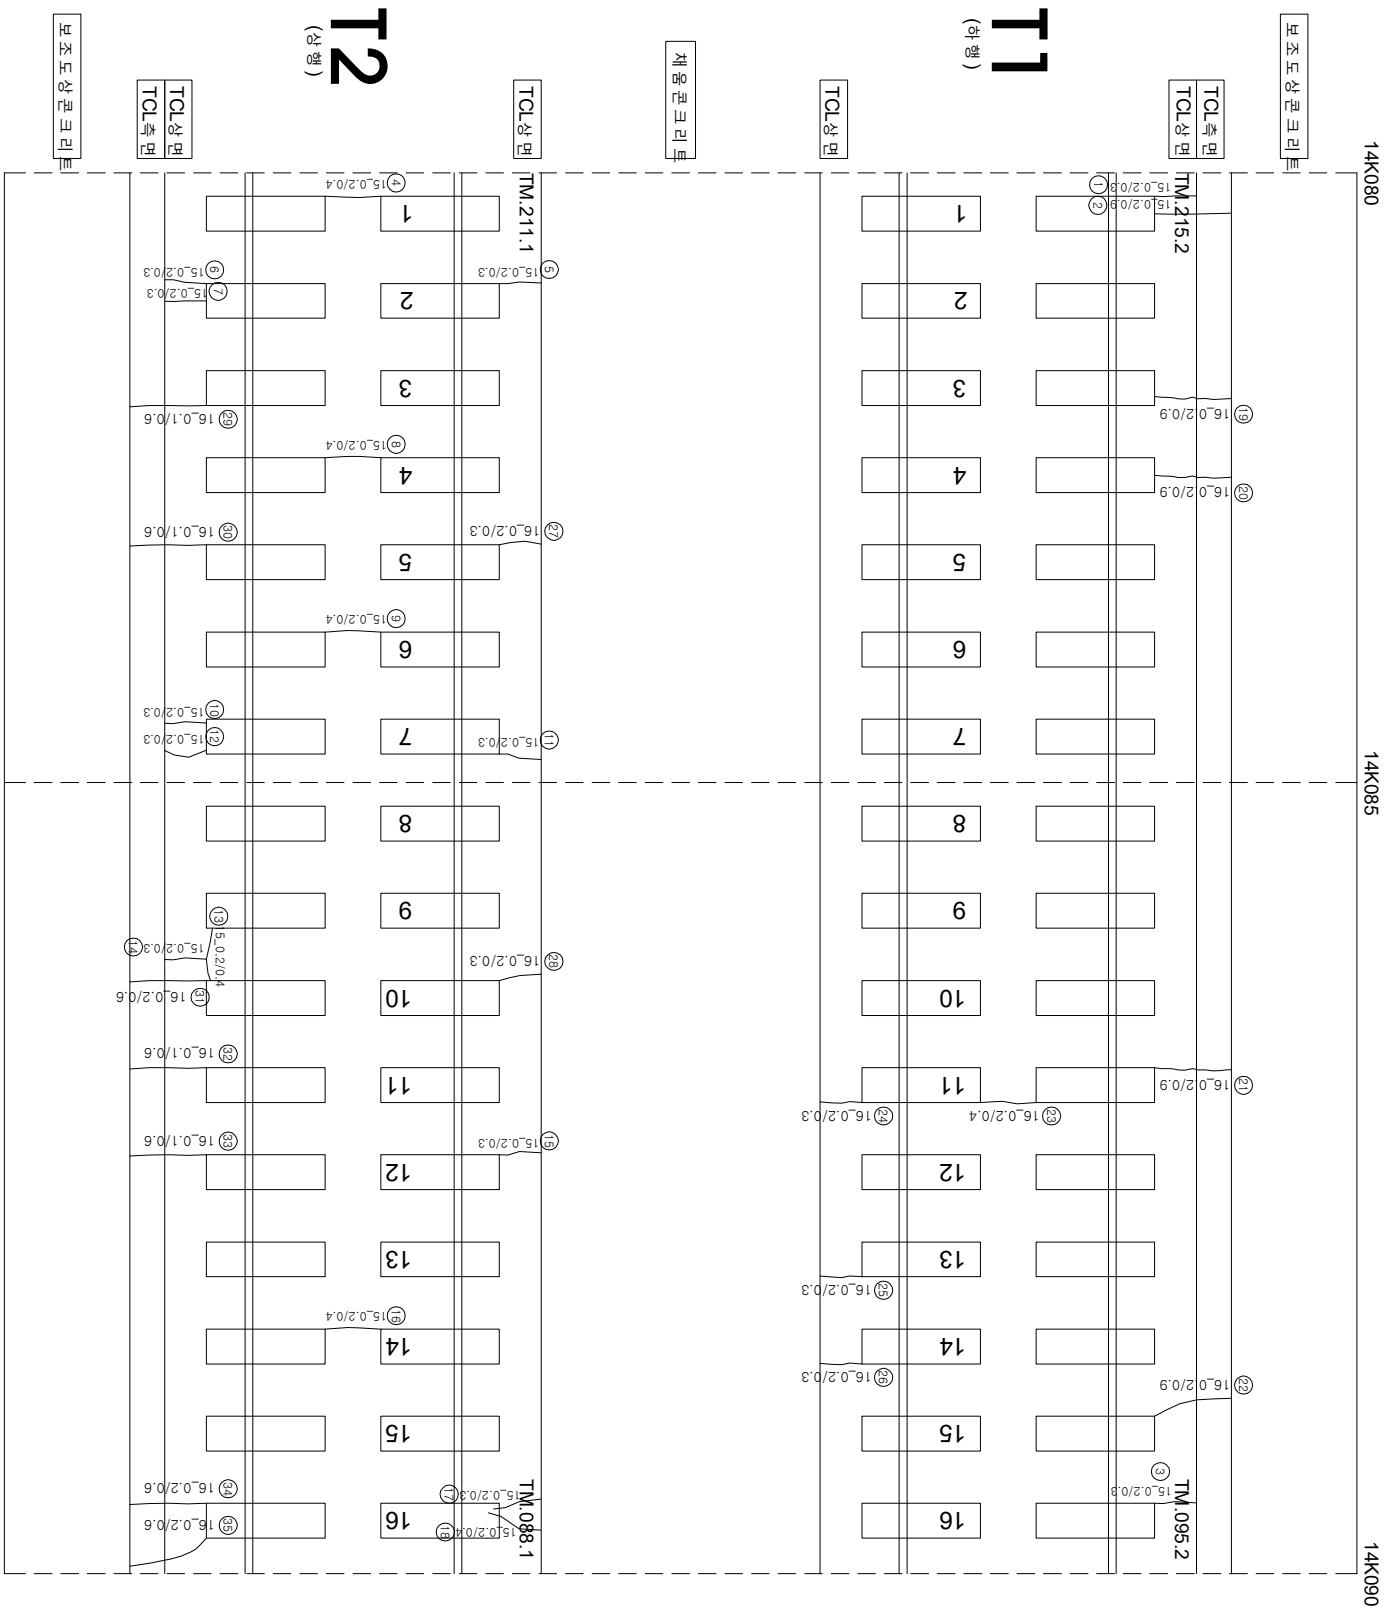
| 연번 | 순상 | 폭 | 연장 | 비고 | 연번 | 순상 | 폭 | 연장 | 비고 |
|---|---|---|---|---|---|---|---|---|---|
| 1 | 균열 | 0.2 | 0.3 | m | 56 | | | | |
| 2 | 균열(변경) | 0.2 | 0.9 | m | 57 | | | | |
| 3 | 균열 | 0.2 | 0.3 | m | 58 | | | | |
| 4 | 균열 | 0.2 | 0.4 | m | 59 | | | | |
| 5 | 균열 | 0.2 | 0.3 | m | 60 | | | | |
| 6 | 균열 | 0.2 | 0.3 | m | 61 | | | | |
| 7 | 균열 | 0.2 | 0.3 | m | 62 | | | | |
| 8 | 균열 | 0.2 | 0.4 | m | 63 | | | | |
| 9 | 균열 | 0.2 | 0.4 | m | 64 | | | | |
| 10 | 균열 | 0.2 | 0.3 | m | 65 | | | | |
| 11 | 균열 | 0.2 | 0.3 | m | 66 | | | | |
| 12 | 균열 | 0.2 | 0.3 | m | 67 | | | | |
| 13 | 균열 | 0.2 | 0.4 | m | 68 | | | | |
| 14 | 균열 | 0.2 | 0.3 | m | 69 | | | | |
| 15 | 균열 | 0.2 | 0.3 | m | 70 | | | | |
| 16 | 균열 | 0.2 | 0.4 | m | 71 | | | | |
| 17 | 균열 | 0.2 | 0.3 | m | 72 | | | | |
| 18 | 균열 | 0.2 | 0.3 | m | 73 | | | | |
| 19 | 균열 | 0.2 | 0.9 | m | 74 | | | | |
| 20 | 균열 | 0.2 | 0.9 | m | 75 | | | | |
| 21 | 균열 | 0.2 | 0.9 | m | 76 | | | | |
| 22 | 균열 | 0.2 | 0.9 | m | 77 | | | | |
| 23 | 균열 | 0.2 | 0.4 | m | 78 | | | | |
| 24 | 균열 | 0.2 | 0.3 | m | 79 | | | | |
| 25 | 균열 | 0.2 | 0.3 | m | 80 | | | | |
| 26 | 균열 | 0.2 | 0.3 | m | 81 | | | | |
| 27 | 균열 | 0.2 | 0.3 | m | 82 | | | | |
| 28 | 균열 | 0.2 | 0.3 | m | 83 | | | | |
| 29 | 균열 | 0.1 | 0.6 | m | 84 | | | | |
| 30 | 균열 | 0.1 | 0.6 | m | 85 | | | | |
| 31 | 균열 | 0.2 | 0.6 | m | 86 | | | | |
| 32 | 균열 | 0.1 | 0.6 | m | 87 | | | | |
| 33 | 균열 | 0.1 | 0.6 | m | 88 | | | | |
| 34 | 균열 | 0.2 | 0.6 | m | 89 | | | | |
| 35 | 균열 | 0.2 | 0.6 | m | 90 | | | | |
