호남고속선 부용터널-135(14.180~14.190km, S133)

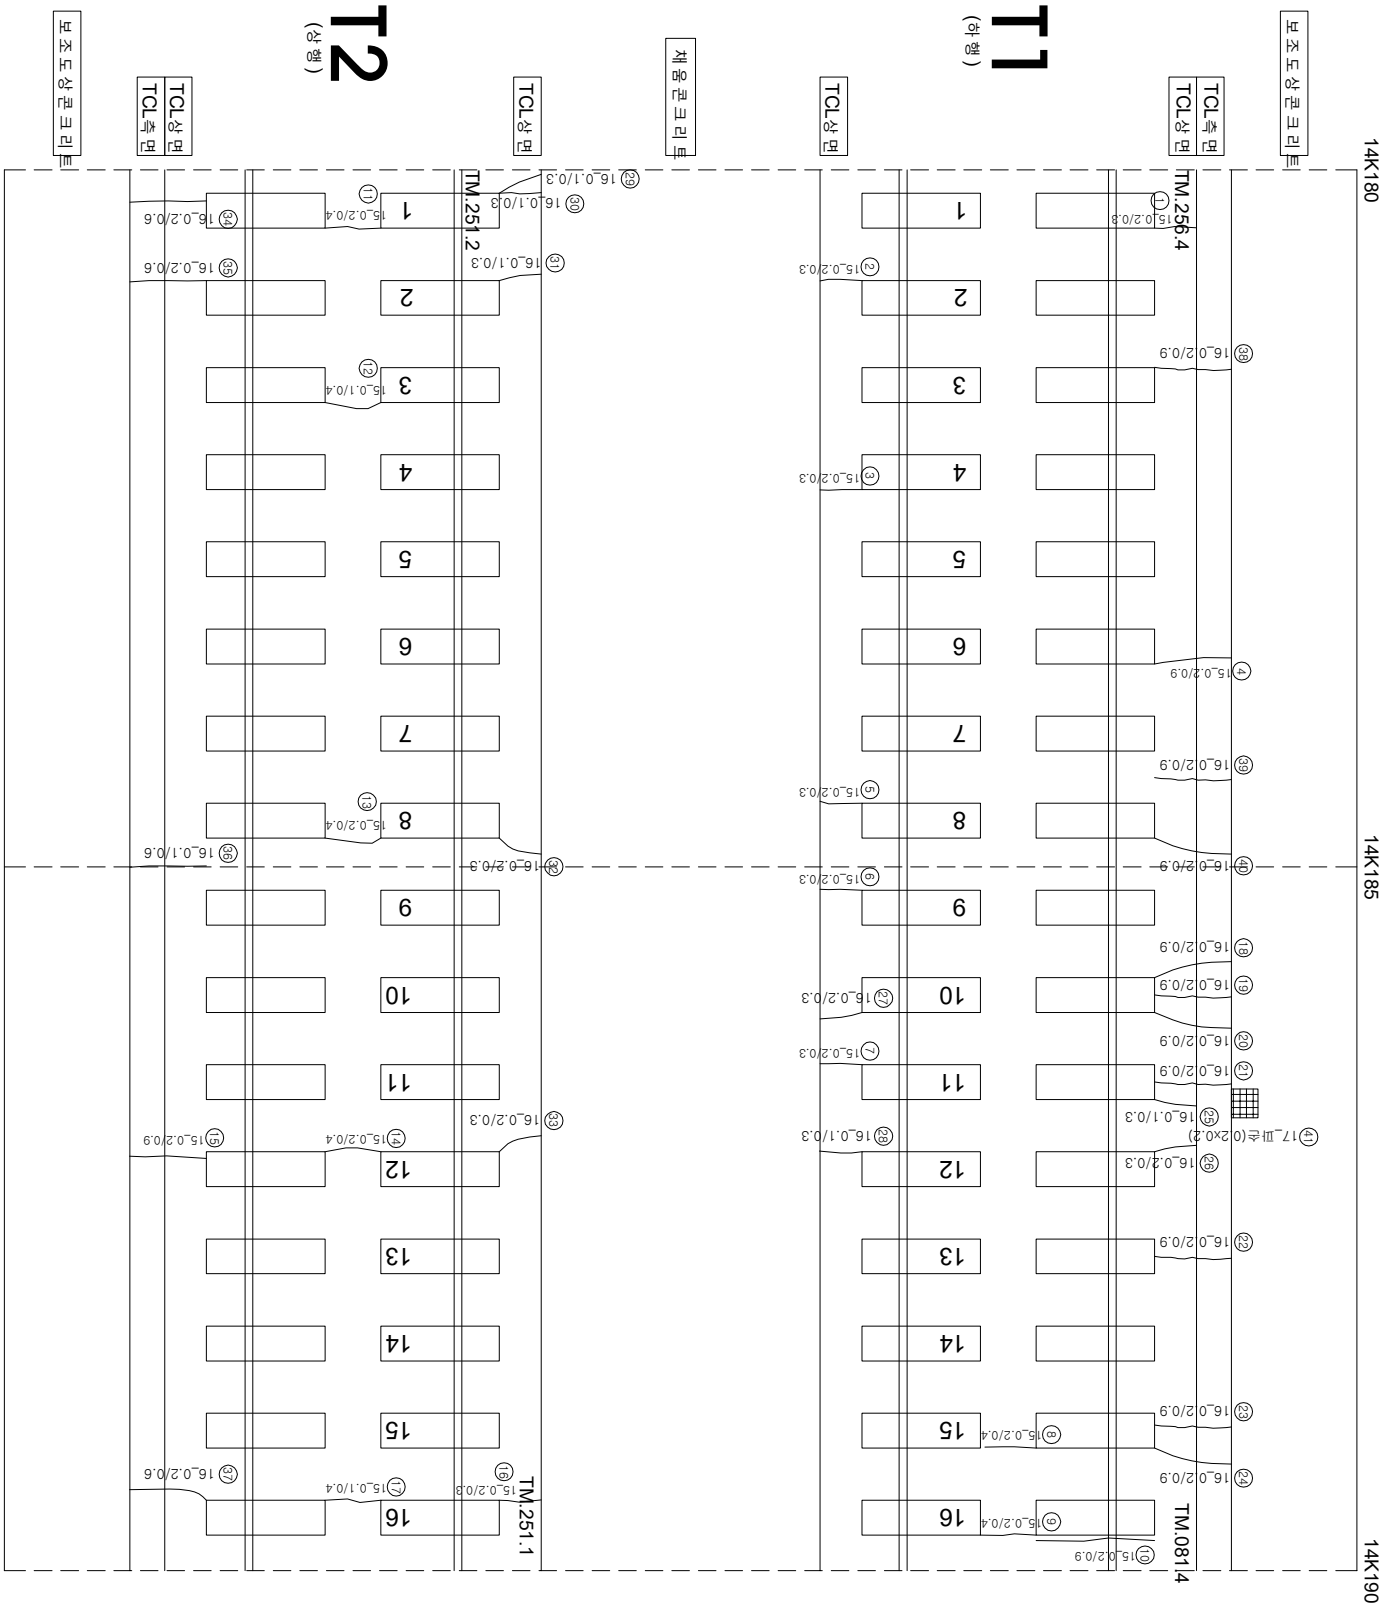
| 연번 | 순상 | 북 | 연장 | 비고 | 연번 | 순상 | 북 | 연장 | 비고 |
|---|---|---|---|---|---|---|---|---|---|
| 10 | 경계부 균열 | 0.2 | mm | 0.9 | m | 65 | | | |
| 41 | 파손 | 0.2 | m | 0.2 | m | 96 | 신규 | | |
