호남고속선 부용터널-145(14.280~14.290km, S143)

| 시 | 행 | 사 | 용 | 역 | 영 | 사 | 단 | | |
|---|---|---|---|---|---|---|---|---|---|
| KORAIL<br>KOREA RAILROAD | 한국철도공사 | 2017년도 호남고속선 오송-광주승정간 콘크리트케도 점검용역 | (주) 한국구조물안전연구원<br>(주) 한국도로안전연구원<br>(재) 한국건설품질연구원 | 이 복 영 | 간 원 강<br>김 경 기<br>문 준 기 | 영원 | 02220 (0.3m이하 : 목박) | 철로받판리 | 철로받판리 |

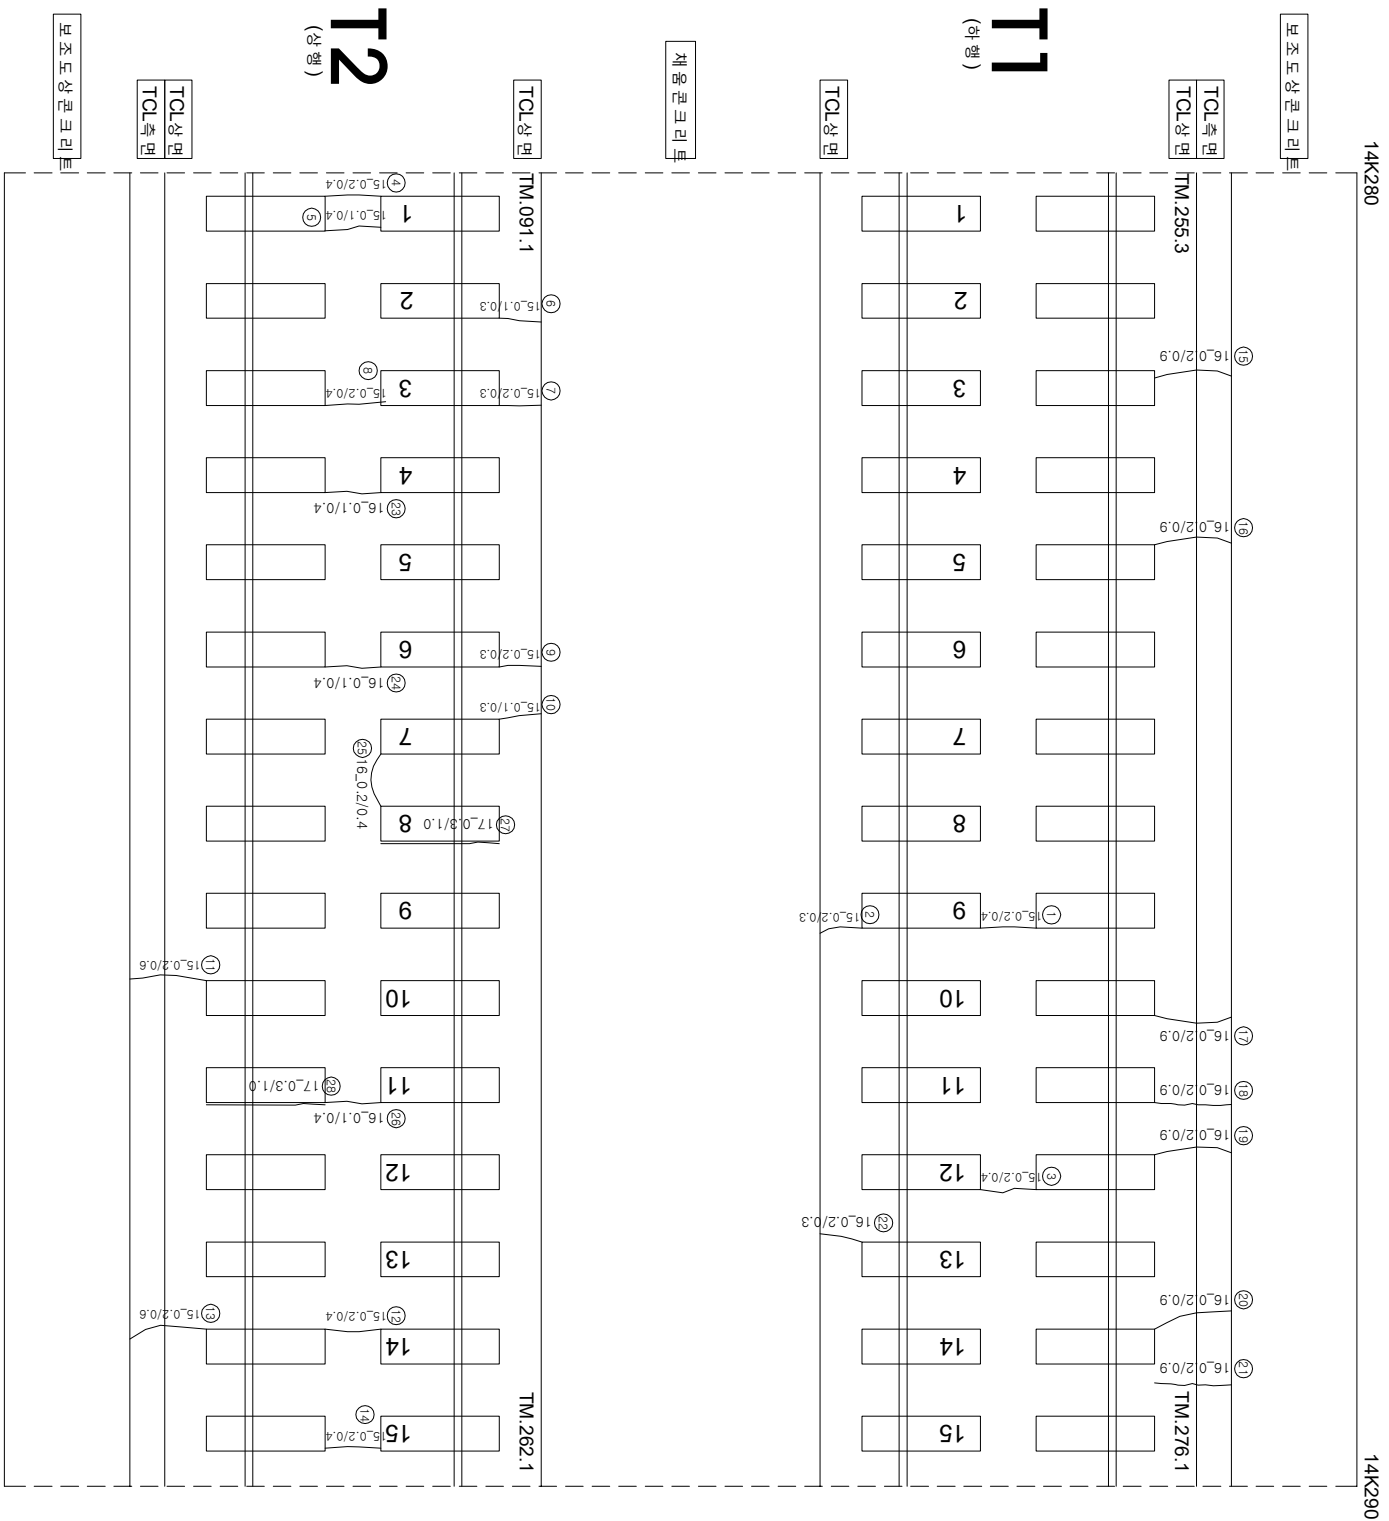
| 연번 | 순상 | 폭 | 연장 | 비고 | 연번 | 순상 | 폭 | 연장 | 비고 |
|---|---|---|---|---|---|---|---|---|---|
| 1 | 균열 | 0.2 mm | 0.4 m | | 56 | | | | |
| 2 | 균열 | 0.2 mm | 0.3 m | | 57 | | | | |
| 3 | 균열 | 0.2 mm | 0.4 m | | 58 | | | | |
| 4 | 균열 | 0.2 mm | 0.4 m | | 59 | | | | |
| 5 | 균열 | 0.1 mm | 0.4 m | | 60 | | | | |
| 6 | 균열 | 0.1 mm | 0.3 m | | 61 | | | | |
| 7 | 균열 | 0.2 mm | 0.3 m | | 62 | | | | |
| 8 | 균열 | 0.2 mm | 0.4 m | | 63 | | | | |
| 9 | 균열 | 0.2 mm | 0.3 m | | 64 | | | | |
| 10 | 균열 | 0.1 mm | 0.3 m | | 65 | | | | |
| 11 | 균열 | 0.2 mm | 0.6 m | | 66 | | | | |
| 12 | 균열 | 0.2 mm | 0.4 m | | 67 | | | | |
| 13 | 균열 | 0.2 mm | 0.6 m | | 68 | | | | |
| 14 | 균열 | 0.2 mm | 0.4 m | | 69 | | | | |
| 15 | 균열 | 0.2 mm | 0.9 m | | 70 | | | | |
| 16 | 균열 | 0.2 mm | 0.9 m | | 71 | | | | |
| 17 | 균열 | 0.2 mm | 0.9 m | | 72 | | | | |
| 18 | 균열 | 0.2 mm | 0.9 m | | 73 | | | | |
| 19 | 균열 | 0.2 mm | 0.9 m | | 74 | | | | |
| 20 | 균열 | 0.2 mm | 0.9 m | | 75 | | | | |
| 21 | 균열 | 0.2 mm | 0.9 m | | 76 | | | | |
| 22 | 균열 | 0.2 mm | 0.3 m | | 77 | | | | |
| 23 | 균열 | 0.1 mm | 0.4 m | | 78 | | | | |
| 24 | 균열 | 0.1 mm | 0.4 m | | 79 | | | | |
| 25 | 균열 | 0.2 mm | 0.4 m | | 80 | | | | |
| 26 | 균열 | 0.1 mm | 0.4 m | | 81 | | | | |
| 27 | 경계부 균열 | 0.3 mm | 1.0 m | 신규 | 82 | | | | |
| 28 | 경계부 균열 | 0.3 mm | 1.0 m | 신규 | 83 | | | | |
