호남고속선 부용터널\_149(14.320~14.330km, S147)

| 시 | 행 사 | 영 역 | 영 역 | 영역 | 사 | 과목명 | | 단 | |
|---|---|---|---|---|---|---|---|---|---|
| KORAIL<br>KOREA RAILROAD | 한국철도공사 | 2017년도 호남고속선 오송-광주승정간 콘크리트케도 점검공여 | (주) 한국구조물안전연구원<br>(주) 한국국토안전연구원<br>(재) 한국건설품질연구원 | 이 복 영 | 김 원 강<br>김 경 기<br>문 준 기 | 조연 | 0220 (0.3m이하 : <b>철석</b> ) | 참모대상분리 | 재료분리 |

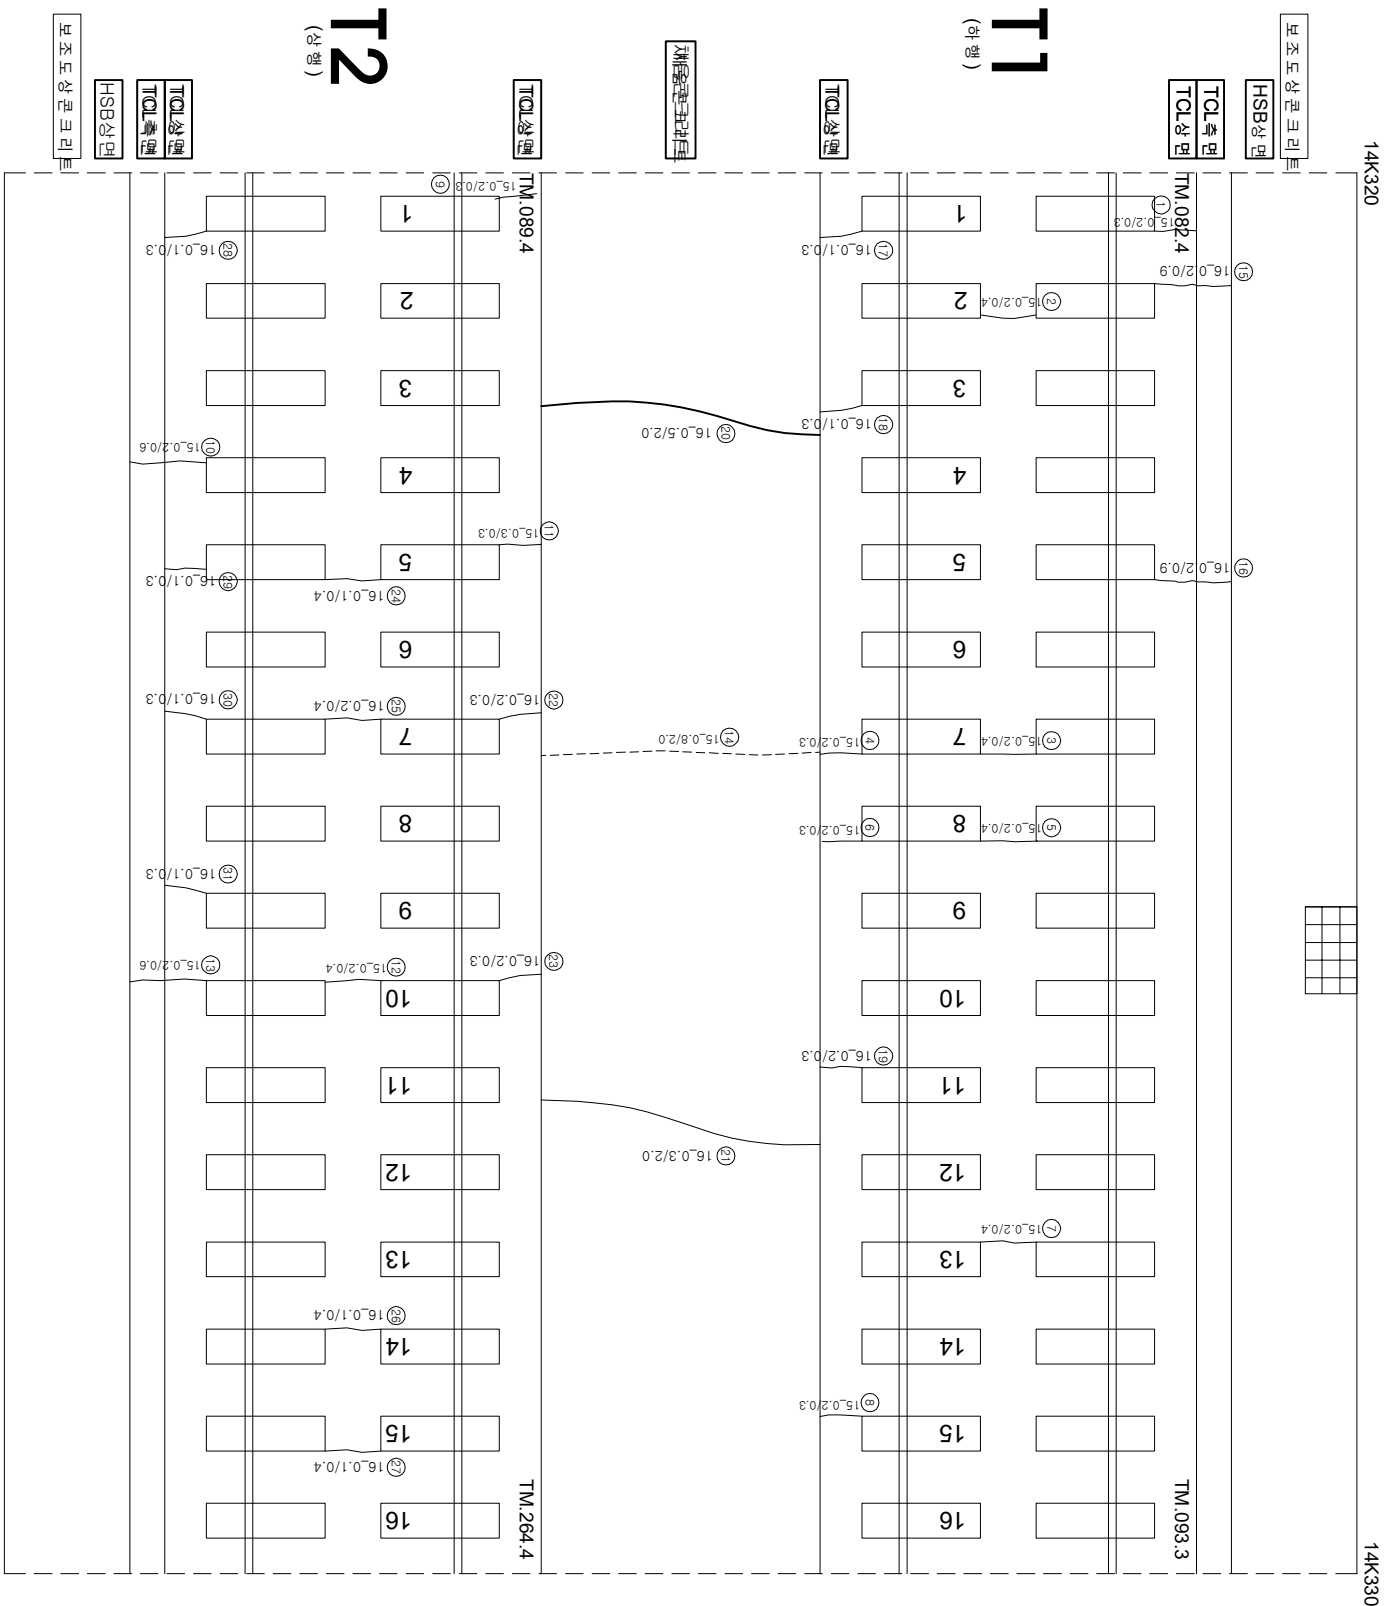
| 연번 | 순상 | 북 | 연장 | 비고 | 연번 | 순상 | 북 | 연장 | 비고 |
|---|---|---|---|---|---|---|---|---|---|
| 1 | 군열 | 0.2 mm | 0.3 m | | 56 | | | | |
| 2 | 군열 | 0.2 mm | 0.4 m | | 57 | | | | |
| 3 | 군열 | 0.2 mm | 0.4 m | | 58 | | | | |
| 4 | 군열 | 0.2 mm | 0.3 m | | 59 | | | | |
| 5 | 군열 | 0.2 mm | 0.4 m | | 60 | | | | |
| 6 | 군열 | 0.2 mm | 0.3 m | | 61 | | | | |
| 7 | 군열 | 0.2 mm | 0.4 m | | 62 | | | | |
| 8 | 군열 | 0.2 mm | 0.3 m | | 63 | | | | |
| 9 | 군열 | 0.2 mm | 0.3 m | | 64 | | | | |
| 10 | 군열 | 0.2 mm | 0.6 m | | 65 | | | | |
| 11 | 군열 | 0.3 mm | 0.3 m | | 66 | | | | |
| 12 | 군열 | 0.2 mm | 0.4 m | | 67 | | | | |
| 13 | 군열 | 0.2 mm | 0.6 m | | 68 | | | | |
| 14 | 군열 | 0.8 mm | 2.0 m | | 69 | | | | |
| 15 | 군열 | 0.2 mm | 0.9 m | | 70 | | | | |
| 16 | 군열 | 0.2 mm | 0.9 m | | 71 | | | | |
| 17 | 군열 | 0.1 mm | 0.3 m | | 72 | | | | |
| 18 | 군열 | 0.1 mm | 0.3 m | | 73 | | | | |
| 19 | 군열 | 0.2 mm | 0.3 m | | 74 | | | | |
| 20 | 군열 | 0.5 mm | 2.0 m | | 75 | | | | |
| 21 | 군열 | 0.3 mm | 2.0 m | | 76 | | | | |
| 22 | 군열 | 0.2 mm | 0.3 m | | 77 | | | | |
| 23 | 군열 | 0.2 mm | 0.3 m | | 78 | | | | |
| 24 | 군열 | 0.1 mm | 0.4 m | | 79 | | | | |
| 25 | 군열 | 0.2 mm | 0.4 m | | 80 | | | | |
| 26 | 군열 | 0.1 mm | 0.4 m | | 81 | | | | |
| 27 | 군열 | 0.1 mm | 0.4 m | | 82 | | | | |
| 28 | 군열 | 0.1 mm | 0.3 m | | 83 | | | | |
| 29 | 군열 | 0.1 mm | 0.3 m | | 84 | | | | |
| 30 | 군열 | 0.1 mm | 0.3 m | | 85 | | | | |
| 31 | 군열 | 0.1 mm | 0.3 m | | 86 | | | | |
