호남고속선 부용터널-158(14.410~14.420km, S156)

| 시 | 행 | 사 | 용 | 역 | 영 | 사 | 단 | | |
|---|---|---|---|---|---|---|---|---|---|
| KORAIL<br>KOREA RAILROAD | 한국철도공사 | 2017년도 호남고속선 오송-광주승정간 콘크리트케도 점검용역 | (주) 한국구조물안전연구원<br>(주) 한국도로안전연구원<br>(재) 한국건설품질연구원 | 이 복 영 | 간 원 강<br>김 경 기<br>문 준 기 | 영원 | 02220 (0.3m이하 : 목박) | 철로받판리 | 철로받판리 |

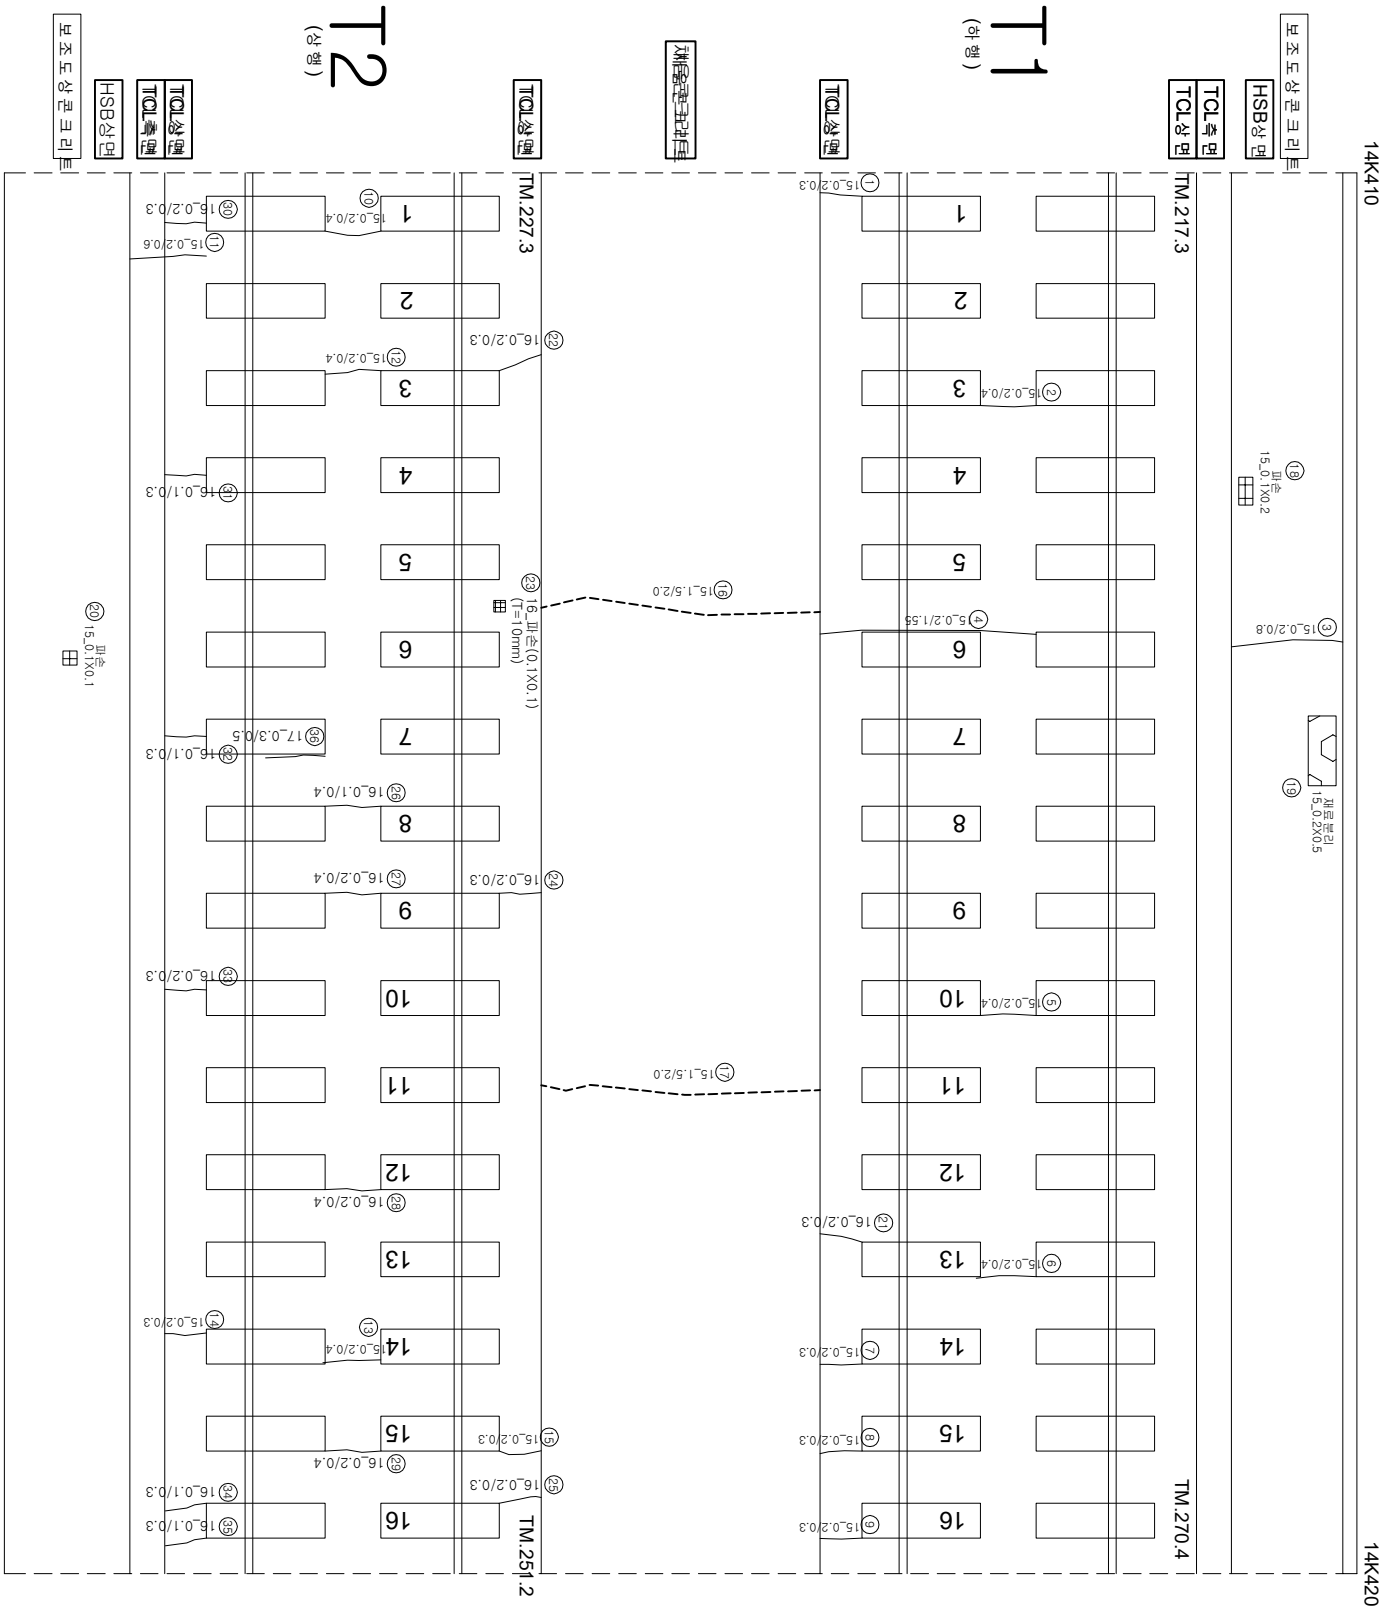
| 연번 | 순상 | 폭 | 연장 | 비고 | 연번 | 순상 | 폭 | 연장 | 비고 |
|---|---|---|---|---|---|---|---|---|---|
| 1 | 균열 | 0.2 mm | 0.3 m | | 56 | | | | |
| 2 | 균열 | 0.2 mm | 0.4 m | | 57 | | | | |
| 3 | 균열 | 0.2 mm | 0.8 m | | 58 | | | | |
| 4 | 경계부 균열 | 0.2 mm | 1.6 m | | 59 | | | | |
| 5 | 균열 | 0.2 mm | 0.4 m | | 60 | | | | |
| 6 | 균열 | 0.2 mm | 0.4 m | | 61 | | | | |
| 7 | 균열 | 0.2 mm | 0.3 m | | 62 | | | | |
| 8 | 균열 | 0.2 mm | 0.3 m | | 63 | | | | |
| 9 | 균열 | 0.2 mm | 0.3 m | | 64 | | | | |
| 10 | 균열 | 0.2 mm | 0.4 m | | 65 | | | | |
| 11 | 균열 | 0.2 mm | 0.6 m | | 66 | | | | |
| 12 | 균열 | 0.2 mm | 0.4 m | | 67 | | | | |
| 13 | 균열 | 0.2 mm | 0.4 m | | 68 | | | | |
| 14 | 균열 | 0.2 mm | 0.3 m | | 69 | | | | |
| 15 | 균열 | 0.2 mm | 0.3 m | | 70 | | | | |
| 16 | 균열 | 1.5 mm | 2.0 m | | 71 | | | | |
| 17 | 균열 | 1.5 mm | 2.0 m | | 72 | | | | |
| 18 | 파손 | 0.1 m | 0.3 m | | 73 | | | | |
| 19 | 재료분리 | 0.2 m | 0.5 m | | 74 | | | | |
| 20 | 파손 | 0.1 m | 0.1 m | | 75 | | | | |
| 21 | 균열 | 0.2 mm | 0.3 m | | 76 | | | | |
| 22 | 균열 | 0.1 mm | 0.4 m | | 77 | | | | |
| 23 | 파손 | 0.1 m | 0.1 m | | 78 | | | | |
| 24 | 균열 | 0.2 mm | 0.4 m | | 79 | | | | |
| 25 | 균열 | 0.2 mm | 0.4 m | | 80 | | | | |
| 26 | 균열 | 0.1 mm | 0.4 m | | 81 | | | | |
| 27 | 균열 | 0.2 mm | 0.4 m | | 82 | | | | |
| 28 | 균열 | 0.2 mm | 0.4 m | | 83 | | | | |
| 29 | 균열 | 0.2 mm | 0.4 m | | 84 | | | | |
| 30 | 균열 | 0.2 mm | 0.3 m | | 85 | | | | |
| 31 | 균열 | 0.1 mm | 0.3 m | | 86 | | | | |
| 32 | 균열 | 0.1 mm | 0.3 m | | 87 | | | | |
| 33 | 균열 | 0.2 mm | 0.3 m | | 88 | | | | |
| 34 | 균열 | 0.1 mm | 0.3 m | | 89 | | | | |
| 35 | 균열 | 0.1 mm | 0.3 m | | 90 | | | | |
| 36 | 경계부 균열 | 0.3 mm | 0.5 m | 인구 | 91 | | | | |
