호남고속선 장재터널\_153(20.140~20.154km, S152)

| 시 | 행 | 사 | 용 | 역 | 영 | 사 | 단 | | |
|---|---|---|---|---|---|---|---|---|---|
| KORAIL<br>KOREA RAILROAD | 한국철도공사 | 2017년도 호남고속선 오송-광주승정간 콘크리트케도 점검용역 | (주) 한국구조물안전연구원<br>(주) 한국도로안전연구원<br>(재) 한국건설품질연구원 | 이복영 | 간윤강<br>김경기<br>문석기 | 영원 | 0220 (0.3m이하 : 목박) | 점도도상판리 | 재료판리 |

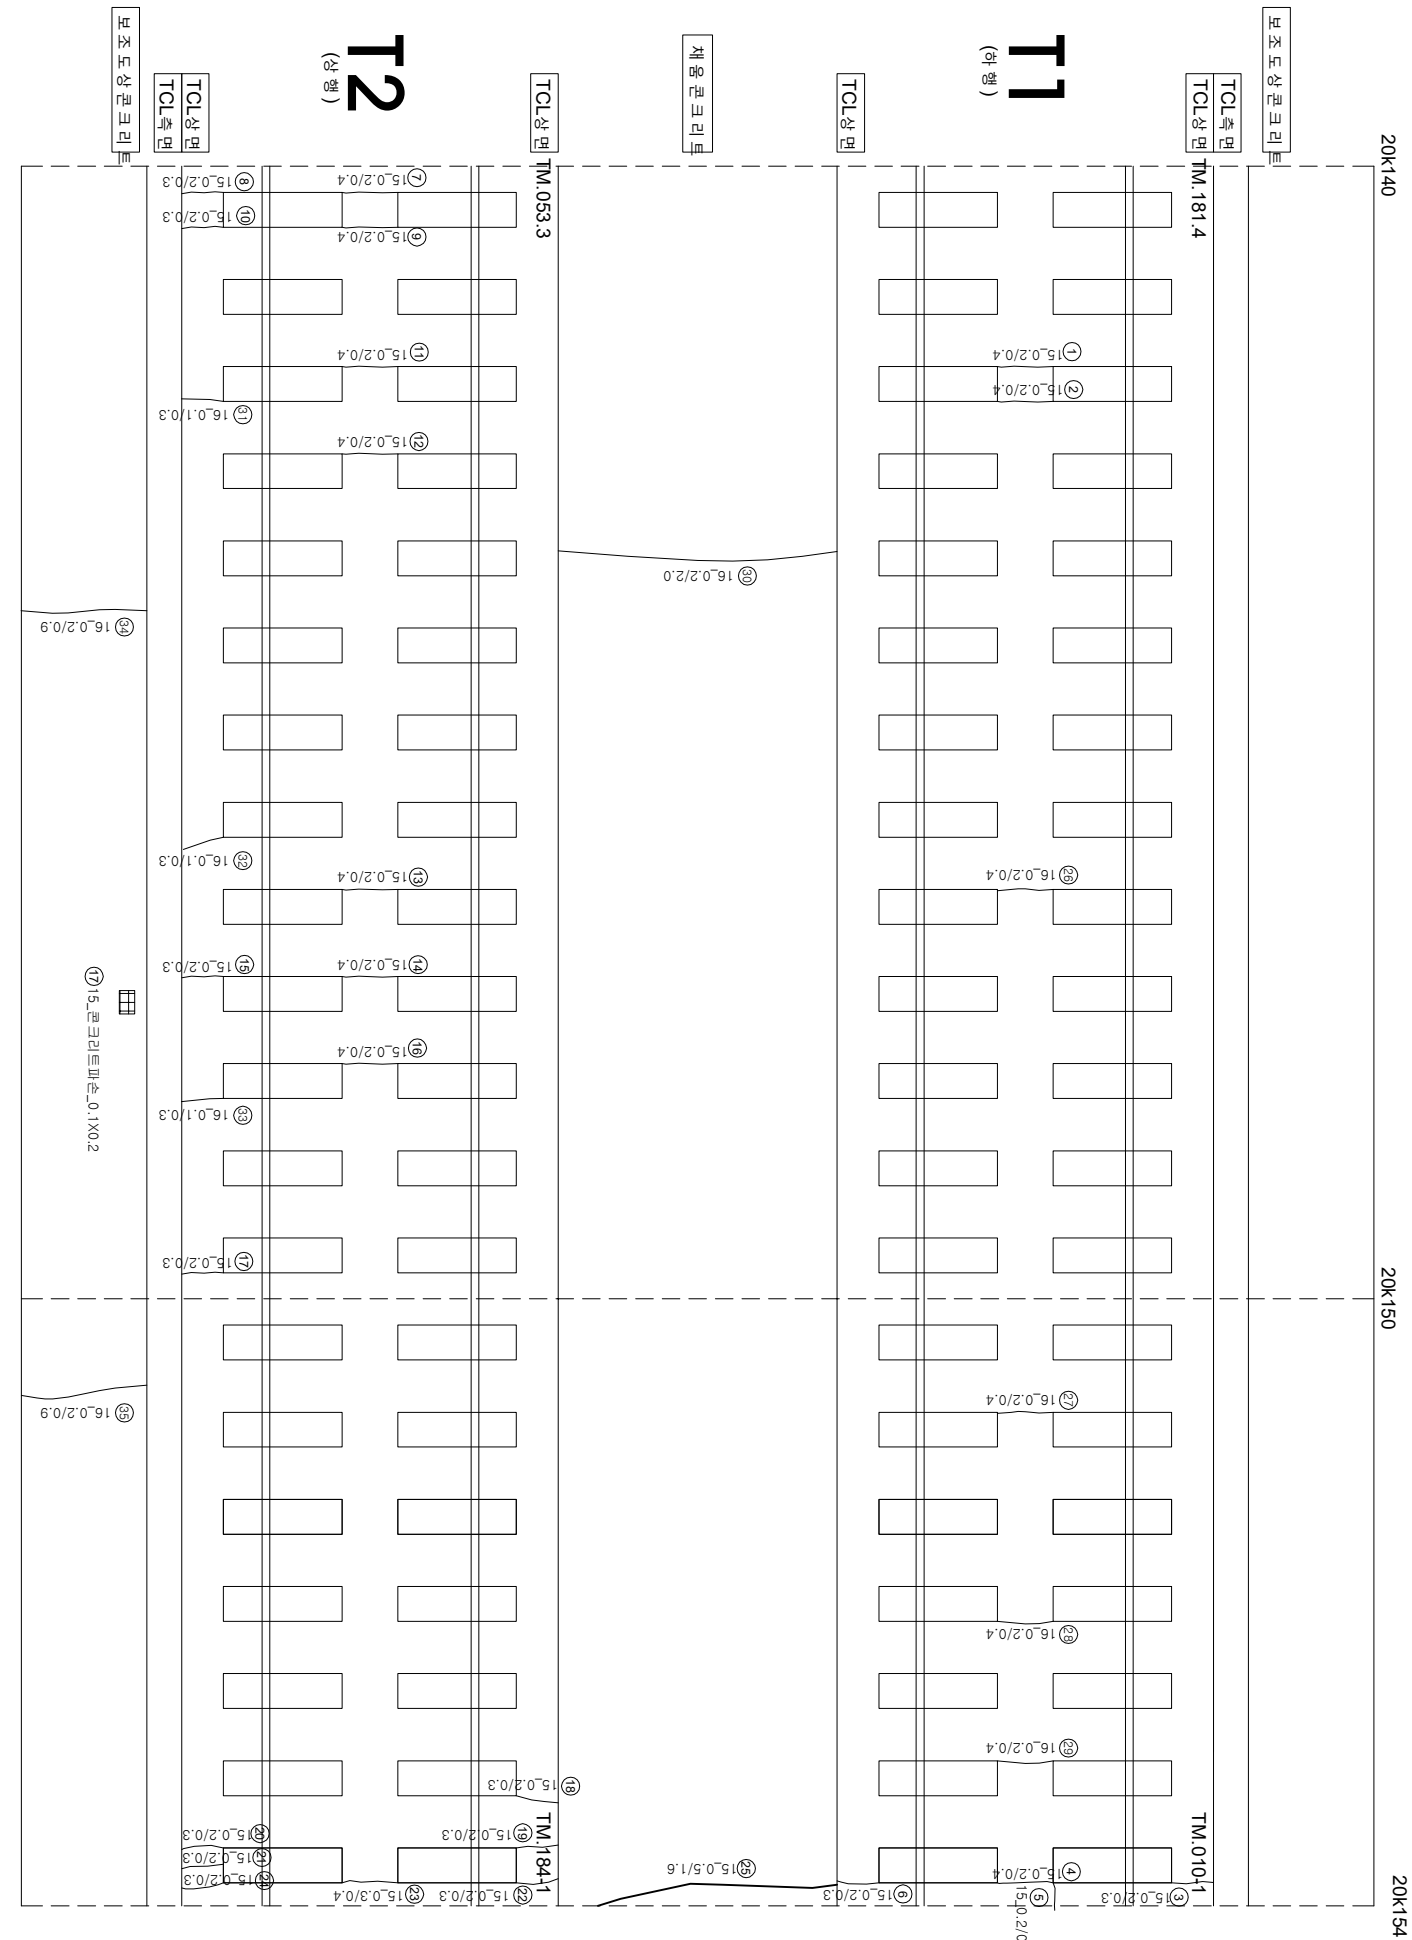
| 연번 | 순상 | 복 | 연장 | 비고 | 연번 | 순상 | 복 | 연장 | 비고 |
|---|---|---|---|---|---|---|---|---|---|
| 1 | 군열 | 0.2 | mm | 0.4 | m | 56 | | | |
| 2 | 군열 | 0.2 | mm | 0.4 | m | 57 | | | |
| 3 | 군열 | 0.2 | mm | 0.3 | m | 58 | | | |
| 4 | 군열 | 0.2 | mm | 0.4 | m | 59 | | | |
| 5 | 군열 | 0.2 | mm | 0.2 | m | 60 | | | |
| 6 | 군열 | 0.2 | mm | 0.3 | m | 61 | | | |
| 7 | 군열 | 0.2 | mm | 0.4 | m | 62 | | | |
| 8 | 군열 | 0.2 | mm | 0.3 | m | 63 | | | |
| 9 | 군열 | 0.2 | mm | 0.4 | m | 64 | | | |
| 10 | 군열 | 0.2 | mm | 0.3 | m | 65 | | | |
| 11 | 군열 | 0.2 | mm | 0.4 | m | 66 | | | |
| 12 | 군열 | 0.2 | mm | 0.4 | m | 67 | | | |
| 13 | 군열 | 0.2 | mm | 0.4 | m | 68 | | | |
| 14 | 군열 | 0.2 | mm | 0.4 | m | 69 | | | |
| 15 | 군열 | 0.2 | mm | 0.3 | m | 70 | | | |
| 16 | 군열 | 0.2 | mm | 0.4 | m | 71 | | | |
| 17 | 복상 | 0.1 | m | 0.2 | m | 72 | | | |
| 18 | 군열 | 0.2 | mm | 0.3 | m | 73 | | | |
| 19 | 군열 | 0.2 | mm | 0.3 | m | 74 | | | |
| 20 | 군열 | 0.2 | mm | 0.3 | m | 75 | | | |
| 21 | 군열 | 0.2 | mm | 0.3 | m | 76 | | | |
| 22 | 군열 | 0.2 | mm | 0.3 | m | 77 | | | |
| 23 | 군열 | 0.3 | mm | 0.4 | m | 78 | | | |
| 24 | 군열 | 0.2 | mm | 0.3 | m | 79 | | | |
| 25 | 군열 | 0.5 | mm | 1.6 | m | 80 | | | |
| 26 | 군열 | 0.2 | mm | 0.4 | m | 81 | | | |
| 27 | 군열 | 0.2 | mm | 0.4 | m | 82 | | | |
| 28 | 군열 | 0.2 | mm | 0.4 | m | 83 | | | |
| 29 | 군열 | 0.2 | mm | 0.4 | m | 84 | | | |
| 30 | 군열 | 0.2 | mm | 2.0 | m | 85 | | | |
| 31 | 군열 | 0.1 | mm | 0.3 | m | 86 | | | |
| 32 | 군열 | 0.1 | mm | 0.3 | m | 87 | | | |
| 33 | 군열 | 0.1 | mm | 0.3 | m | 88 | | | |
| 34 | 군열 | 0.2 | mm | 0.9 | m | 89 | | | |
| 35 | 군열 | 0.2 | mm | 0.9 | m | 90 | | | |
