호남고속선 영곡터널\_7(22.464~22.477km, S7)

외관조사망도 번호

U6\_영곡터널\_7(22k464~22k477)

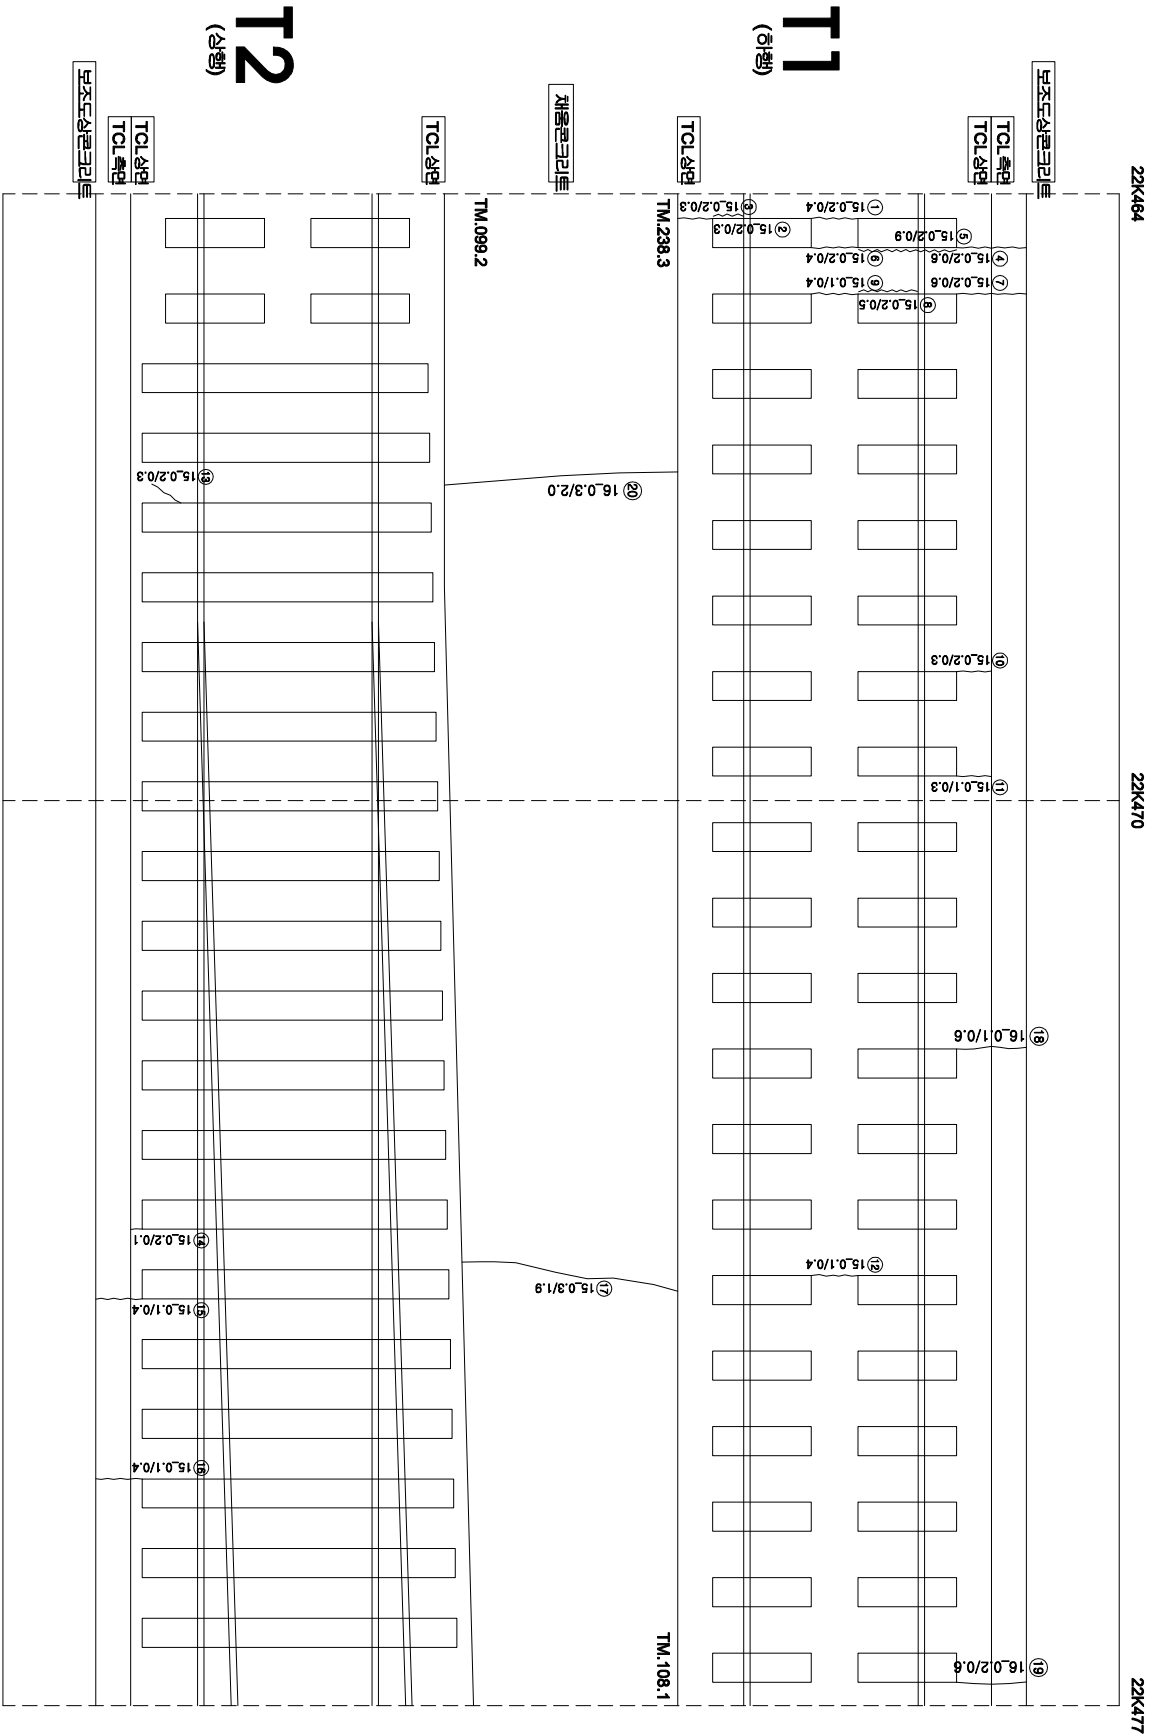
| 연번 | 순상 | 폭 | 단면 | 비고 | 연번 | 순상 | 폭 | 단면 | 비고 |
|---|---|---|---|---|---|---|---|---|---|
| 1 | 균열 | 0.2 mm | 0.4 m | | 56 | | | | |
| 2 | 경계부 균열 | 0.2 mm | 0.3 m | | 57 | | | | |
| 3 | 균열 | 0.2 mm | 0.3 m | | 58 | | | | |
| 4 | 경계부 균열 | 0.2 mm | 0.6 m | | 59 | | | | |
| 5 | 균열 | 0.2 mm | 0.8 m | | 60 | | | | |
| 6 | 균열 | 0.2 mm | 0.4 m | | 61 | | | | |
| 7 | 균열 | 0.2 mm | 0.6 m | | 62 | | | | |
| 8 | 경계부 균열 | 0.2 mm | 0.5 m | | 63 | | | | |
| 9 | 균열 | 0.1 mm | 0.4 m | | 64 | | | | |
| 10 | 균열 | 0.2 mm | 0.3 m | | 65 | | | | |
| 11 | 균열 | 0.1 mm | 0.3 m | | 66 | | | | |
| 12 | 균열 | 0.1 mm | 0.4 m | | 67 | | | | |
| 13 | 균열 | 0.2 mm | 0.3 m | | 68 | | | | |
| 14 | 균열 | 0.2 mm | 0.1 m | | 69 | | | | |
| 15 | 균열 | 0.1 mm | 0.4 m | | 70 | | | | |
| 16 | 균열 | 0.1 mm | 0.4 m | | 71 | | | | |
| 17 | 균열 | 0.3 mm | 1.9 m | | 72 | | | | |
| 18 | 균열 | 0.1 mm | 0.6 m | | 73 | | | | |
| 19 | 균열 | 0.2 mm | 0.6 m | | 74 | | | | |
| 20 | 균열 | 0.3 mm | 2.0 m | | 75 | | | | |
