호남고속선 영곡터널\_381(27.045~27.057km, S381)

| 시 | 행 사 | 용 역 명 | 용 역 사 | 과 일 전 지 | | 장 아 지 | 구 간 | |
|---|---|---|---|---|---|---|---|---|
| KORAIL<br>KOREA RAILROAD | 한국철도공사 | 2017년도 호남고속선 오송-광주승정간 콘크리트케도 점검공역 | (주) 한국국조물안전연구원<br>(주) 한국국토안전연구원<br>(재) 한국건설품질연구원 | 이 복 영<br><br>김 원 강<br>김 경 기<br>문 준 기 | | 0.220 (0.3m이하 : 폭식) | 참목도상반리 | |

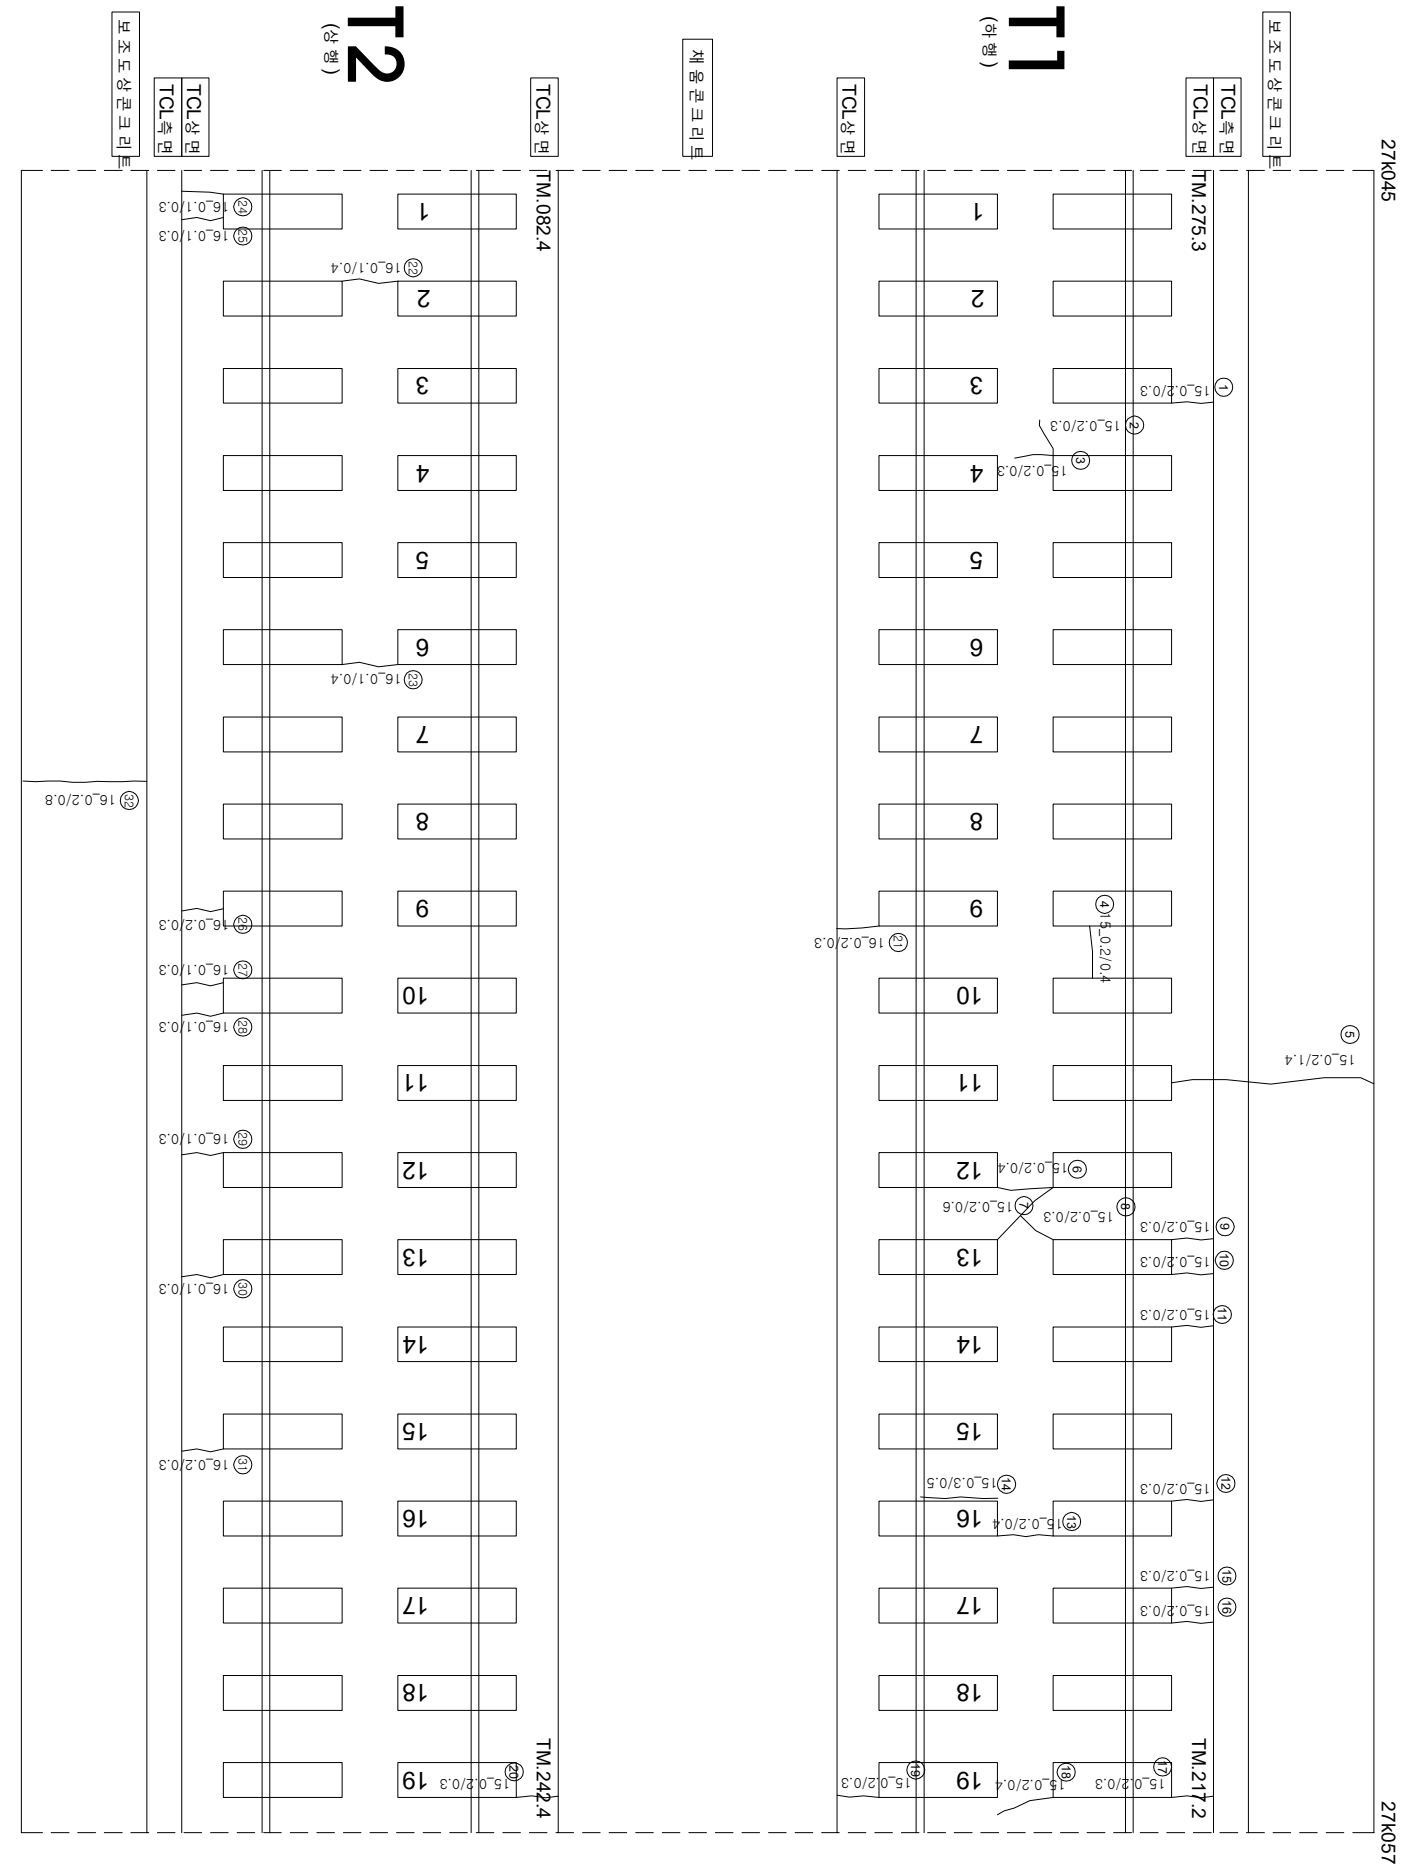
| 연번 | 순차 | 폭 | 연장 | 비고 | 연번 | 순차 | 폭 | 연장 | 비고 |
|---|---|---|---|---|---|---|---|---|---|
| 1 | 균열 | 0.2 mm | 0.3 m | | 56 | | | | |
| 2 | 균열 | 0.2 mm | 0.3 m | | 57 | | | | |
| 3 | 균열 | 0.2 mm | 0.3 m | | 58 | | | | |
| 4 | 균열 | 0.2 mm | 0.4 m | | 59 | | | | |
| 5 | 균열 | 0.2 mm | 1.4 m | | 60 | | | | |
| 6 | 균열 | 0.2 mm | 0.4 m | | 61 | | | | |
| 7 | 균열 | 0.2 mm | 0.6 m | | 62 | | | | |
| 8 | 균열 | 0.2 mm | 0.3 m | | 63 | | | | |
| 9 | 균열 | 0.2 mm | 0.3 m | | 64 | | | | |
| 10 | 균열 | 0.2 mm | 0.3 m | | 65 | | | | |
| 11 | 균열 | 0.2 mm | 0.3 m | | 66 | | | | |
| 12 | 균열 | 0.2 mm | 0.3 m | | 67 | | | | |
| 13 | 균열 | 0.2 mm | 0.4 m | | 68 | | | | |
| 14 | 경계부 균열 | 0.3 mm | 0.5 m | | 69 | | | | |
| 15 | 균열 | 0.2 mm | 0.3 m | | 70 | | | | |
| 16 | 균열 | 0.2 mm | 0.3 m | | 71 | | | | |
| 17 | 균열 | 0.2 mm | 0.3 m | | 72 | | | | |
| 18 | 균열 | 0.2 mm | 0.4 m | | 73 | | | | |
| 19 | 균열 | 0.2 mm | 0.3 m | | 74 | | | | |
| 20 | 균열 | 0.2 mm | 0.3 m | | 75 | | | | |
| 21 | 균열 | 0.2 mm | 0.3 m | | 76 | | | | |
| 22 | 균열 | 0.1 mm | 0.4 m | | 77 | | | | |
| 23 | 균열 | 0.1 mm | 0.4 m | | 78 | | | | |
| 24 | 균열 | 0.1 mm | 0.3 m | | 79 | | | | |
| 25 | 균열 | 0.1 mm | 0.3 m | | 80 | | | | |
| 26 | 균열 | 0.2 mm | 0.3 m | | 81 | | | | |
| 27 | 균열 | 0.1 mm | 0.3 m | | 82 | | | | |
| 28 | 균열 | 0.1 mm | 0.3 m | | 83 | | | | |
| 29 | 균열 | 0.1 mm | 0.3 m | | 84 | | | | |
| 30 | 균열 | 0.1 mm | 0.3 m | | 85 | | | | |
| 31 | 균열 | 0.2 mm | 0.3 m | | 86 | | | | |
| 32 | 균열 | 0.2 mm | 0.8 m | | 87 | | | | |
